# INSPECTOR CLUSEAU'S HOME INSPECTION SERVICE

## INSPECTION REPORT

1234 Main St.  
Loudon TN 37774

08/28/2018 9:00AM

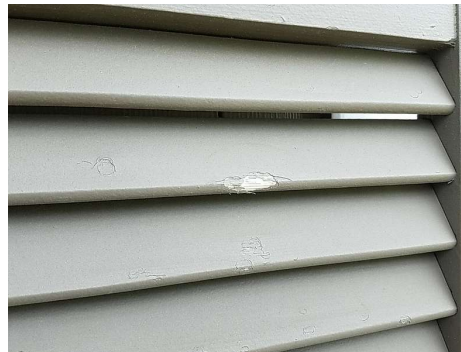
There are blemishes in the surface at several areas around the home (primarily on the front wall - west side facing directional weather). The blemishes are in the surface of the shutters and trim pieces. Wood surfaces should be repaired and painted to discourage deterioration. The blemishes on the trim pieces are mainly aesthetic and can be replaced as desired.

Contact a qualified siding specialist.

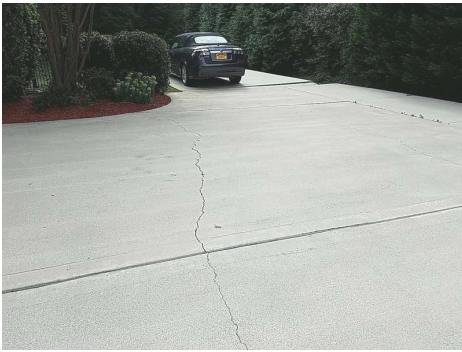
#### Walkways and Driveways: Common Settlement Cracks

Settlement cracks are common to occur and typically are not a reflection of a significant concern. I recommend keeping all cracks sealed to discourage water entry and further cracking and deterioration.

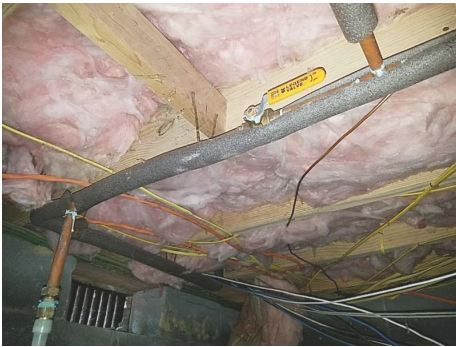
50-60PSI

Water pressure is recommended to be between 40-80 PSI.

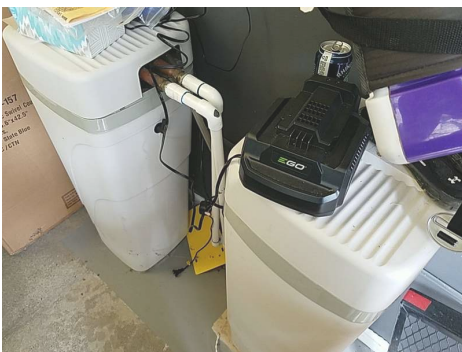
The water softener system in the garage is no longer connected to the plumbing system and is not in service. Consult with the owner to inquire if the system is intended to be removed prior to closing.

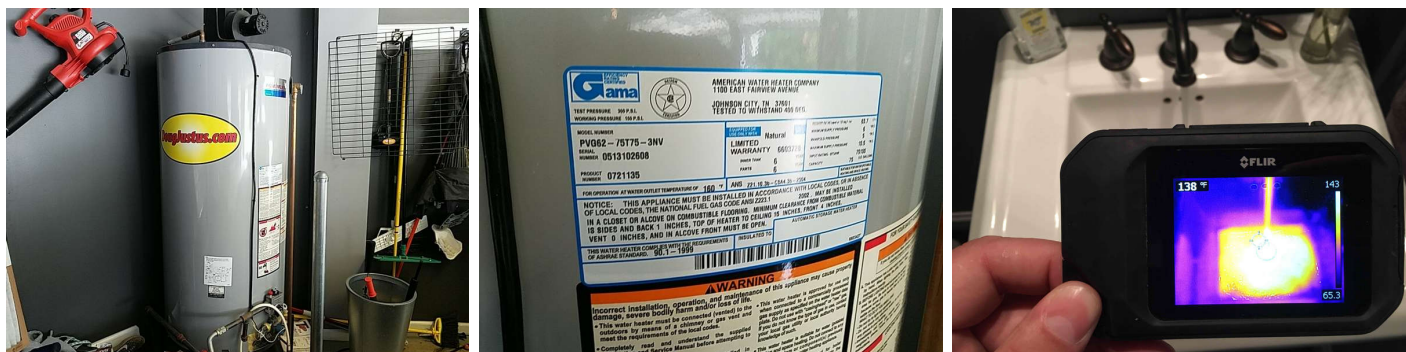
Energy Source: Gas, Gallons: 75, Nearing Average Life Expectancy, Age: 12-14

NOTE: common life expectancy for water heaters is 10-15 years for most units.

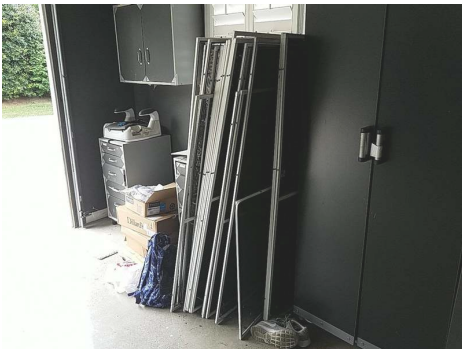
#### Windows: Screens Not Installed

There are no screens installed on various windows. NOTE: the screens are installed in the garage.

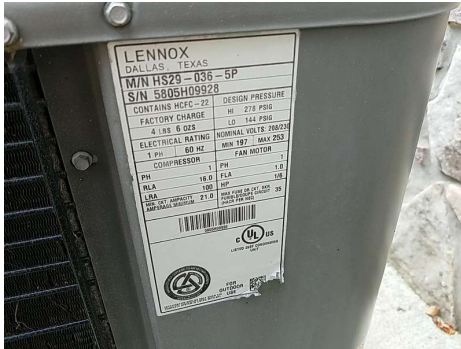
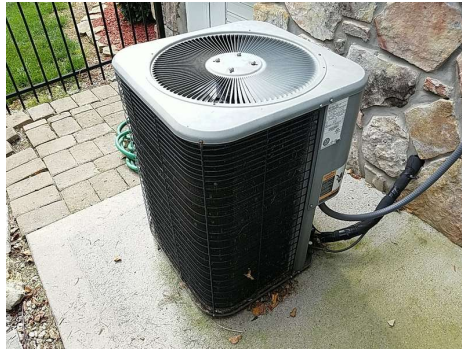
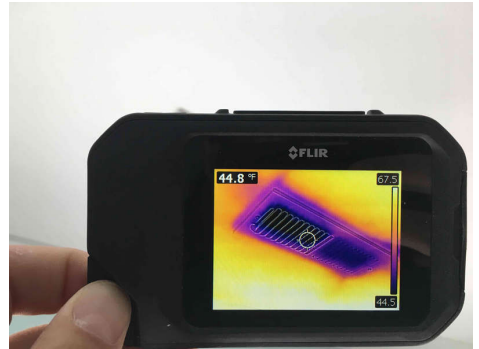
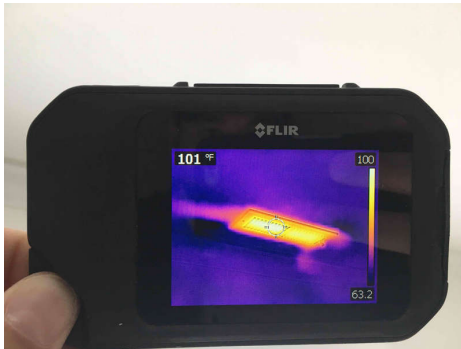
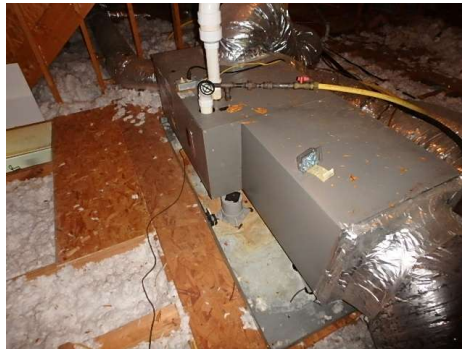
**Compressor:** Brand: Lennox / **Age (Years):** 12-13 / **Tons:** 3

NOTE: the ages listed are approximated based on the dates listed on the manufacturer's label on the unit. The average life expectancy for heating and cooling equipment is 10-15 years for most systems.

**Central System: Component Nearing or Exceeded Life Expectancy**

Common life expectancy for most HVAC systems and components is 10-15 years. There are components present that are nearing or have past the average service life. Notable deficiencies will be listed in this report. I recommend obtaining a home warranty for all components that are nearing or have past their average life along with budgeting for repairs or replacement.

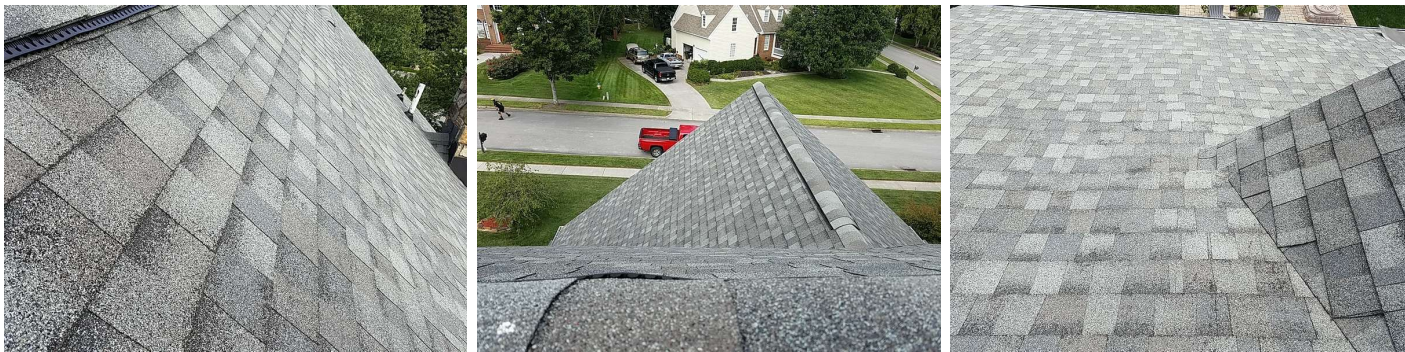
### Shingles: New Dimensional

The shingles are new. This shingle will generally last around 20-25 years in our climate depending on weather conditions and general maintenance.

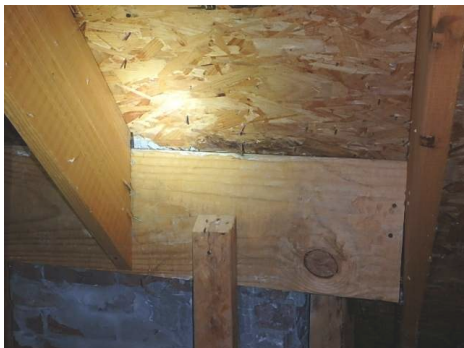
### General: Signs of Previous Leak

There were signs of previous leaks in the attic. All accessible areas were tested with a moisture meter and no moisture was detected unless otherwise specified in this report.

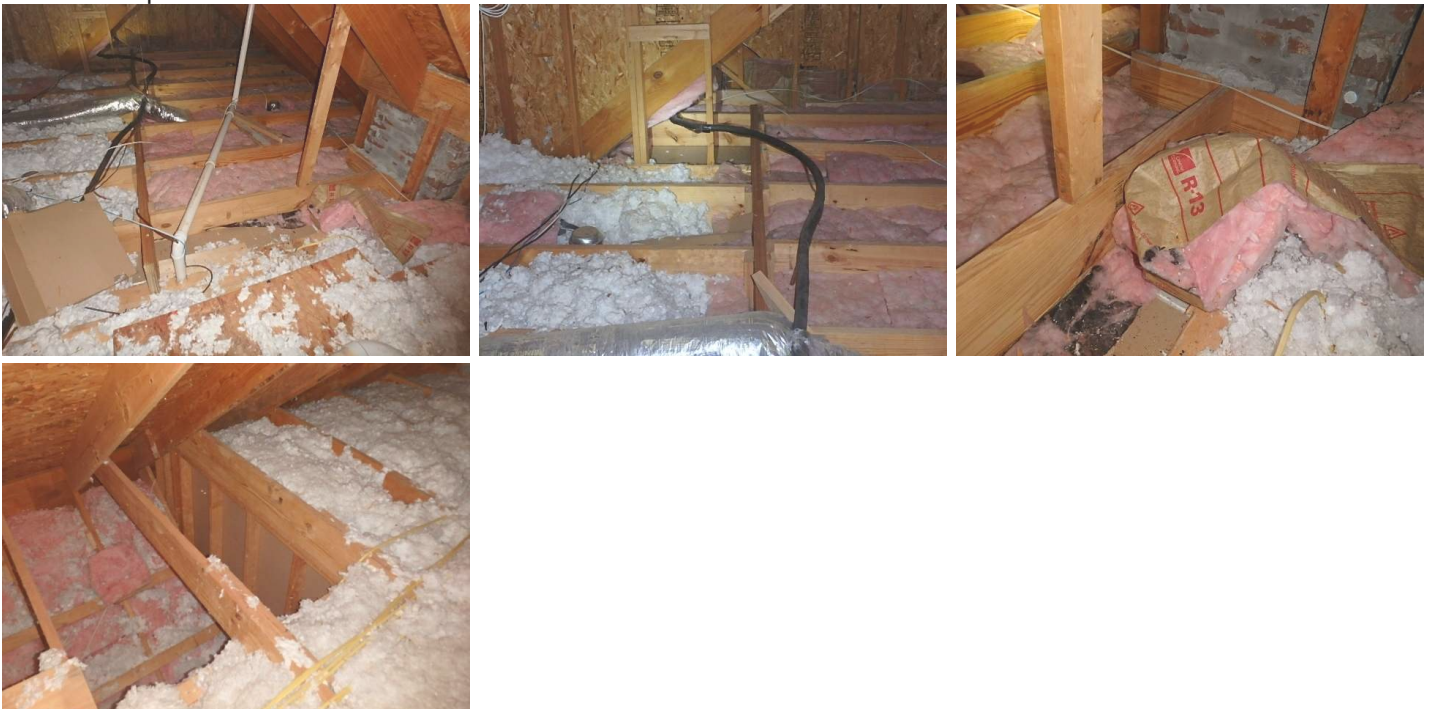
There are areas in the attic that are not properly insulated. This will reduce energy efficiency. I recommend adding or repairing the missing or weak insulation so that all areas are properly insulated for best efficiency. NOTE: current standard for attic insulation is R38.

Contact a qualified insulation contractor.

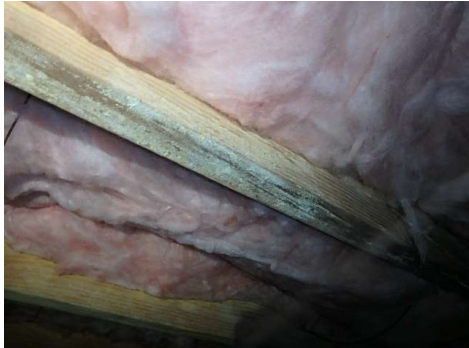
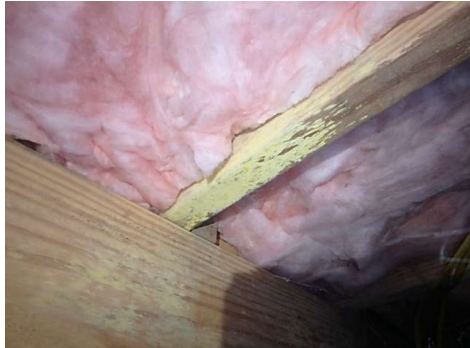
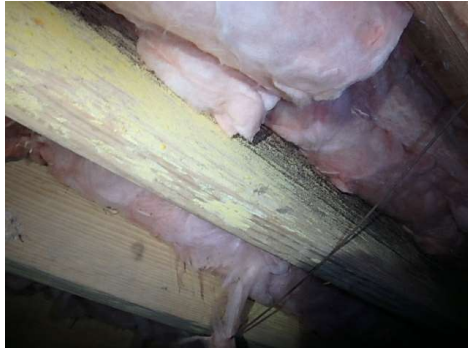
There is fungus on the framing at various locations in the crawlspace. This is an indication of elevated humidity / moisture levels. I recommend contacting an environmental contractor for further review and for possible methods of correction (removal and treatment of the fungus) and prevention (addressing the cause of elevated humidity levels).

Contact a qualified environmental contractor
