SWAN HOME INSPECTIONS PLLC

HOME INSPECTION

1234 Main St.
Porter TX 773654687

PROPERTY INSPECTION REPORT

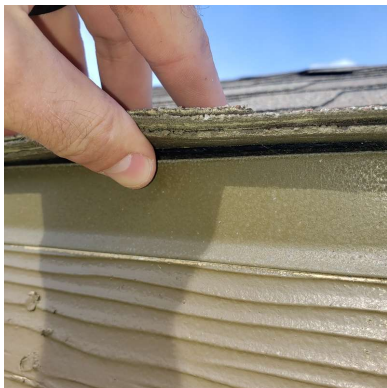
Layers Of Shingles :

One layer of shingles was observed.

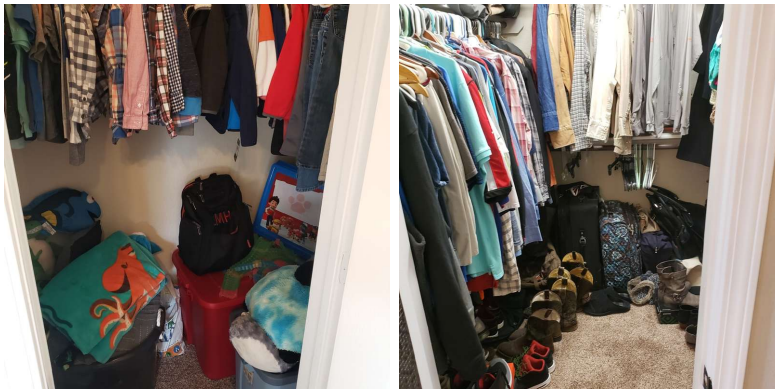
Belongings In Closet :

One or more closets were unable to be fully inspected due to the current homeowners belongings being present.

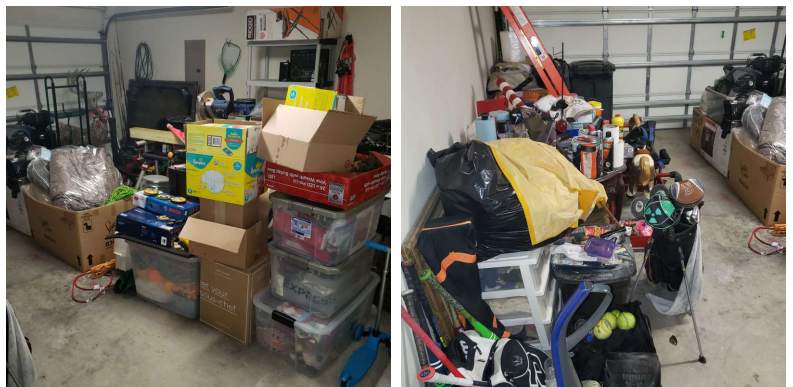
Homeowners Belongings :

Areas of the garage were unable to be fully inspected due to the current homeowners belongings being present.

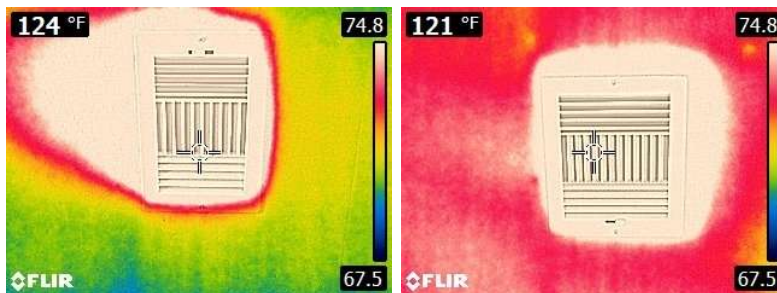
Appears Functional :

Heat supply appears to be in working order. Supply air from the heating system should be 100 Farenheight or more. The photo(s) below is/are a thermal image of the supply air temperature at register(s) at the time of the inspection.

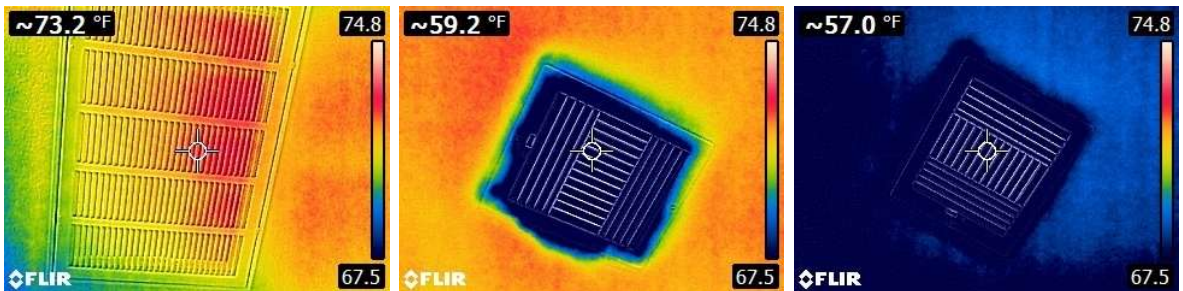
Delta T:

A temperature differential was performed and the cooling system perform within normal ranges (14-22 degrees). A thermal reading of the differential temperature of the supply (ambient) air and the return (vent) air was the test performed, disassembly of the air conditioning system was not performed.

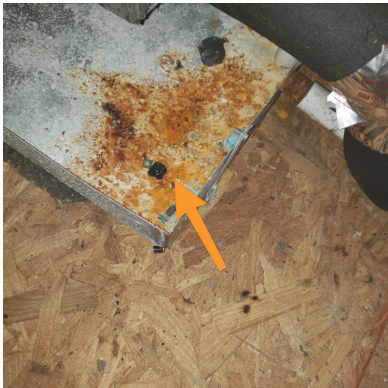
The drain pan is rusted and may fail prematurely. This should ideally be corrected to help prevent water intrusion into the wall/ceiling structure.

Recommendation: Contact a qualified professional.

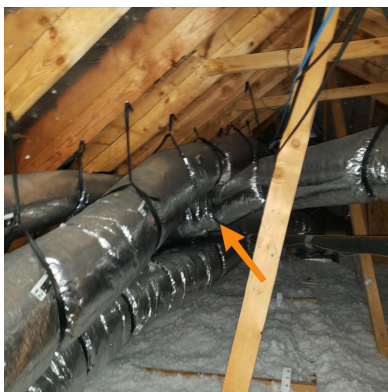
Various supply/return ducts were observed to be in contact with each other. Condensation can develop between contacted areas of the duct work. Separation of contacted ducts is recommended.

Recommendation: Contact a qualified professional.

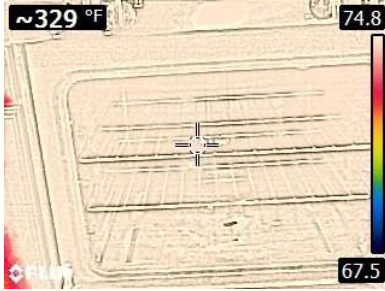
The oven was tested at 350 and read within the acceptable 25 range, in my opinion the oven appear to be functioning as intended.

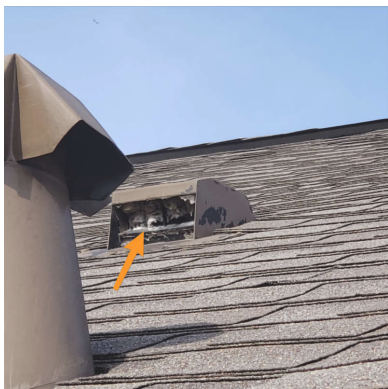
The dryer vent was observed to have lint/be dirty. Recommend having the vent clean by a qualified professional.

Recommendation: Contact a qualified professional.
