SCOTT HOME INSPECTION, LLC

RELOCATION HOME ASSESSMENT FIELD REPORT

1234 Main St.
Arvada CO 80004

04/18/2019 9:00AM

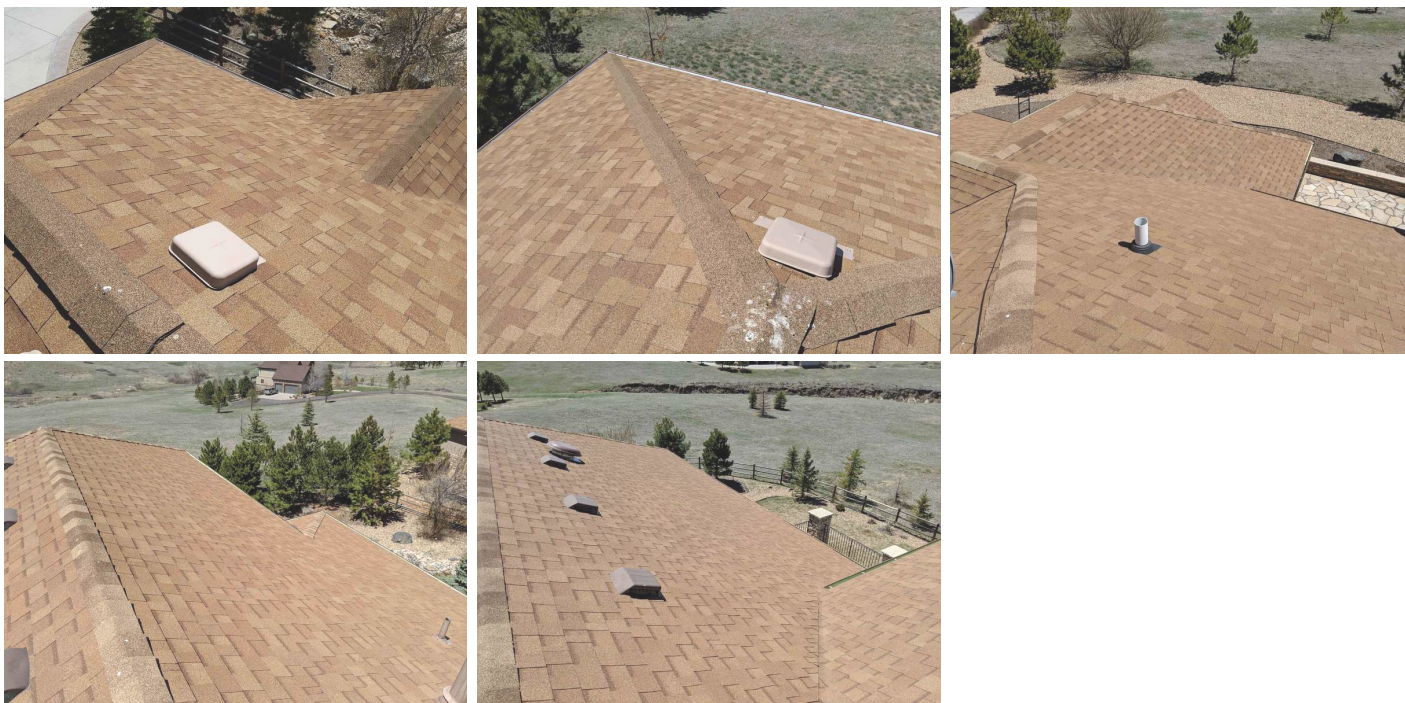
ROOF COVERINGS: Roof walked - no concerns noted

The roof was walked and fully inspected. No concerns or defects were noted at this time.

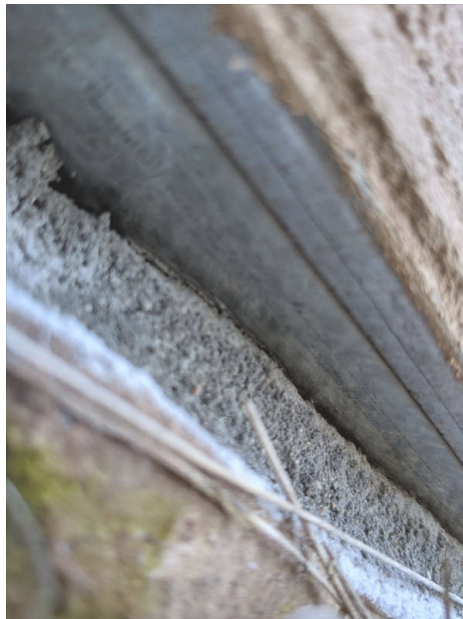
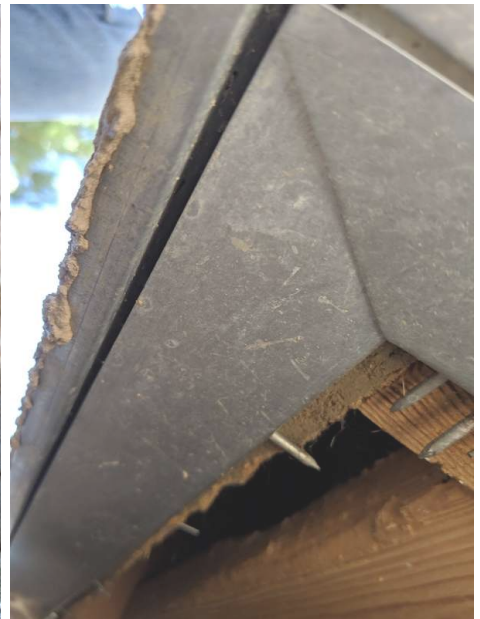
Bottom edge of stucco

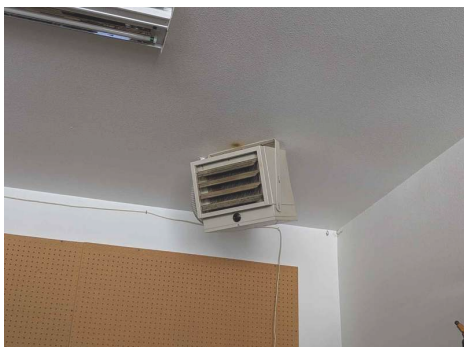
GARAGE HEATING SYSTEM: No concerns noted

The garage has a separate heating system installed. The unit was turned on at the thermostat, and run to ensure it was functional. The unit appears to be working properly with no concerns noted.

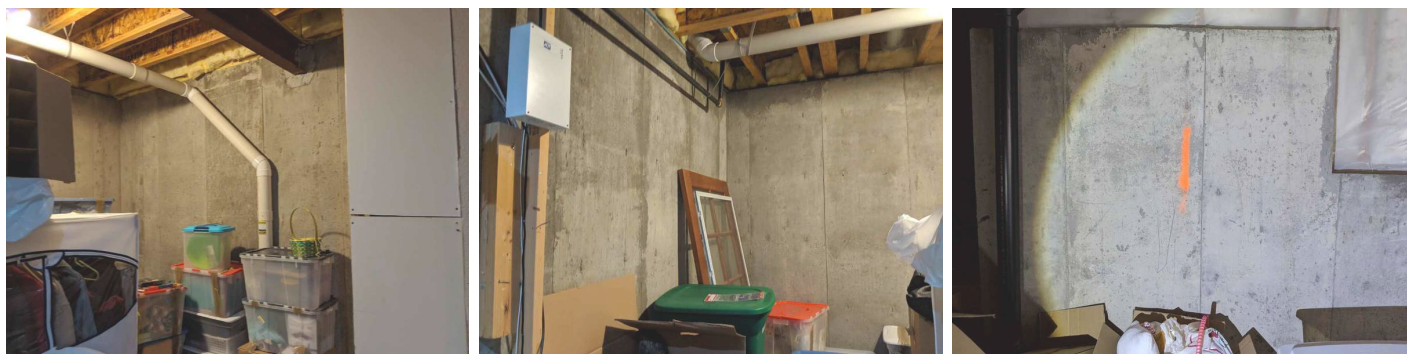
FOUNDATION: Limited visibility of foundation

A limited inspection of the home's foundation was performed. On the inside of the home, the foundation is not visible due to insulation covering the basement walls and/or a finished basement. A visual inspection of the foundation was conducted on the exterior of the home where possible, by observations made above the soil and below the homes outer covering. No obvious foundation concerns were noted. Also, interior indications (ie walls, ceilings and door operation) indicate no obvious structural issues.

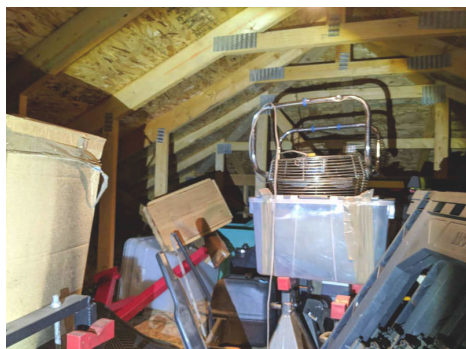
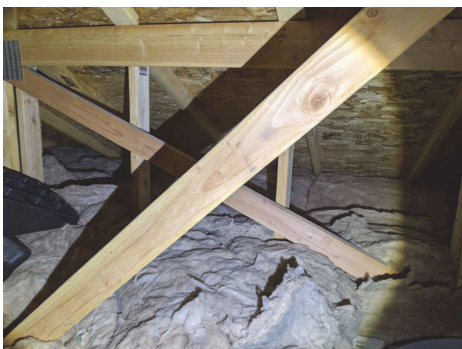
Garage Attic

ROOF FRAMING: No concerns noted

The attic was visually inspected and is properly ventilated, with no structural or moisture concerns noted.

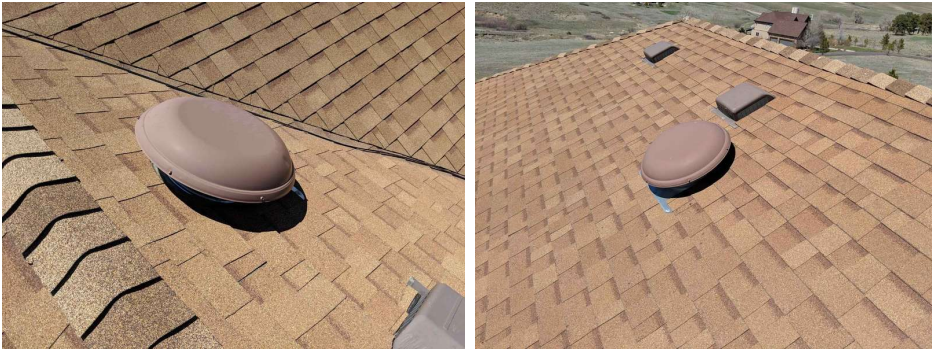
ATTIC FAN: Attic fan operational (2 Units)

There is a thermostatically controlled attic vent fan installed in the attic. This is present to keep the attic ventilated, when the temperature is excessive. The unit was tested and appears to be installed properly.

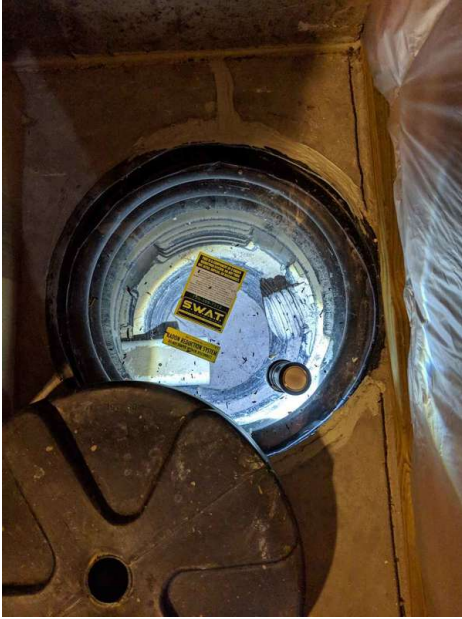
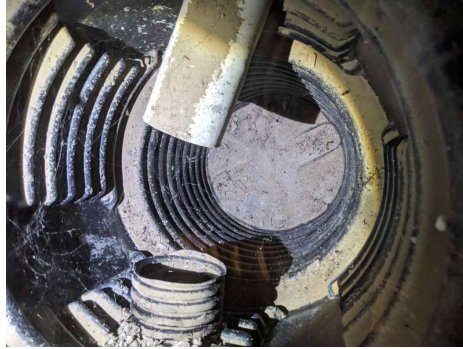
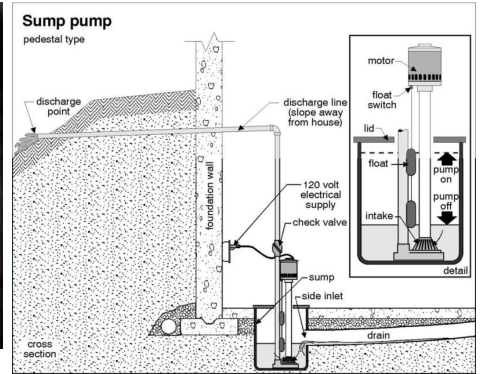
SUMP PUMP: Pit - no pump present

A sump pit is present in this home, however there is no sump pump installed. There was no water in the pit. After a heavy rain or snow melt, the pit should be checked to ensure there is not an excessive amount of water retained. If there is a considerable amount of water in the pit after a heavy rain/snow, a pump should be installed. This is noted for information and maintenance only.

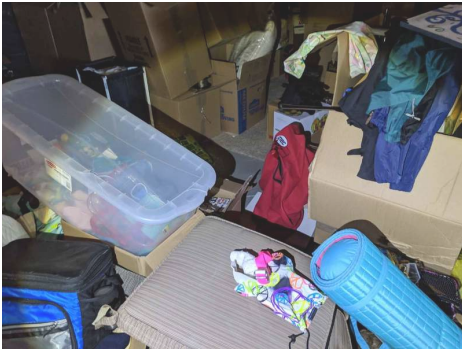
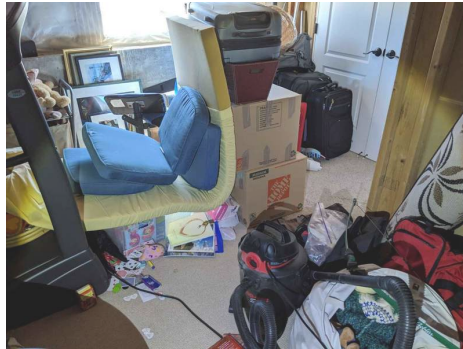
FLOORS: Floor not visible

Visibility of some of the basement floor was limited by finished flooring and/or personal items. The floor was walked where possible, and no concerns were noted.

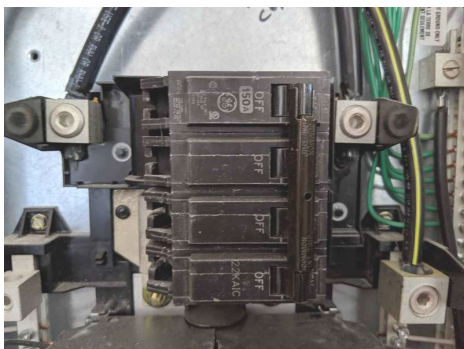
Main for garage panel

MAIN DISCONNECT DEVICE AND LOCATION: Located and inspected

The main electrical panel was located and the exterior housing was observed and is in good condition. The main electrical service disconnect can be used to shut off all power to the home in the event of an electrical emergency or when electrical repairs are needed.

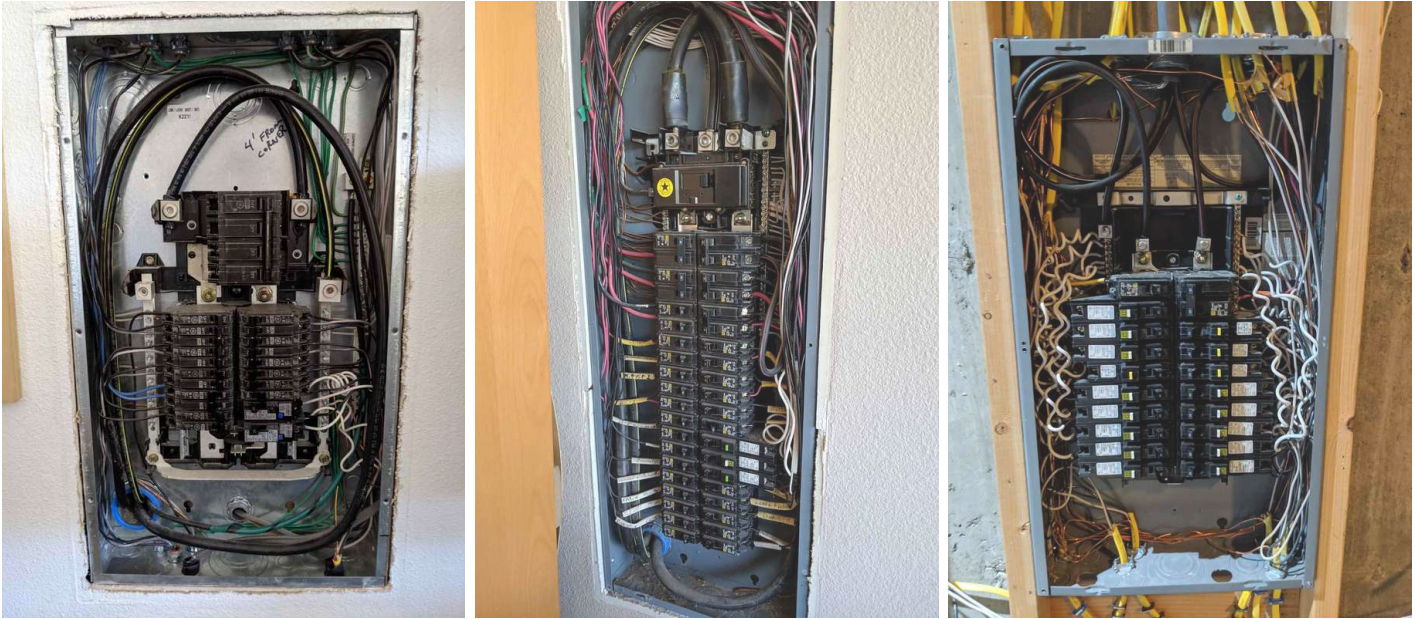
Exterior garage

MAIN & DISTRIBUTION PANELS, SERVICE AND GROUNDING EQUIPMENT, AND LOCATION: Panel(s) inspected - no concerns noted

The interior of the electric panel(s) was inspected, with no concerns noted at this time.

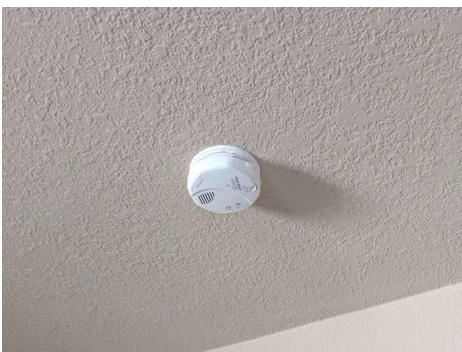
CARBON MONOXIDE ALARMS: Units present In all recommended locations

CO detectors are currently present in the proper locations. Colorado state law requires that all homes being purchased are required to have Carbon Monoxide Alarms installed by the seller. This is a requirement for homes that have a fuel-fired heating system or appliance, a fireplace, or an attached garage. The CO Alarm(s) must be installed within 15 feet of the entrance to each sleeping room. This can be in a hallway outside bedrooms. If bedrooms are located on more than one level, then a separate CO alarm must be installed outside each bedroom area on each level. This inspection includes a review of the presence of CO alarms, and includes pressing the 'test' button to verify operation.

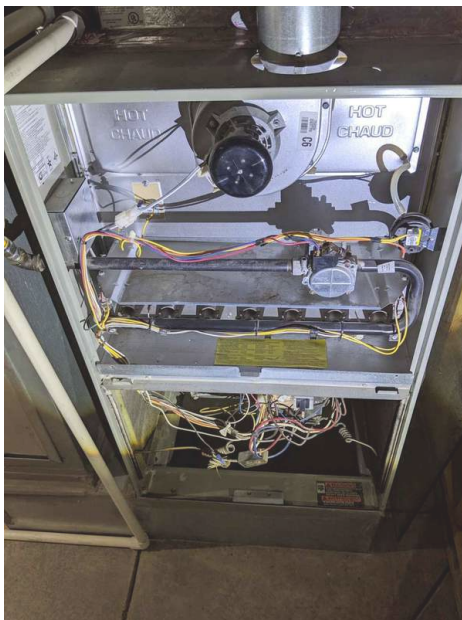
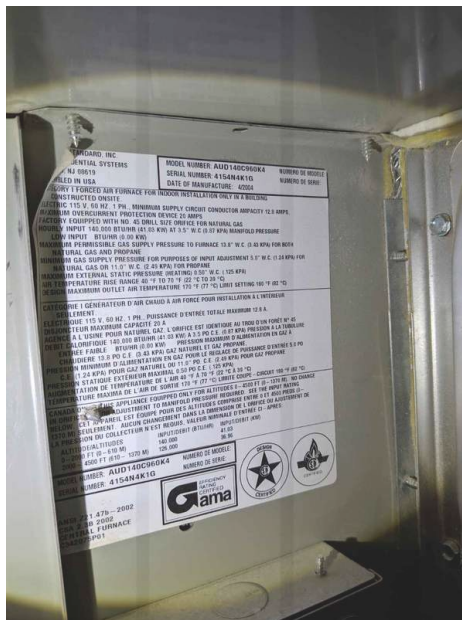
HEATING EQUIPMENT: Furnace tested - no concerns noted

The furnace was fully tested and inspected, and is operating properly at this time. The unit appears to be in good condition. No actions are needed. Periodic changing of the filter and an annual service check up and cleaning of the unit is recommended, to keep the furnace in good working condition.

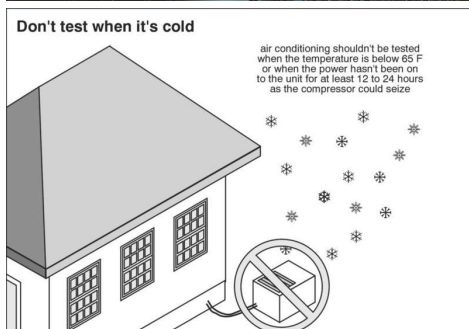
The A/C system(s) was not tested for proper operation because the outside air temperature is 65 degrees or less. Damage to the unit can occur if operated below this temperature. Liquid can be in the compressor unit, and can damage the compressor if run. A limited visual inspection of the system and electrical service was conducted with no concerns noted.

Contact a qualified professional.

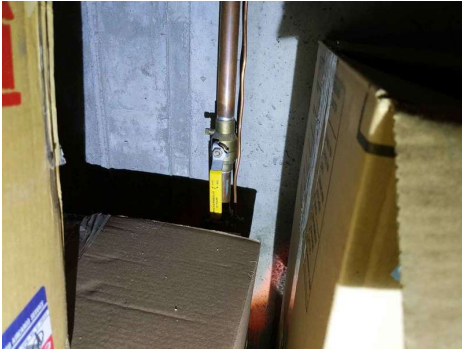
MAIN WATER SHUT-OFF LOCATION: Inspected - no concerns noted

The main water shut-off was inspected, with no visible concerns noted. This can be used to turn all of the water off to the home in the event of a plumbing emergency or when plumbing repairs are needed. **Note:** we do not operate shut off valves - the inspection is a visual review for leaks.

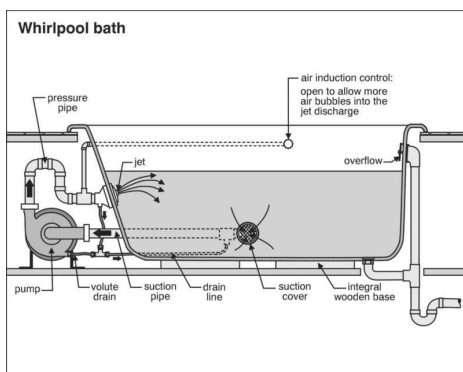
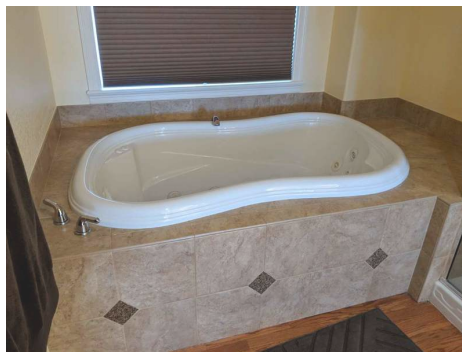
JETTED TUBS: Jetted tub - limited test performed

The jet powered bath tub function was tested at time of inspection. We perform a limited functional test of jetted tubs. We turn on the power switch at the unit, to verify that the pump operates and comes on. We confirm the electrical connection to the unit, and visually inspect under the unit, when an access door is available. We do not fill the tub completely and run the jets with water in the tub. The reason for this is that many times, if a tub has not been used recently, mildew will be present in the jet lines, and will flush into the tub causing the need to clean the tub completely. We recommend that prior to use, the tub be filled, the jets run, and the unit cleaned completely.

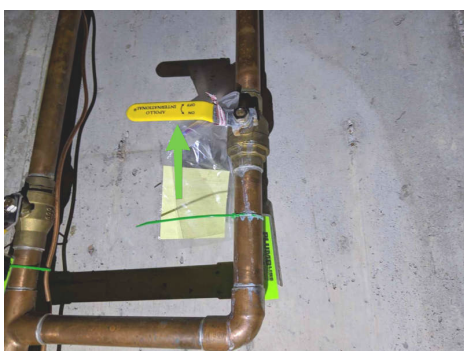
SYSTEM OPERATION: Sprinkler system winterized - visual only

The sprinkler system was not tested due to the colder outside temperatures and appears to be winterized for the season. The main shut off valve for the system was checked and is off at this time. A basic visual inspection of components was performed. The condition of the system is unknown, and it is unknown if proper winterizing was performed. Verify with the current owner that the system was blown-out or drained down and winterized properly. A full test should be done when the system can be de-winterized properly to verify operation.

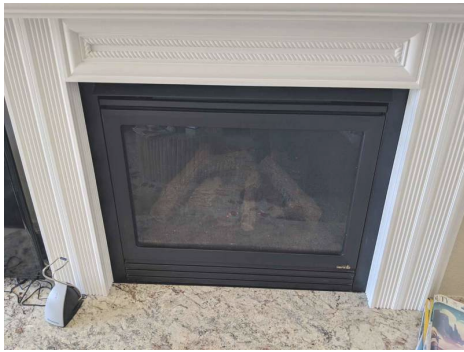
Living room

GAS/LP FIREPLACES: Tested - no concerns noted

The gas fireplace(s) was tested and was functional at the time of the inspection, with no concerns noted.

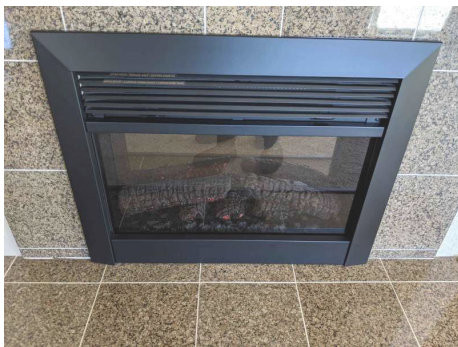
GAS/LP FIREPLACES: Electric fireplace

There is an electronic fireplace present. No concerns noted.

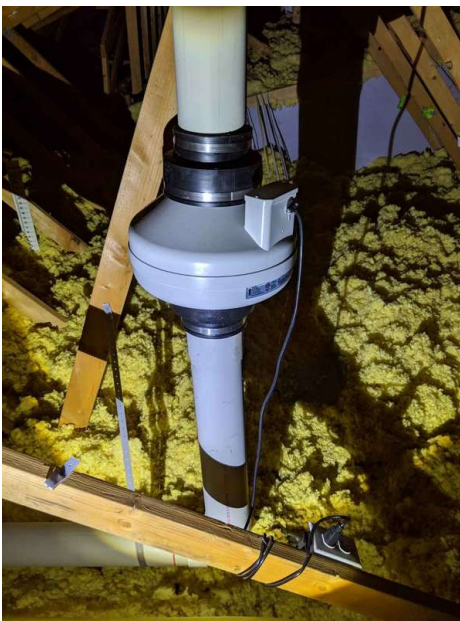
This home appears to have an **active** radon mitigation system. An **active** radon mitigation system has four basic elements: (1) an electric vent fan (located outside of conditioned space, i.e., in the attic, garage or outside the building envelope); (2) a system failure warning device (may also be in the basement); (3) a vent pipe running between sub-slab gravel up to above the roof or eave; and, (4) sealed and caulked cracks and joints. The estimated life of a quality vent fan (operating continuously) is 10 years. In an existing home, the vent fan, wiring and piping are all part of the same installation.
