CAP CITY PROPERTY INSPECTIONS

HOME INSPECTION REPORT COPY

1234 Main St.
Grove City OH 43123

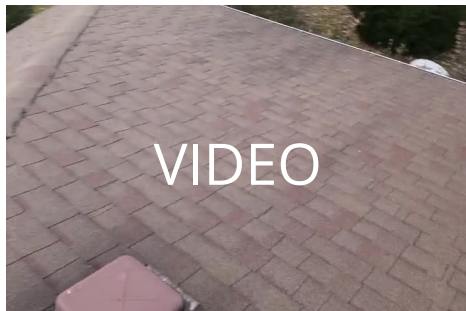
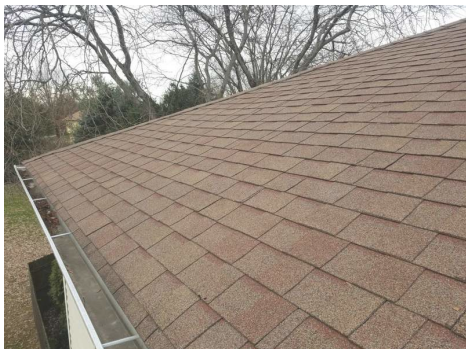
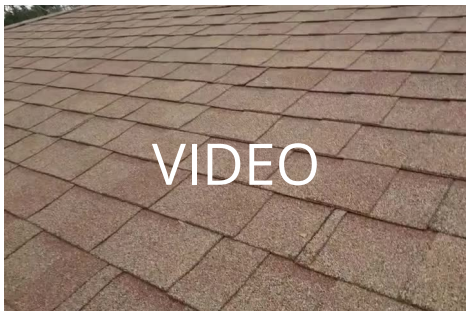
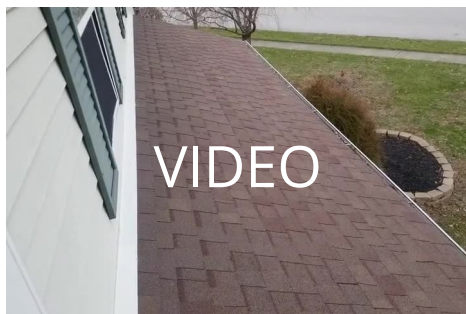
Roof Covering: The roof had not yet reached the Mid Point of it's service life.

The roof had not yet reached the Mid Point of it's service life. These photos are for your information.

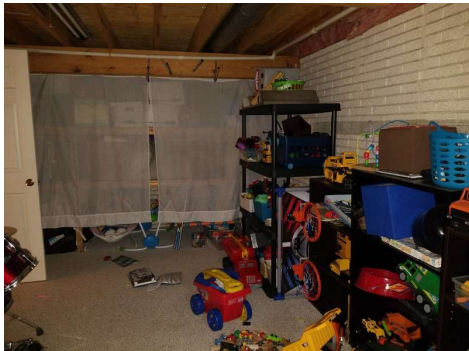
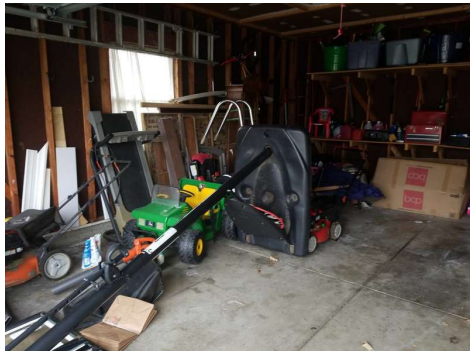
BASEMENT & GARAGE

The inspection was restricted in the noted areas by owners possessions. We were unable to fully view these areas.

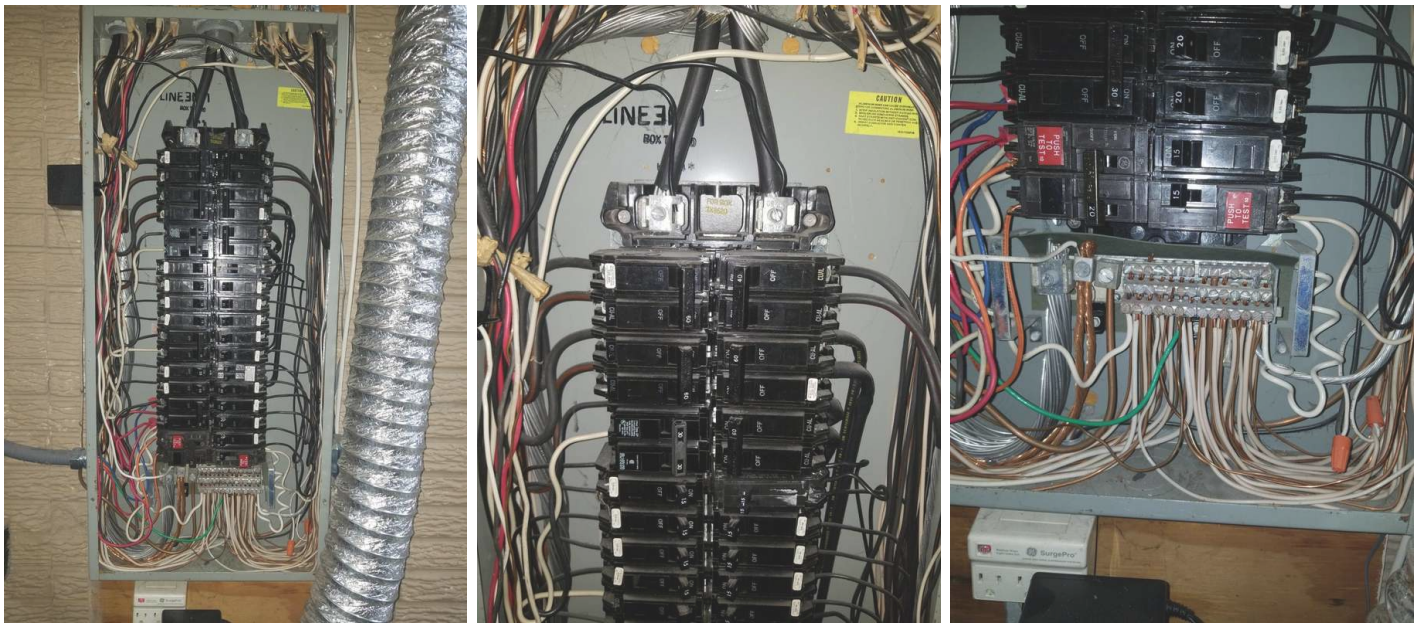
Service Equipment: FYI Photo/Video

This photo of the service panel is for your information.

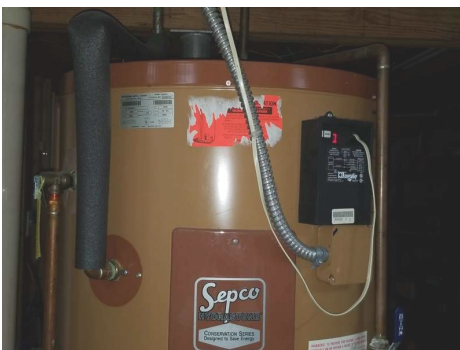
Water Heater: Water heater rented from utility

The water heater appeared to be rented from the utility company. You should ask the owner for any information related to this rental agreement.

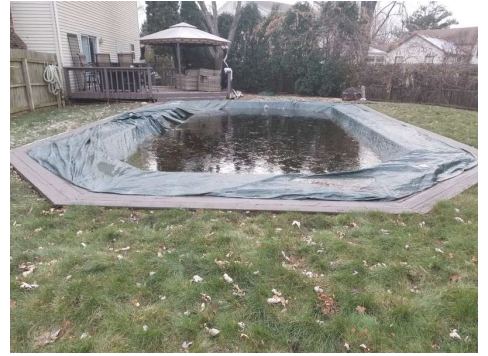
SWIMMING POOL NOT INSPECTED

The swimming pool was not inspected. Inspection of pools fall outside of a general home inspection. You should have the pool serviced and inspected by a qualified swimming pool professional.
