# PREMIER HOME INSPECTIONS OF THE CSRA

## YOUR CUSTOM HOME INSPECTION REPORT

1234 Main St.  
North Augusta SC 29841

Buyer Name  
01/23/2019 9:00AM

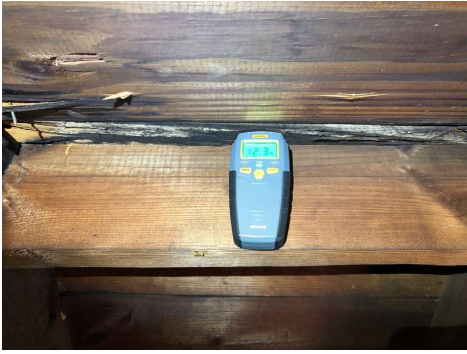
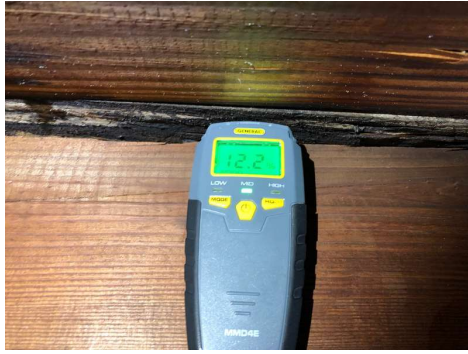
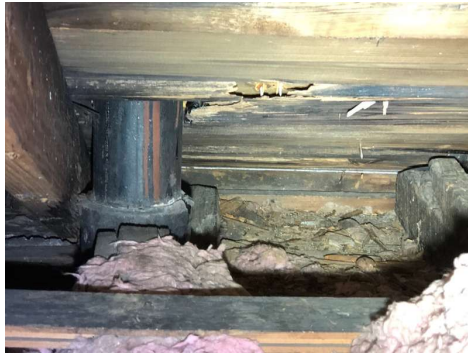
Back Left Side Vent Pipe

**ACTIVE LEAK**

There was an active leak on the roof decking. The moisture reading recorded higher than normal moisture levels. Evaluation and repairs are recommended.

\* The observed leaks were observed at the roof ridge adjacent to the front gable.

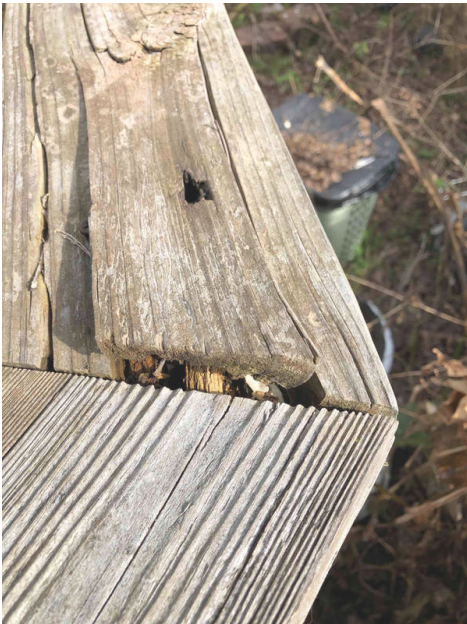
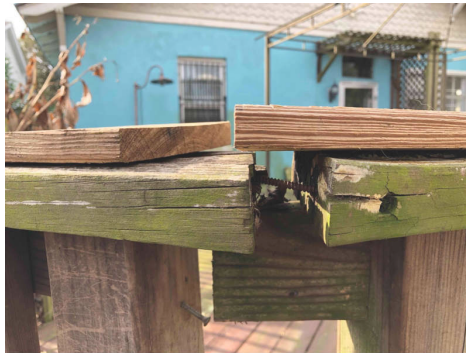
The guard rail exhibited wood rot damages likely due to prolonged water/moisture exposure over time. The damaged areas should be replaced. As part of general maintenance, exterior decking components and the decking surface should be inspected, repainted, and sealed at least every 5 years to ensure the deck structure and all components are in good condition and to prolong the life of the deck.

\*A portion of the railing system was pulling apart. The specific location is the back left side of the railing system.

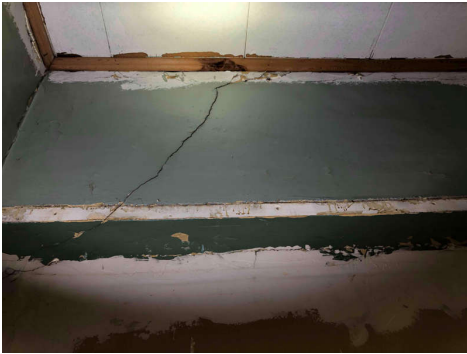
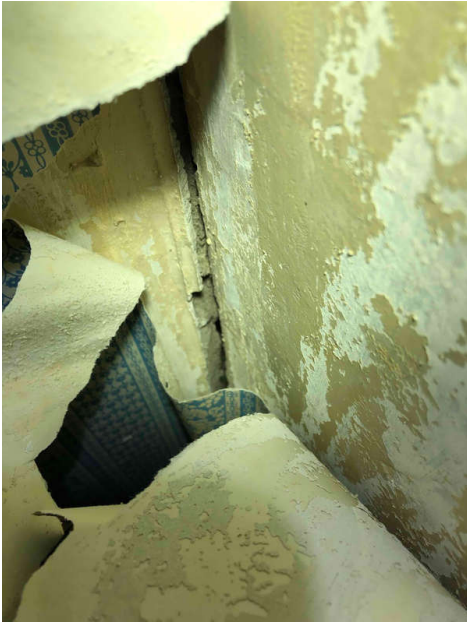
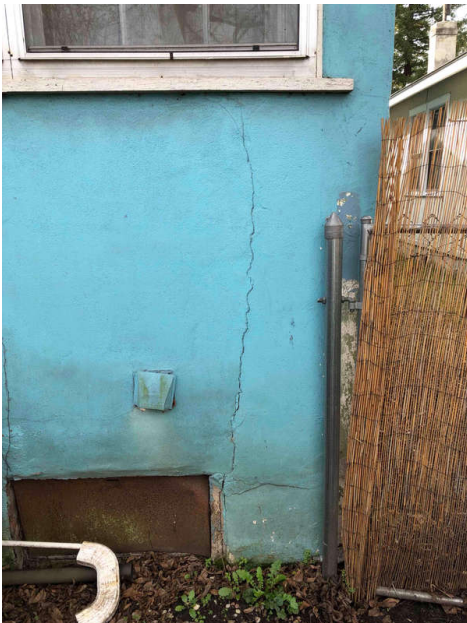
Settlement cracking was observed to have multiple planes of movement in multiple locations both interior and exterior. Generally speaking, the more planes of movement, the more problematic the settlement can be. Further evaluation by a licensed structural engineer is recommended.

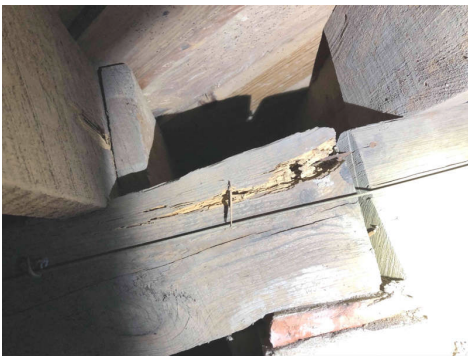
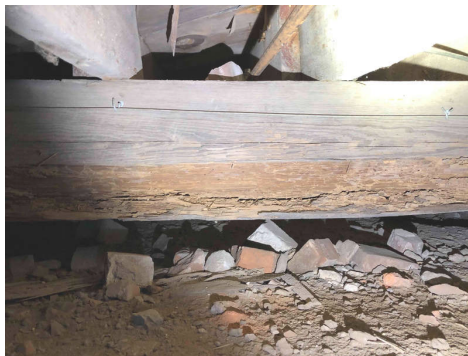
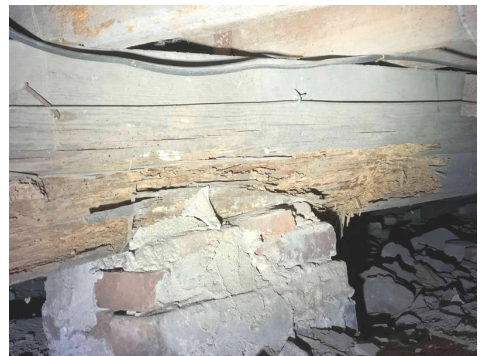
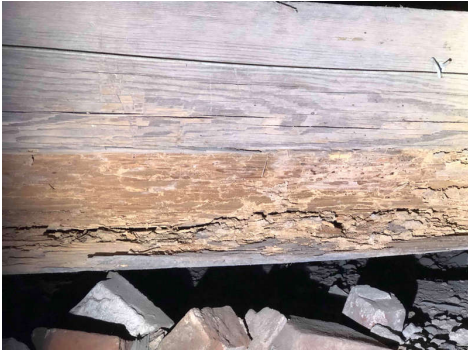
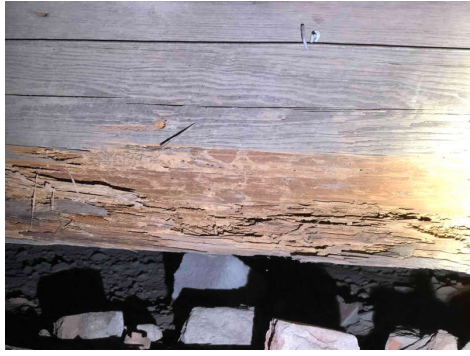
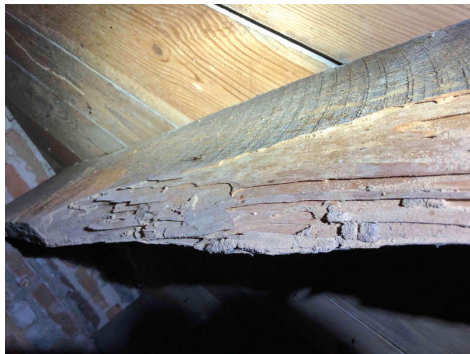
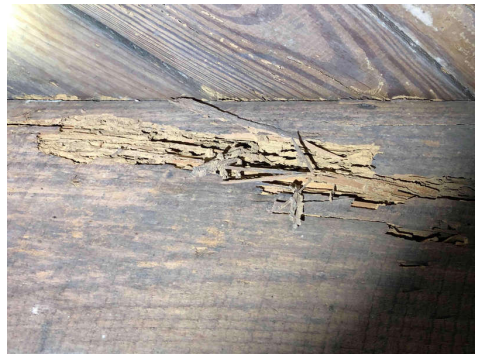
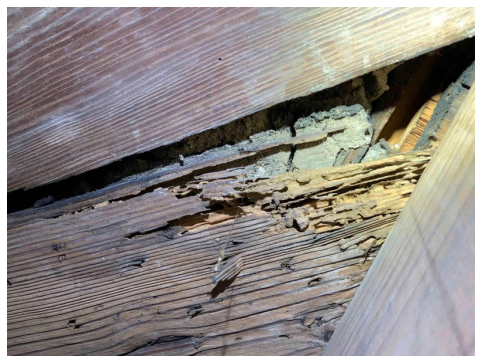
Past termite damage observed in the crawlspace. At the time of the inspection there was no active termite activity observed. A termite letter/inspection is recommended prior to the end of your due diligence period.

\* Termite damage was observed at various locations in the crawlspace. The floor joists and subfloor exhibited damages.

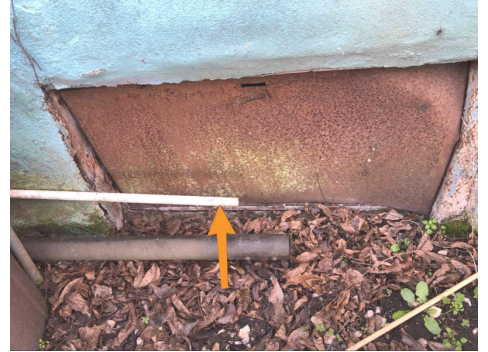
REAR OF HOME

The condensate drain line terminates in front of the rear crawlspace access. The drain line should be relocated away from the crawlspace entrance and the foundation wall.

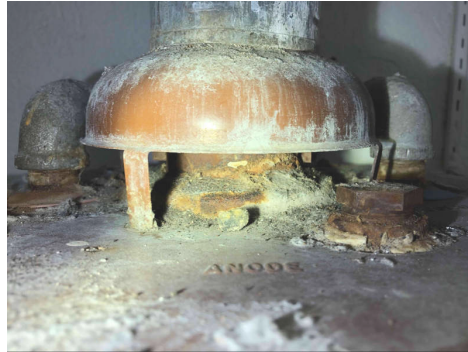
**RUST OBSERVED**

Rust was observed below the exhaust flue, at the top of the water heater. Staining on the flue suggests water leaks. There was no active leaks present. Given the age of the unit, budget for future replacement.

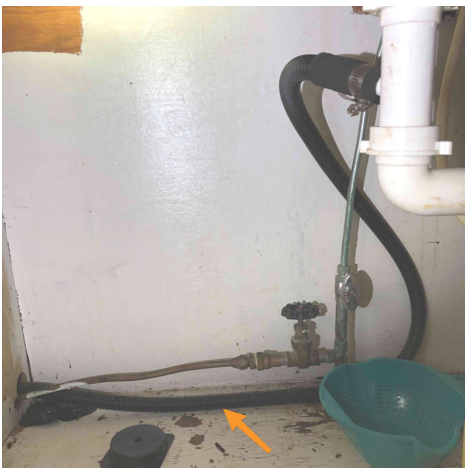
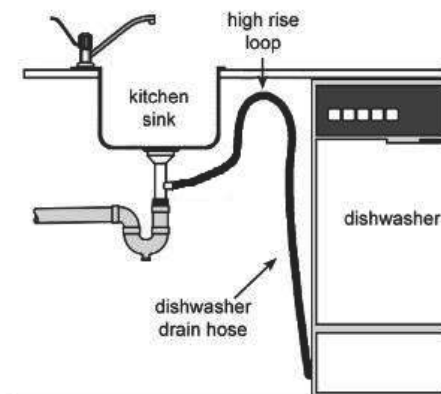
#### ACTIVE LEAK

There was an active leak below the kitchen sink. The leak was coming from the sink spray nozzle.

Recommended DIY Project

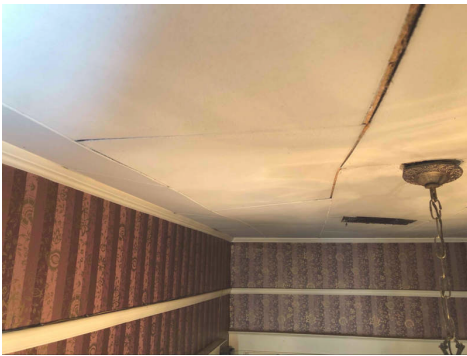
9.1.2 Living Spaces

**CEILING TILES SAGGING**

The ceiling tiles were sagging in various locations throughout the home. The most notable area of sagging was above the front door entrance.

The sagging did not appear to be the result of subsequent damage from leaks in the roof. Tiles appeared to have detached from the plaster ceiling. This may be the result of settlement, moisture, or quite possibly detachment overtime.
