HOME INSPECTION REPORT

1234 Main St.
Port Orchard Washington 98367

01/16/2018 9:00AM

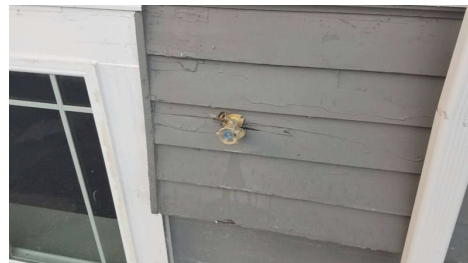
3.8.2 Exterior Plumbing

NOT SECURED TO WALL

The hose bib is not secured to the wall. This could potentially damage the Plumbing. Recommend securing.

Recommendation

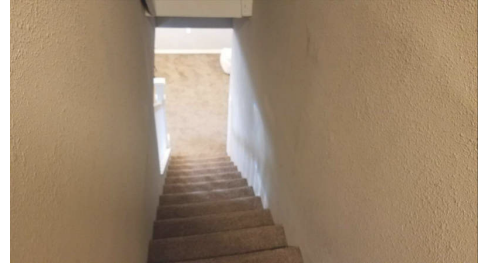
15.10.2 Handrails & Guardrails

THE BALUSTERS IN THE STAIR RAILS ARE LOOSE OR DAMAGED AND SHOULD BE SERVICED

Contact a qualified handyman.

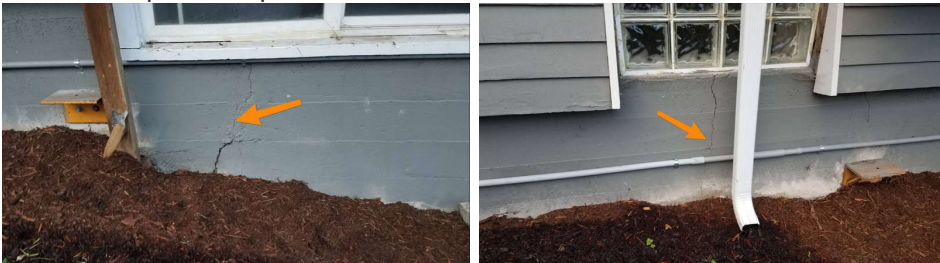
18.2.2 Foundation

SMALL CRACKS

Contact a qualified professional.

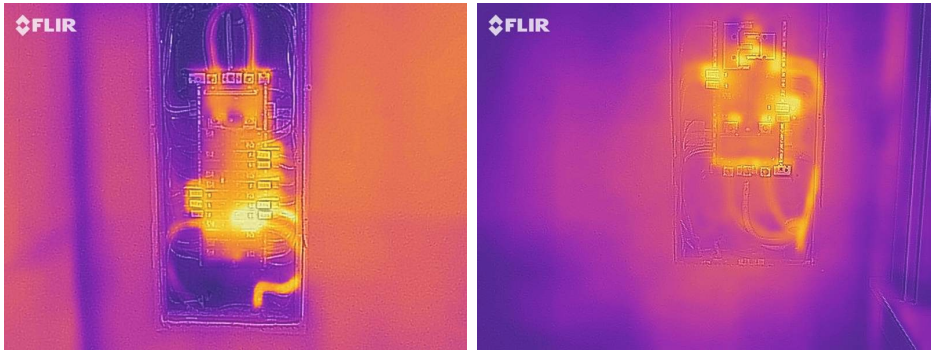
The electrical system was evaluated for overheating breakers, circuits and fixtures. All connected devices and fixtures including switches, outlets and fixtures and breakers were found to be within normal temperature ranges. Attached are a number of photos for your information. Any Deficiencies will be noted below.

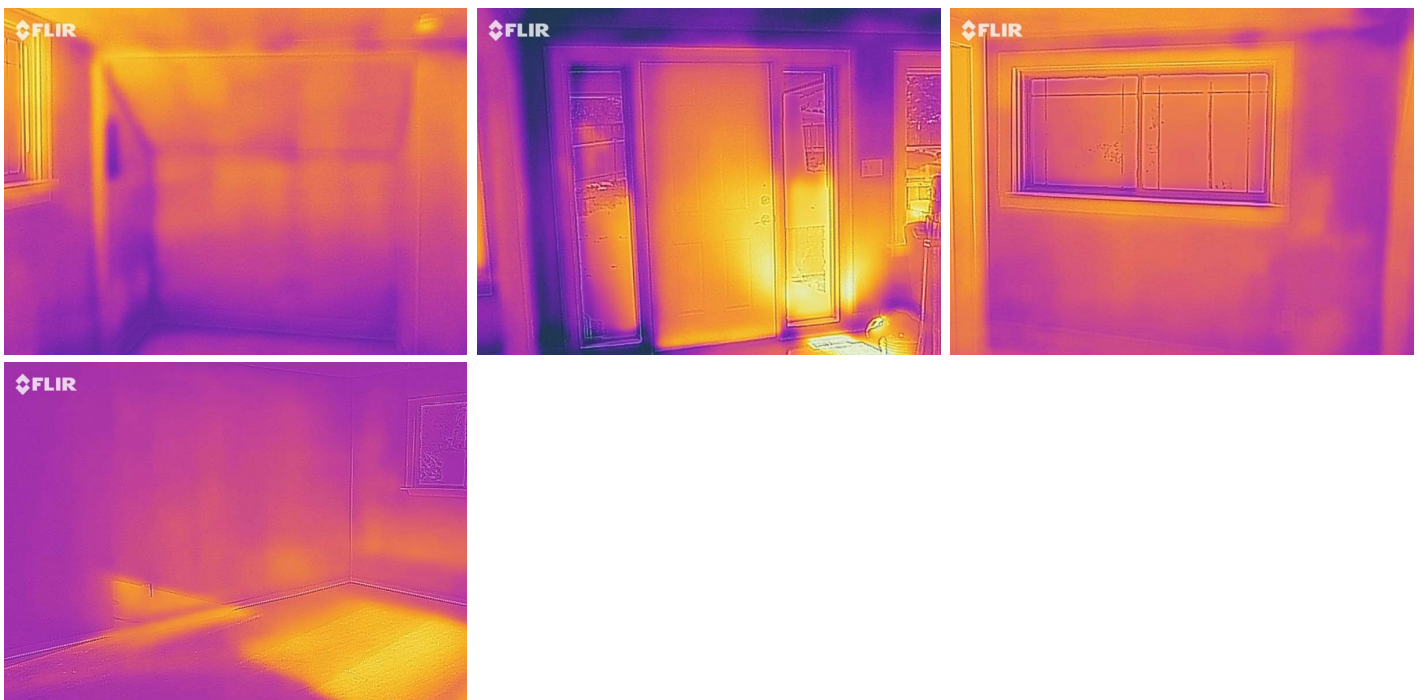
During our Thermal survey of the walls, windows and doors, it showed no significant abnormal temperature readings or excessive air infiltration. As a result, it appears that the walls and ceilings are insulated to meet the building standards for this age of home and no excessive heat loss. Included are several photos for you information. Any deficiencies will be noted below.

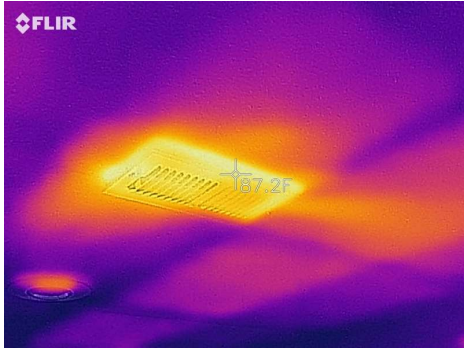
The heater/cooling systems appear to be providing adequate temperatures for conditioning the interior.

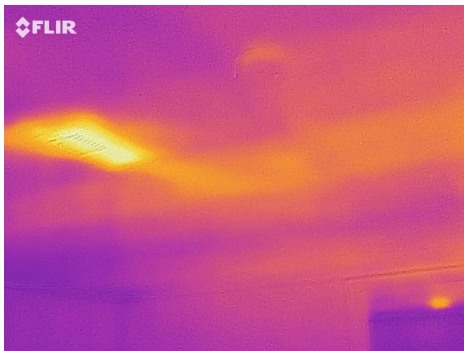
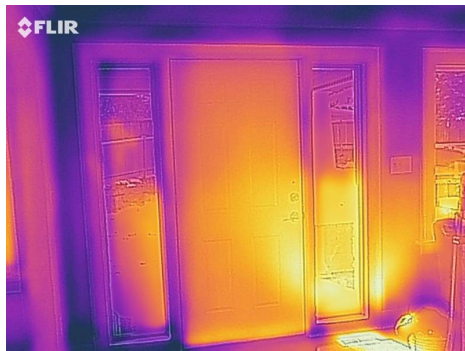
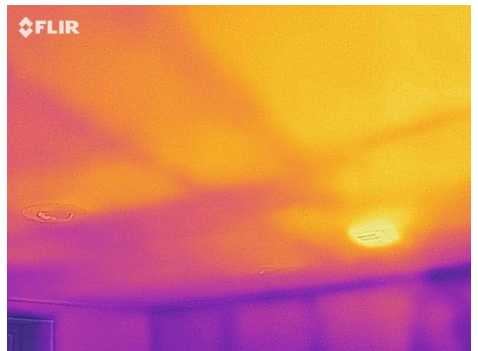
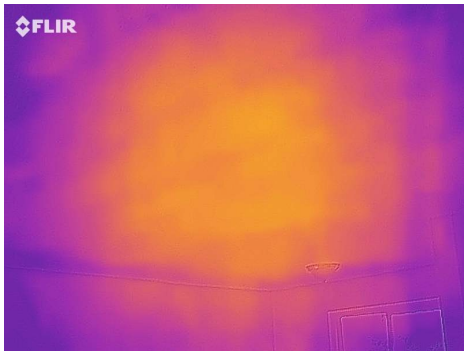
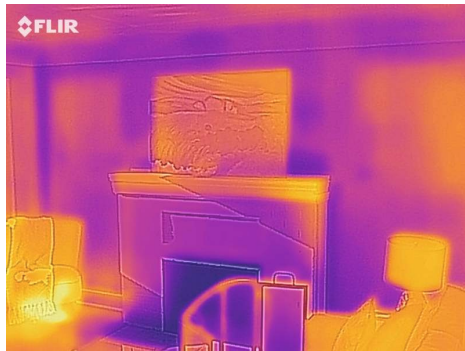
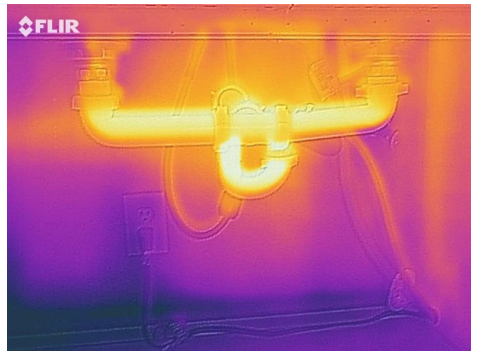
A Thermal survey of the Ceilings, Walls, and floors showed no significant evidence of leakage or water intrusion. Areas of focus are below roof valleys, skylights, chimneys and other penetrations. Additionally, below any second floor bathrooms, laundry rooms and other water fixtures. We have included several photos from our infrared camera for your information. Any deficiencies will be noted below.

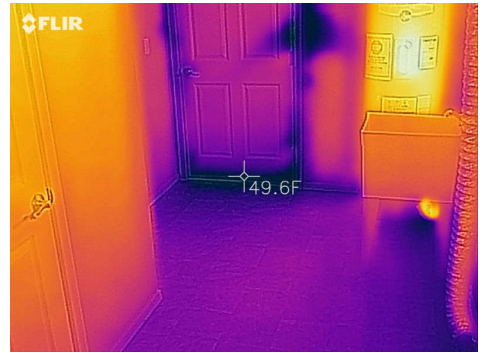
One or more window and/or doors appear to have damaged or missing weatherstripping or were not sealed. Recommend installing weatherstripping around all exterior doors for improved energy efficiency.

Contact a qualified professional.

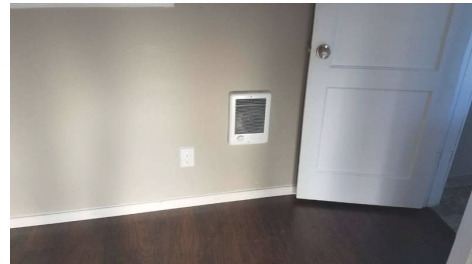
HEAT FAILED

One of the heater failed to operate. Recommend repair.

Contact a qualified professional.

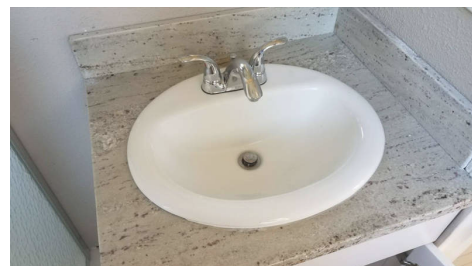
The drain stop needs repair.

Contact a qualified professional.

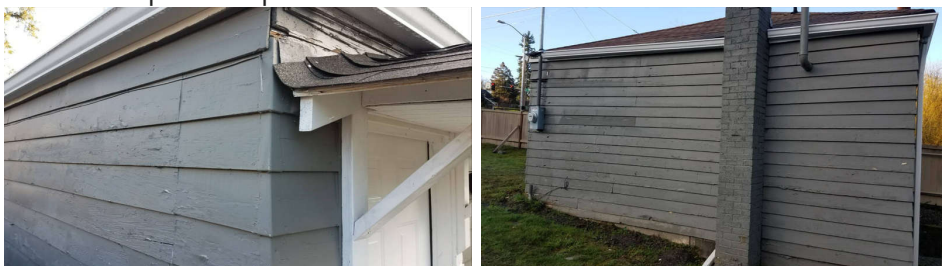
22.7.1 Exterior conditions

The exterior siding was weathered. Maintenance and repairs are needed.

Contact a qualified professional.
