RESIDENTIAL HOME INSPECTION

1234 Main St.
Wellington 6022

Inspector
Adam Collins
NZQA carpentry level 4, LBP-132631
+64 210372132
inquest.kiwi@gmail.com

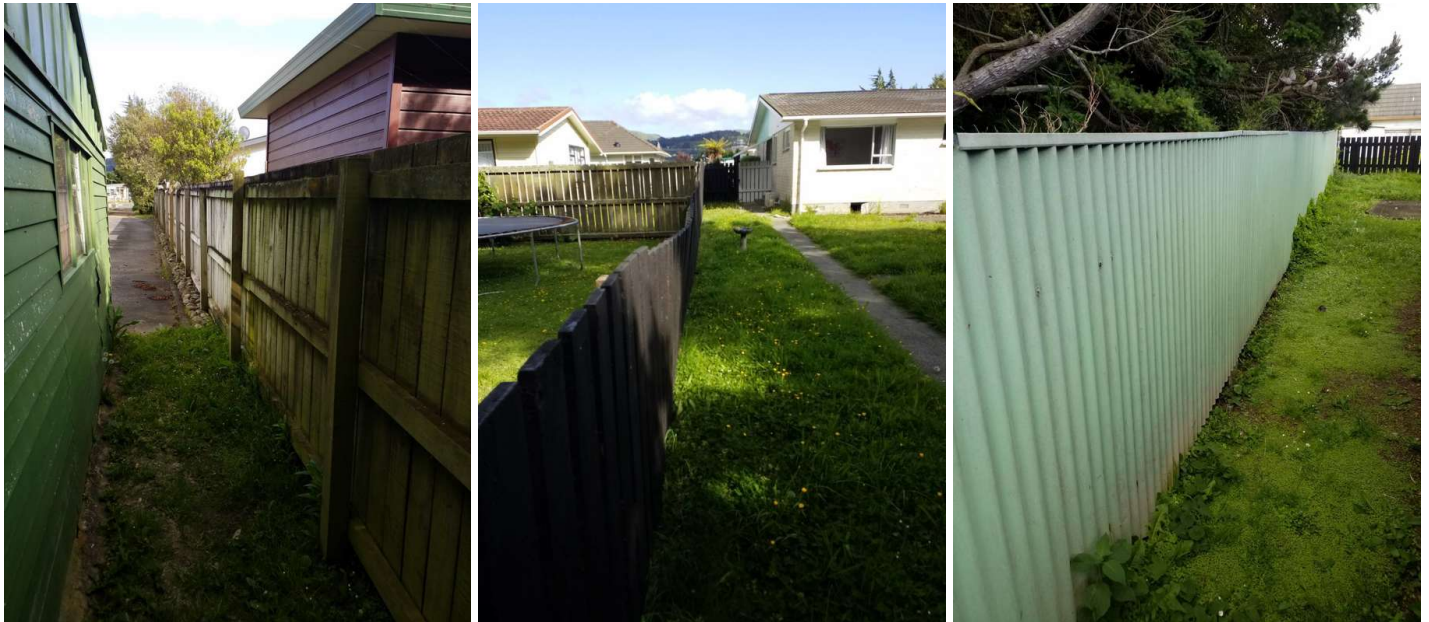
2.1.1 Fencing

FENCING - BROKEN POST

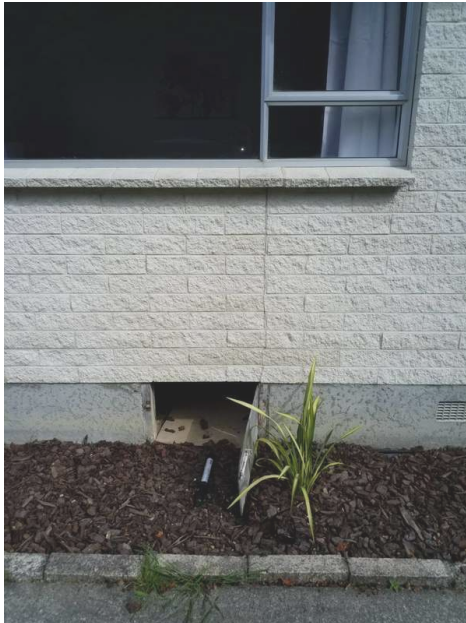
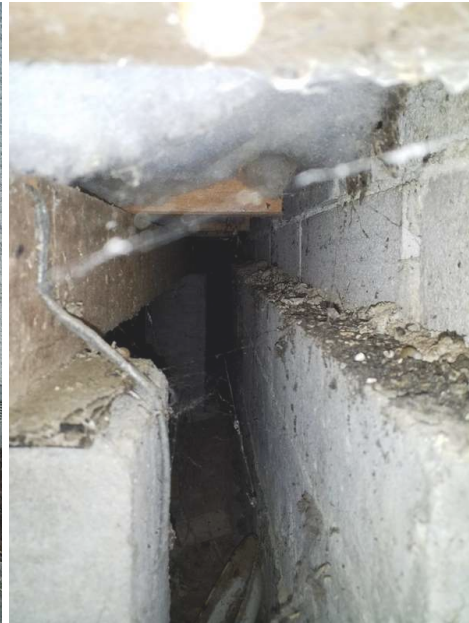
3.2.1 Structural Masonry

Possible moisture issue with this style of construction.

STRUCTURAL MASONRY - MAJOR DEFECT

Our inspector has found what we would consider major Issues, we recommend you seek advice from a professional specific to this type of construction or obtain a structural engineers report

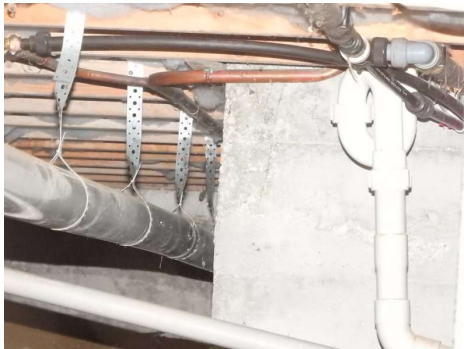
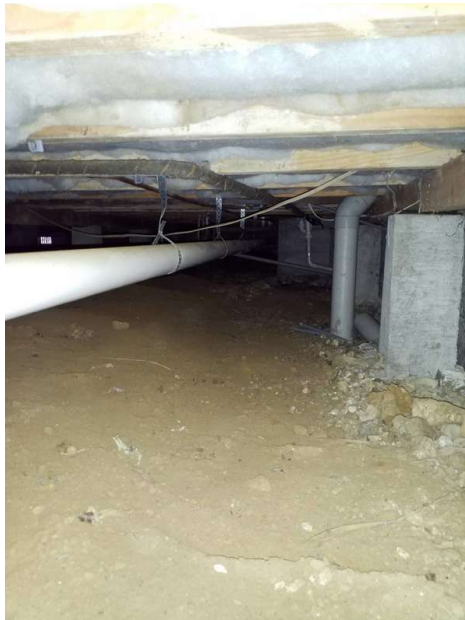
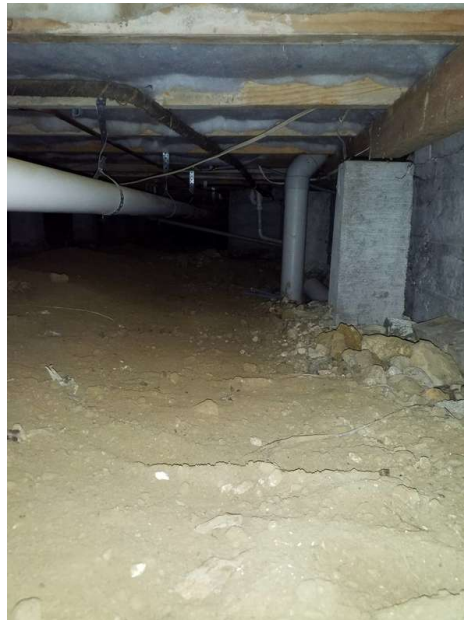
5.1.1 Subfloor Space

Loose or hanging cables can be a safety hazard especially if they come into contact with the ground.

Often insurance companies won't cover damage done by Dux Quest piping, especially if it has leaked before.

We recommend these cables be properly secured and checked for fault or redundancy by a registered electrician.

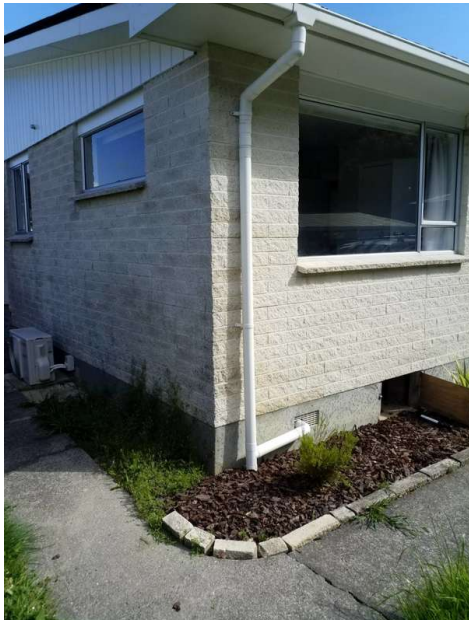
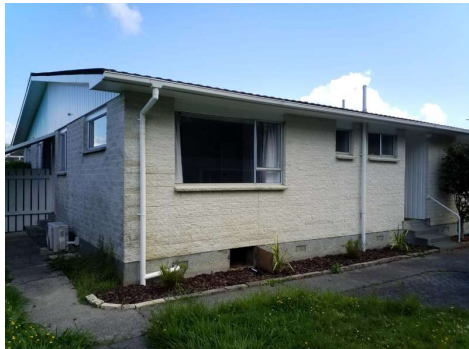
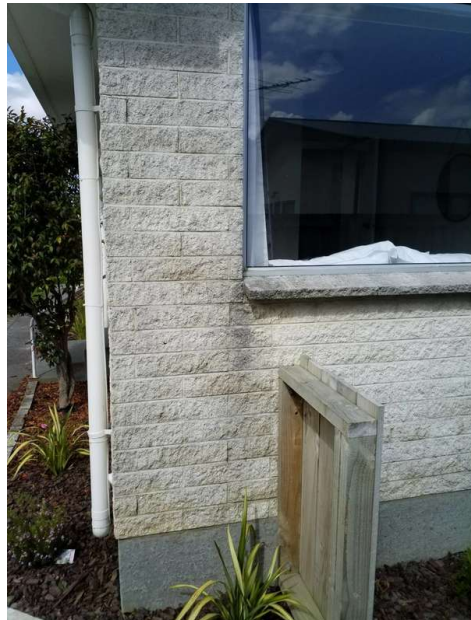
7.2.1 Fibre cement sheet product

CRACKING

Cracked, missing, loose Masonry

Maintenance or repair required in this area

This cladding system is not using weep holes to ventilate the cavity. The cavity system here is relying on ventilation from the subfloor, this encourages warm moist air from the underfloor to circulate the internal wall cavity thus creating a good growing environment for mould. This is considered bad building practice and should be rectified should works be carried out in this area.

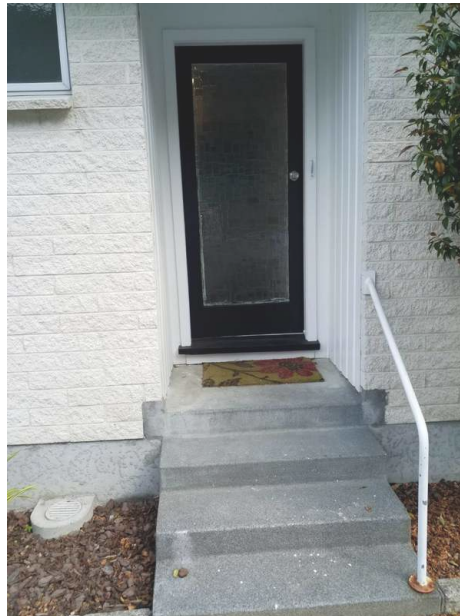
Overall excellent condition aside from some corrosion to the handrail.

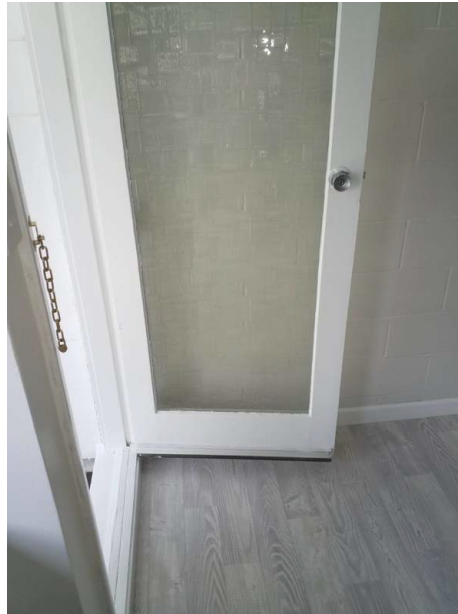
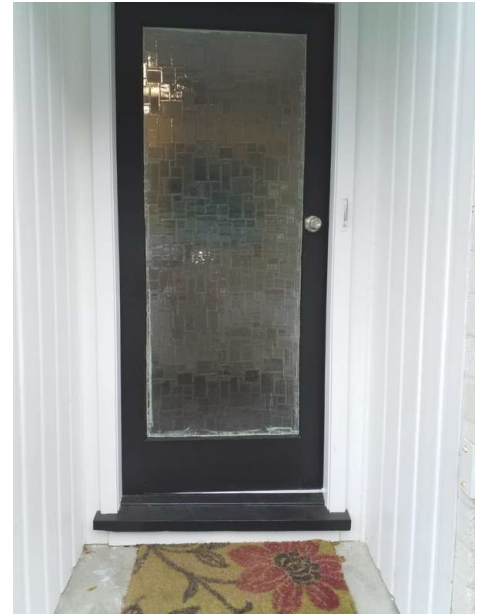
The timber joinery is generally in good condition for its age, reasonable level of security. the alluminium joinery is starting to show its age some maintenance required here.

We recommend that any entrance door should have safety glass.

This door is missing its clashing strip at the bottom, the back door has one. Maintenance or repair required in this area

Contact a qualified window repair/installation contractor.

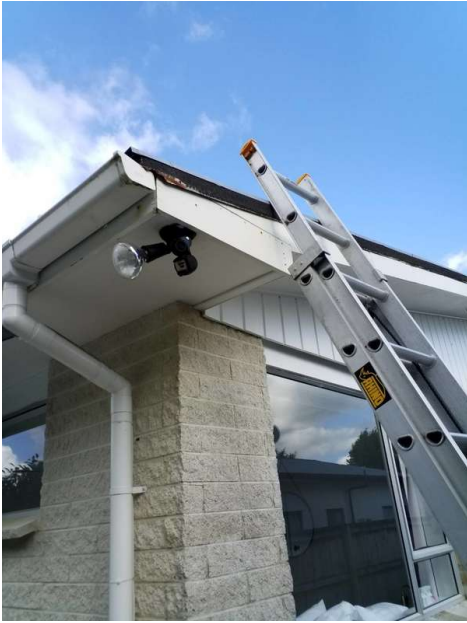
10.2.1 Material - Pressed metal tiles

CORROSION

We have found rust in this area.

Maintenance or repair required in this area.

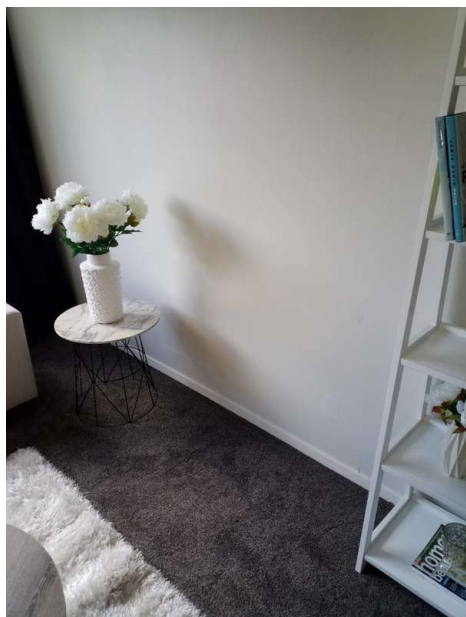
Recently painted over wallpaper, some patching. Not good level of finish.

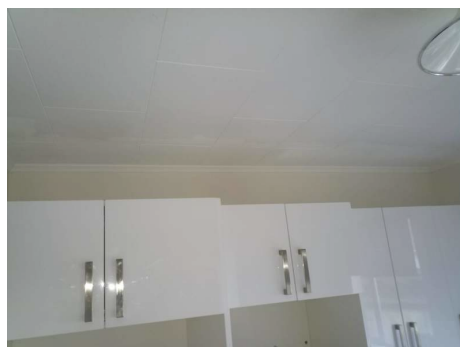
Some recent repair where old kitchen has been removed

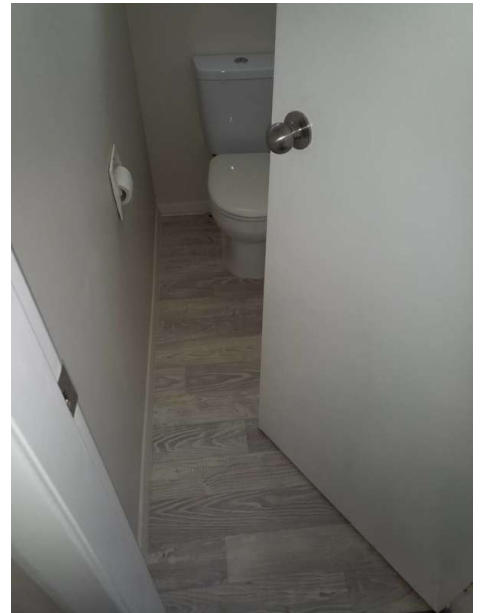
Door stops., Binding loose or badly fitting doors, Type - Hinged, Type - Hollow core, Defective door hardware, Damage to frames and trim
No privacy lock

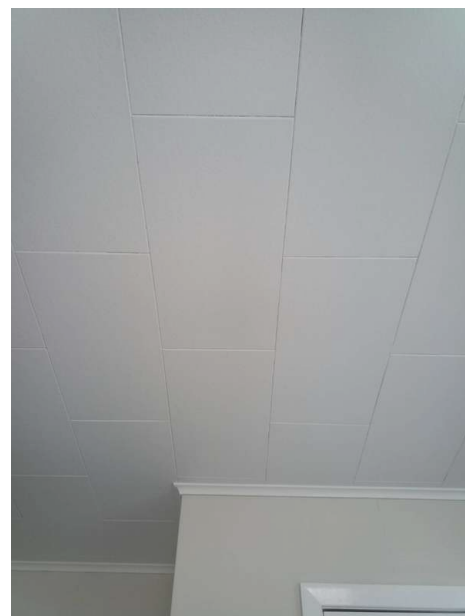
Sagging, Damaged lining, Dampness and moisture damage, Cracking, Nails popping, Spray textured coating (possibility of asbestos), Material - Pinex

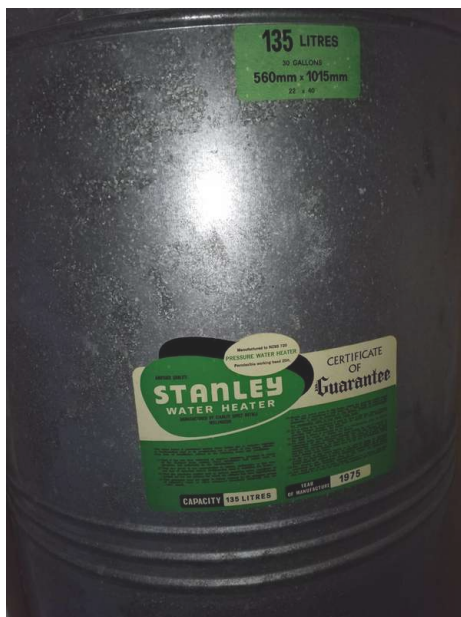
There is some pipe lagging on this system that may contain asbestos.

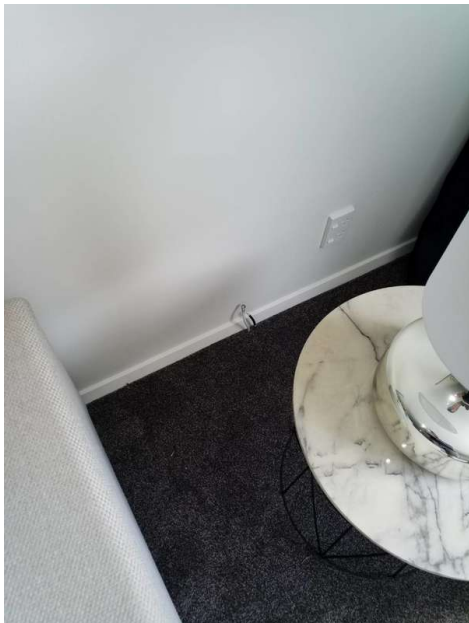
i couldnt locate a Phone jack os sorts but i should imagine wifi can be attached at this point.
