PEOPLE'S CHOICE HOME INSPECTIONS, LLC

RESIDENTIAL INSPECTION

1234 Main St.
Charleston SC 29412

Buyer Name
04/05/2019 9:00AM

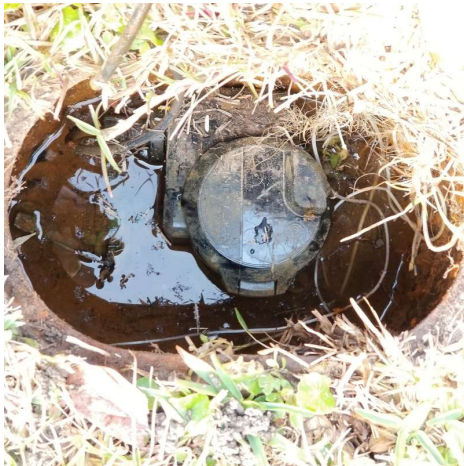
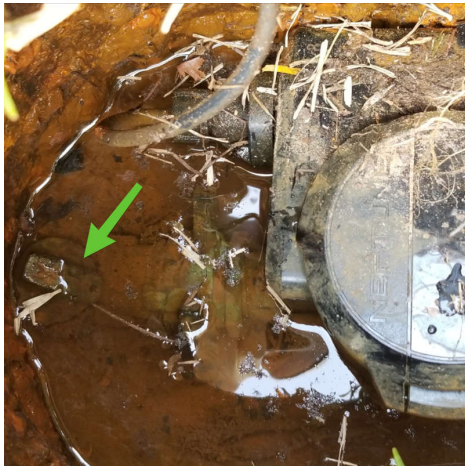
General: Location of Main Shut off

At water meter

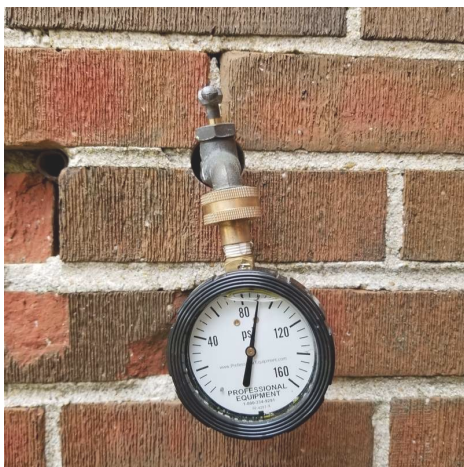
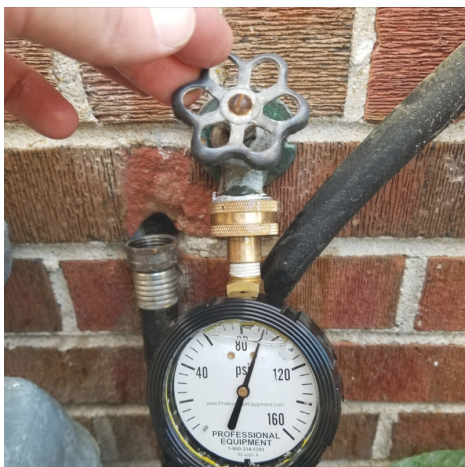
General: Corrosion on pipe

The water supply piping exhibited heavy corrosion that will shorten the expected long term service life of the pipes. The source of moisture should be identified and corrected by a qualified plumbing contractor. Recommend monitoring pipes periodically to inspect for leaks.

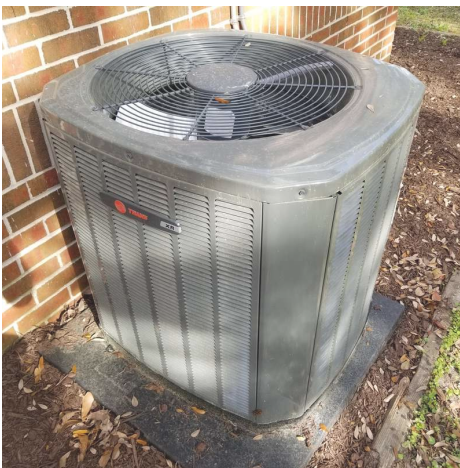
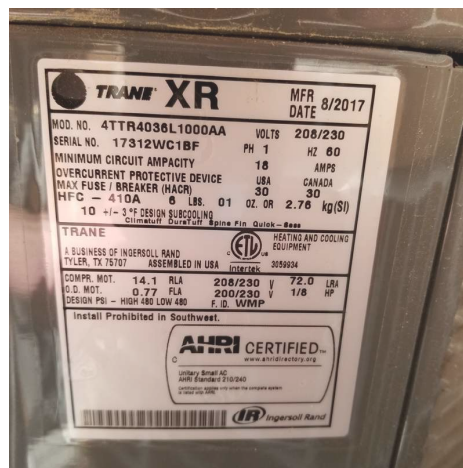
Condensing Unit: Pictures of Unit

The condensing unit was in good condition.

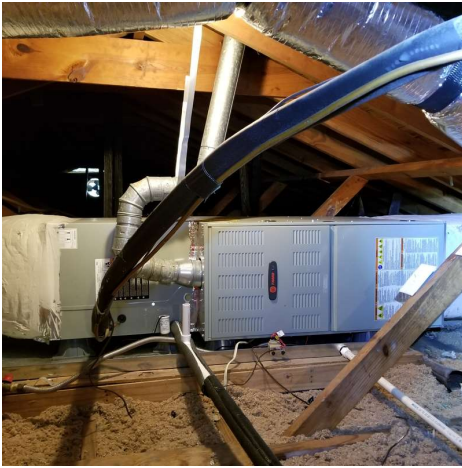
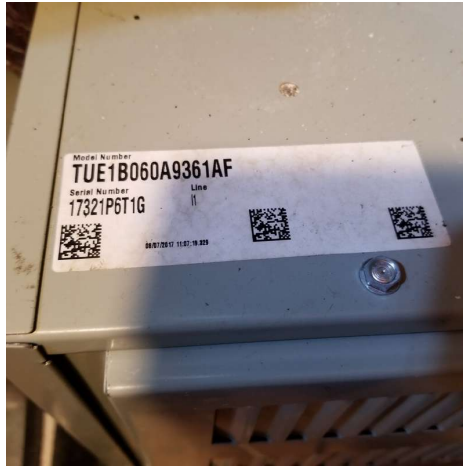
Air Handler: Pictures of unit

The air handler appeared in good condition. The unit ran and cold as expected.

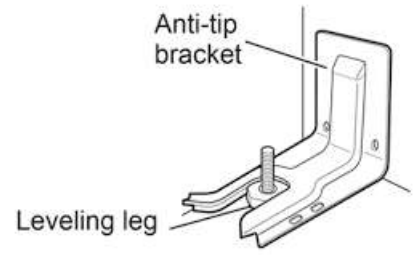
9.3.1 Microwave

HANDLE BROKEN

The microwaves handle is damaged. Recommend a qualified professional make corrections.

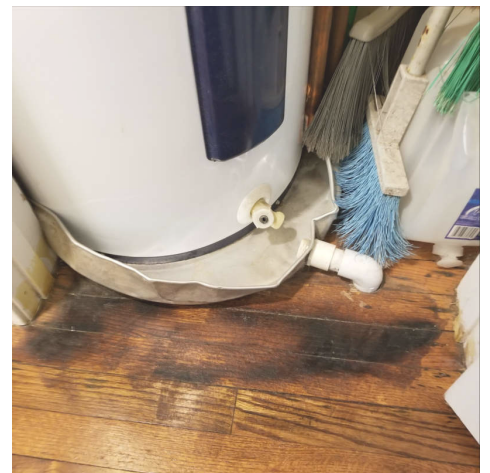
Wood flooring is damaged from what appears a past leak. Recommend having a qualified contractor evaluate and refinish wood flooring as necessary.

Contact a qualified professional.

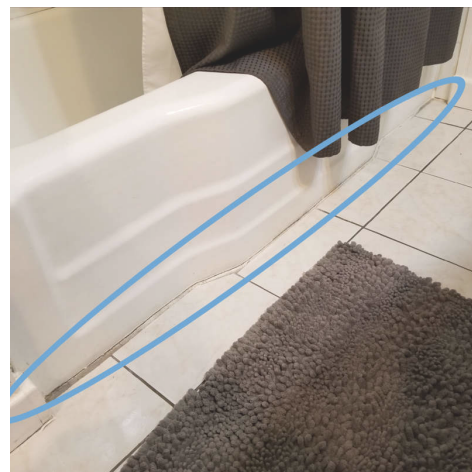
Caulk is missing or deteriorated along the base of one or more bathtubs, where flooring meets the tub. It should be replaced where deteriorated and/or applied where missing to prevent water intrusion and damage to the floor structure.

Recommended DIY Project

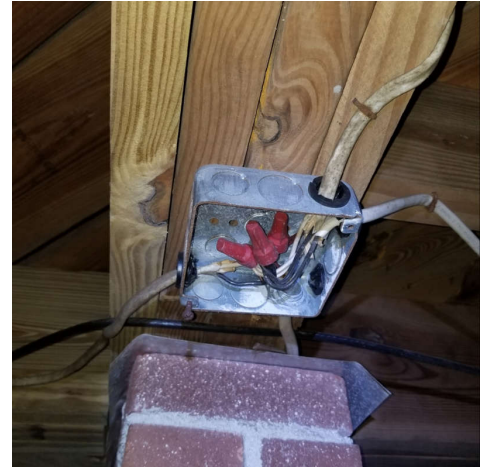
There are open junction boxes in the crawlspace. The proper cover needs to be installed to prevent damage to the wires or possible un-contained sparking.

Contact a qualified electrical contractor.
