RESIDENTIAL INSPECTION

1234 Main St.
Kilgore Tx 75662

PROPERTY INSPECTION REPORT

By: John Vaden - T.R.E.C. #21359 04/23/2019 9:00AM
(Name and License Number of Inspector) (Date)

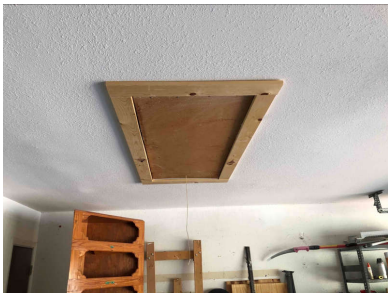
The stairway was not labeled as a fire-rated assembly. The Code addresses separation between the garage and attic, garage and dwelling and habitable areas and attic spaces, in terms of gypsum thickness, door thickness or 20-minute fire rated doors including attic stairs

Recommendation: Contact a qualified professional.

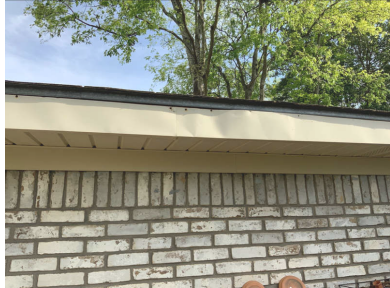
Front of home right side of garage

The siding over the fascia is in need of repair in areas it is wrinkled and there are nail heads exposed and rusted.

Recommendation: Contact a qualified siding specialist.

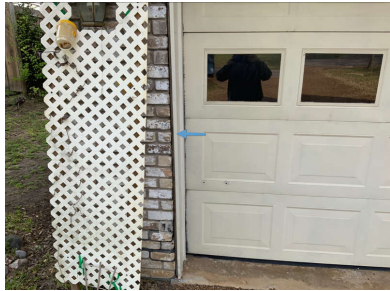
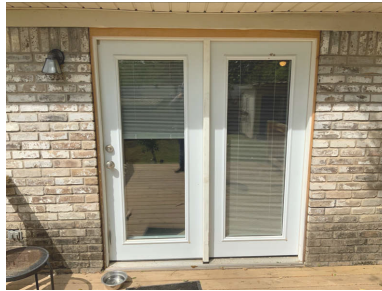
There are areas of bare wood on the exterior around the home be stained or painted to prevent premature deterioration.

Recommendation: Contact a qualified professional.

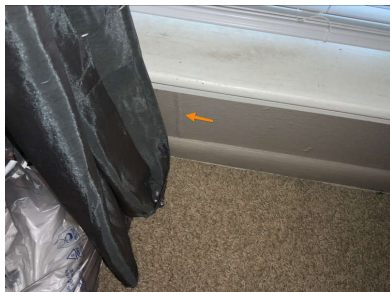
Master Bedroom window left side
bottom

The same tape on the wall and one or more areas is bulging this is likely due to seam tape not being installed properly. This is cosmetic in nature and can be repaired easily during maintenance.

Recommendation: Contact a qualified drywall contractor.

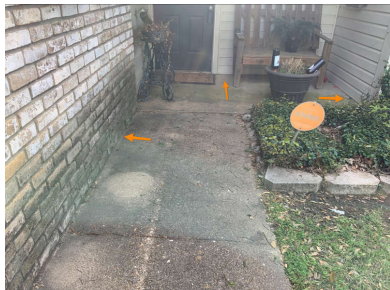
Cladding materials without proper clearances are considered to be conducive to wood destroying Insect (WDI) infiltration, which means that termites and other WDI's could gain undetected access into the home.

Recommendation: Recommend monitoring.

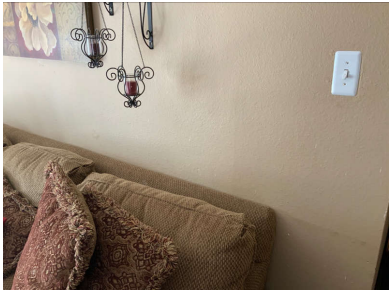
The walls of this home have typical drywall flaws on them, such as dings, scrapes, patching, and touch up paint. These flaws are typical to any home whether new or old and should be repaired during times of maintenance.

Recommendation: Contact a handyman or DIY project

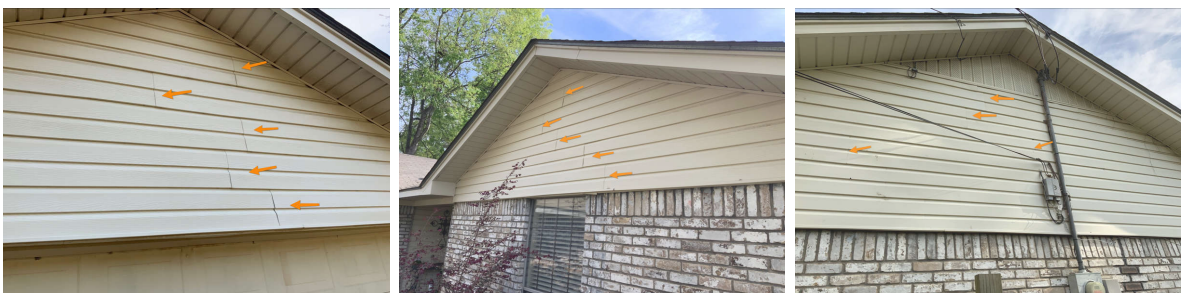
Over garage door

The seams on the vinyl siding need to be sealed to prevent them from detaching from the home the installation of this siding was not performed in the typical professional way. It does work it just needs to be monitored for separation or loosening over time.

Recommendation: Contact a qualified siding specialist.

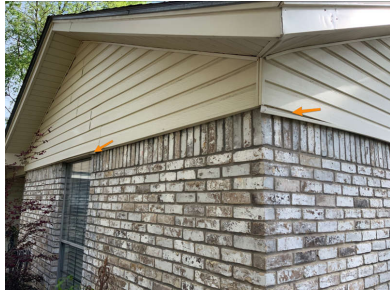
The metal/vinyl trim on the home is in need of re-securing in areas.

Recommendation: Contact a qualified siding specialist.

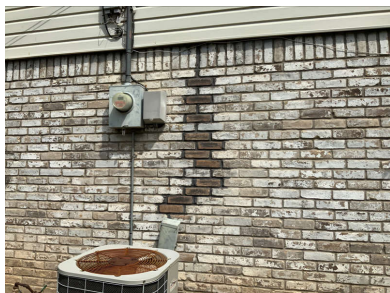
Repairs were made to the brick on the right side of the home these areas were patched and do not show signs of further movement, we recommend asking seller when repairs were made, so that you will know how long the repair has been there to judge how long it has been since movement has occurred.

Recommendation: Recommend monitoring.

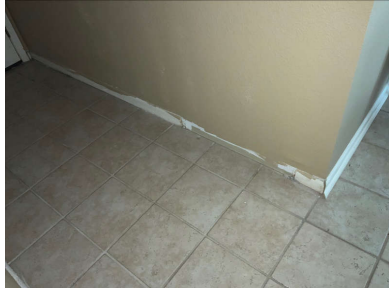
Entryway

There are areas of baseboard trim that are in need of painting, caulking, or repair/replacement in one or more areas around the home.

Recommendation: Contact a handyman or DIY project

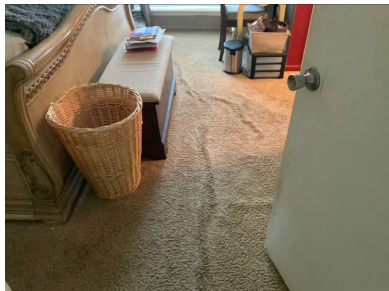
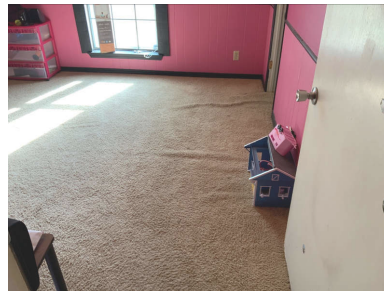
There are one or more areas throughout the home where the carpet could use stretching so that it does not become a trip hazard.

Recommendation: Contact a qualified professional.

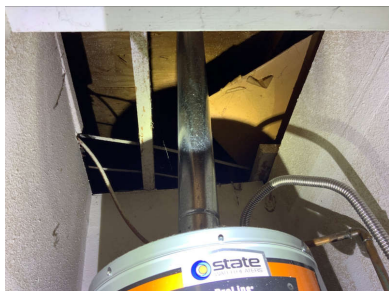
The ceiling in the water heater closet in the garage needs to be replaced this is considered lack of fire barrier in the garage and should be replaced for safety.

Recommendation: Contact a qualified drywall contractor.

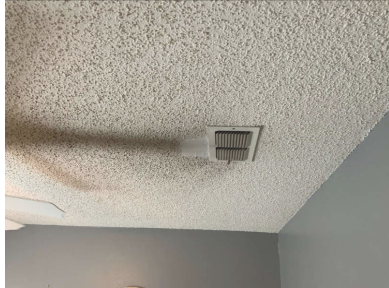
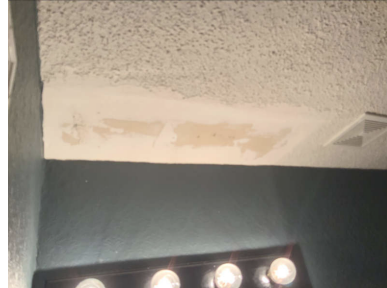
There are areas of the home where the ceiling texture and/or paint are in need of cosmetic touch up. We recommend that a painter or drywall contractor be contacted to repair these areas.

Recommendation: Contact a qualified professional.

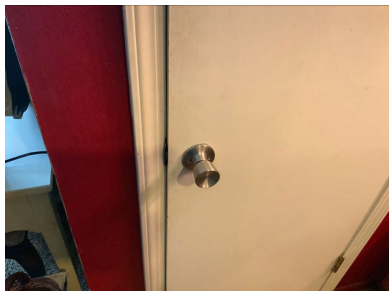
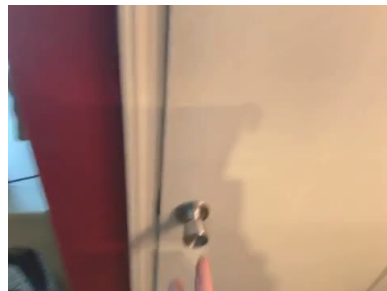
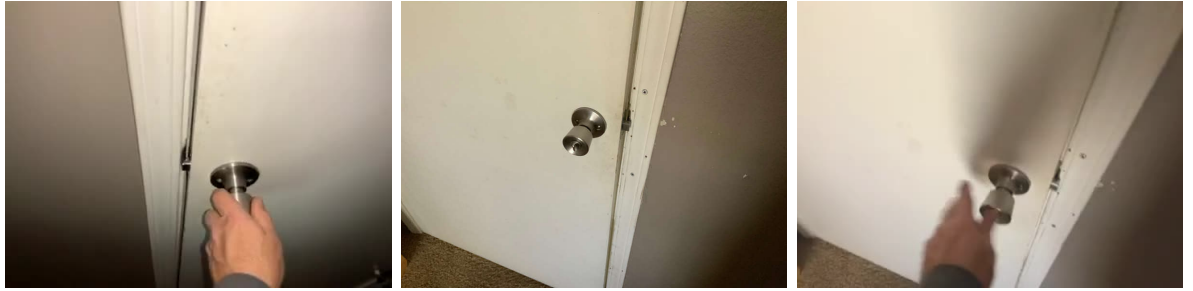
Door doesn't latch properly. This can be a sign of settlement or improper installation. We Recommend handyman [repair](#) latch and/or strike plate.

Recommendation: Contact a qualified handyman.

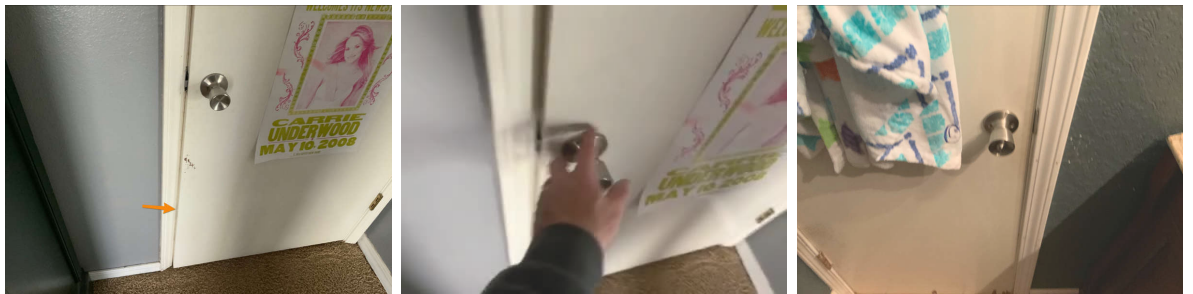
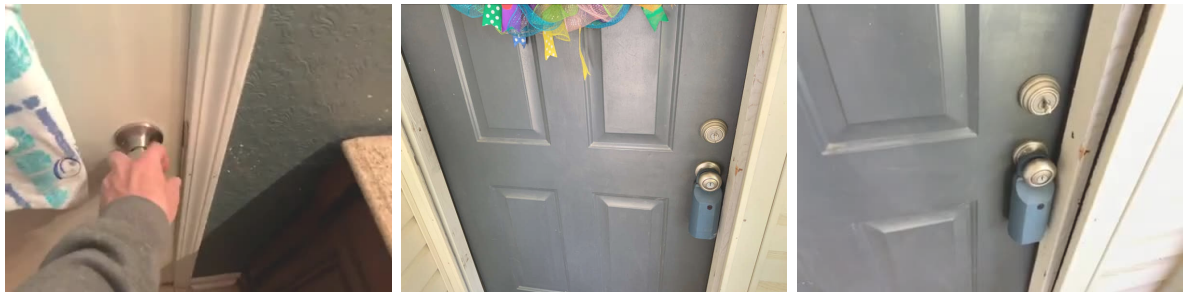
There are one or more doors in this home that drag in the frame. These doors could use adjustments so that they close properly.

Recommendation: Contact a handyman or DIY project

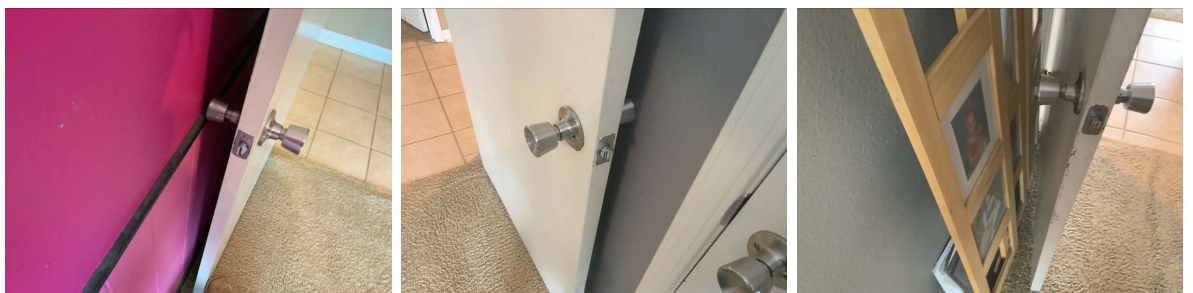
Several of the doors are missing their door stops. This condition will lead to damage of the wall surfaces. We recommend door stops be installed where needed.

Recommendation: Contact a handyman or DIY project

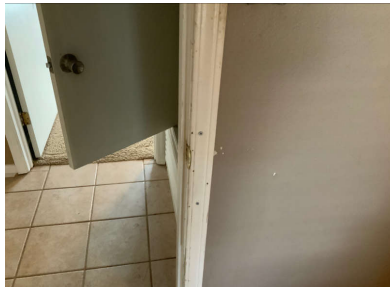
Master Bedroom

The door trim in the master bedroom has screws for fasteners on the trim. Not that this is deficient but watch your hands and items you may carry through the door way and make sure they don't get caught on screw heads.

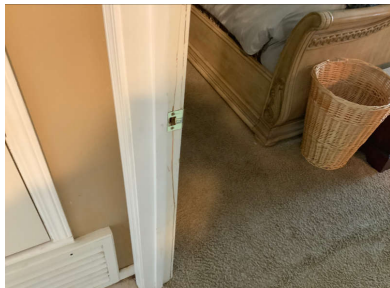
Master Bedroom

There are one or more door frames in this home that have been damaged and are in need of repair.

Recommendation: Contact a qualified handyman.

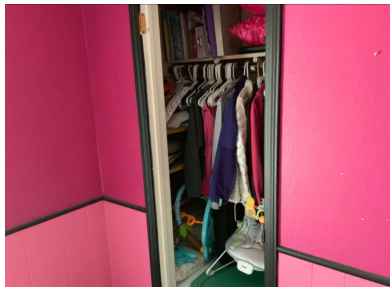
Middle bedroom closet door

There are one or more doors that are missing in this home.

Recommendation: Contact a handyman or DIY project

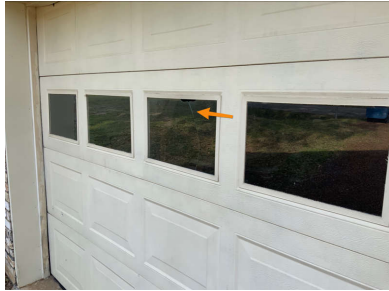
Garage door

These windows will need repair or replacement

Recommendation: Contact a qualified professional.

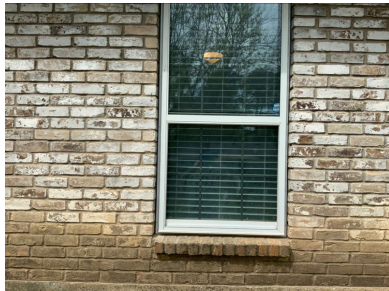
We recommend that all window edges be caulked on the interior and exterior to seal them off and help keep them more energy efficient.

Recommendation: Contact a handyman or DIY project

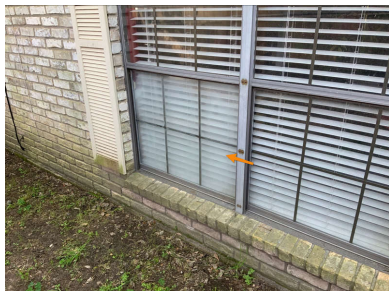
Left side of home

Observed condensation and/or fogging between the window panes, which indicates a failed seal. Recommend qualified window contractor evaluate & replace.

Recommendation: Contact a qualified window repair/installation contractor.

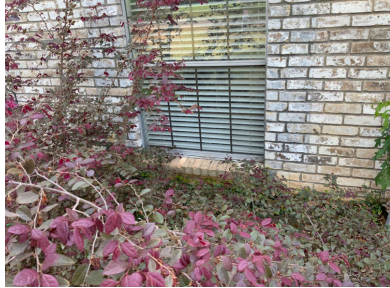
Front of home

One or more windows are missing a screen. Recommend replacement.

Recommendation: Contact a qualified window repair/installation contractor.

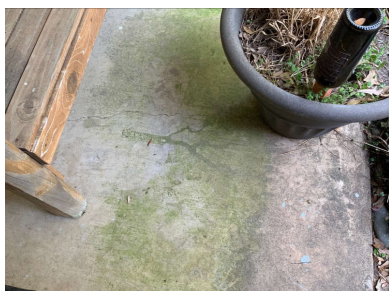
Front porch

1: Cracks in concrete flatwork around the home

There were cracks in the sidewalks and driveways around this home in various locations. We recommend that these areas be sealed/repared to prevent moisture accumulation.

Recommendation: Contact a qualified professional.

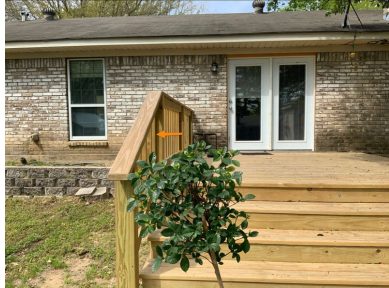
Handrail Grip

There are no graspable handrails installed on the step railing of this home. We recommend that graspable hand rails be installed for easy grip.

Recommendation: Contact a qualified carpenter.

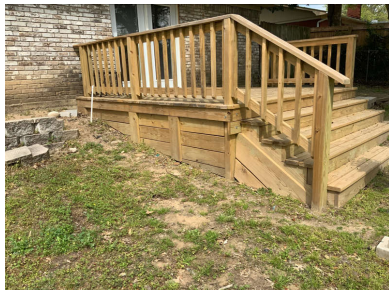
There is wood to ground contact in one or more areas of the property, this is considered a conducive condition that could allow wood destroying insects to gain access to the structure without being seen. We recommend that these areas be treated regularly by a pest control company as often as they recommended, which would be every 5-10 years on average.

Recommendation: Recommend monitoring.

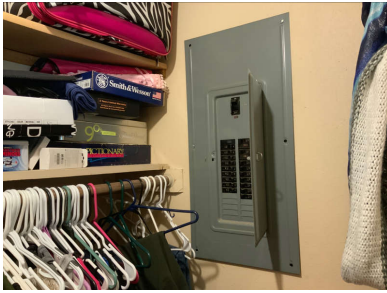
The electrical panel is located in a clothes closet. Under current electrical standards, this is no longer an accepted practice. This is an as-built condition but Per TREC standards of practice we are required to report this condition as a deficiency.

Recommendation: Contact a qualified professional.

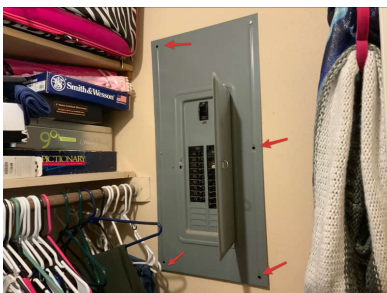
3: Screws missing

One or more of the cabinet cover plate screws are missing and need to be replaced. When screws or replaced they screws need to be blunt tip the screws and not sharp wood screws or self tapping screws for reasons of safety. Sharp tips cruise can puncture the electrical line and cause potential shock hazards.

Recommendation: Contact a qualified professional.

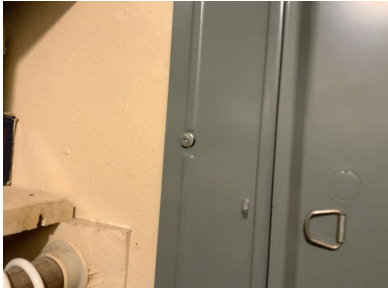
4: Sharp screws in electrical panel

The screws in the electrical panel or Sharp tipped, the screw(s) should be replaced with blunt tip screws to prevent piercing wires with sharp tipped screws. We recommend replacing the screws for safety reasons to avoid shock hazard.

Recommendation: Contact a qualified professional.

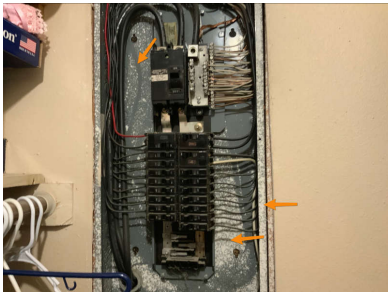
5: There is drywall texture in the panel

There is drywall texture in the interior of the electrical panel. It is recommended that this be cleaned out of the panel and was a sub standard job from the building contractor.

Recommendation: Contact a qualified professional.

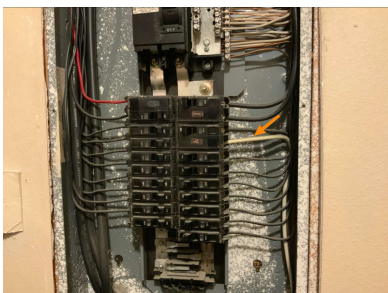
6: White wires need reidentification

This is a "newer" requirement however it is a good safety upgrade that should be considered.

Recommendation: Contact a qualified professional.

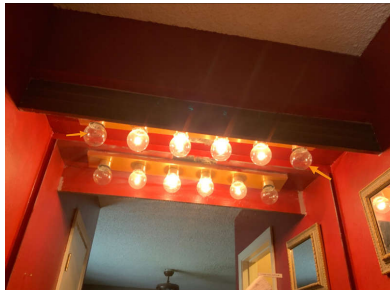
Master Bedroom Vanity

1: Bulbs missing or burned out

There are bulbs missing or burned out in one or more fixtures around the home.

Recommendation: Recommended DIY Project

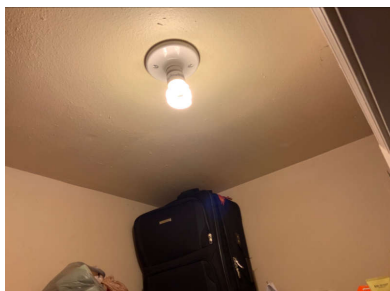
Master Bedroom Closet By Vanity

2: Closet lights and a globe

One or more closet lights need globes or covers installed on them. Safety precautions should be taken around these light fixtures.

Recommendation: Recommended DIY Project

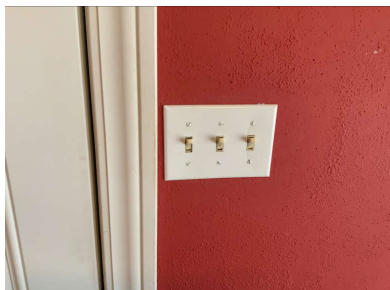
Next to garage door

3: Cover Plates Damaged

One or more receptacles and/or light switches have a damaged cover plate. Recommend replacement.

Recommendation: Contact a qualified electrical contractor.

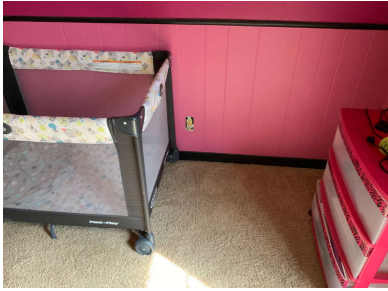
Middle bedroom

4: Cover Plates Missing

One or more receptacles/light switches are missing a cover plate. This causes short and shock risk. Recommend installation of plates.

Recommendation: Contact a qualified electrical contractor.

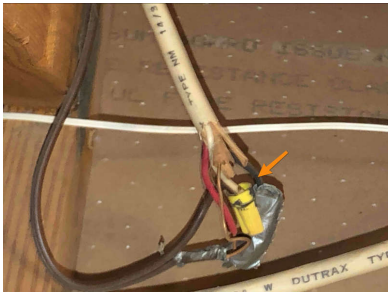
Attic

5: Exposed Ends & Splices

All wire connections & charged wires with exposed ends and splices should be covered in junction boxes for safety. Recommend a qualified electrician correct.

Recommendation: Contact a qualified electrical contractor.

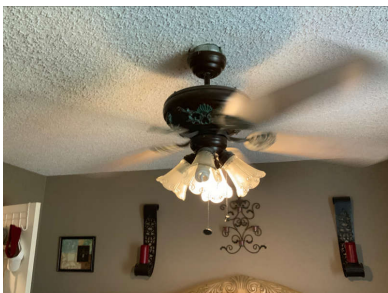
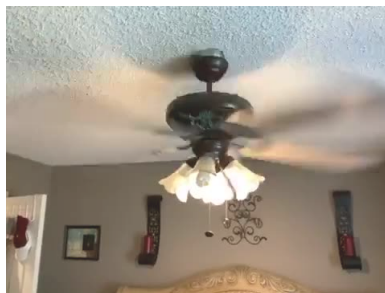
Master Bedroom

6: Fan WOBBLING - MINOR

The ceiling fan slightly wobbled when operated. The fan may be out of balance. Repairs are recommended as needed by a qualified person.

Recommendation: Contact a qualified professional.

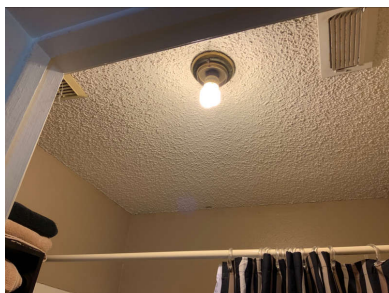
Master Bathroom

There are one or more light fixtures throughout the home that need a cover over the junction box and a globe installed over the light.

Recommendation: Contact a qualified electrical contractor.

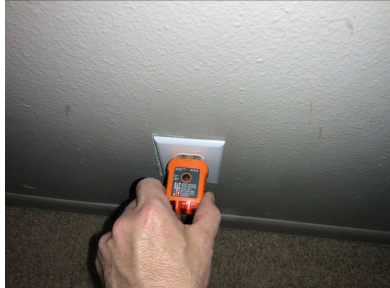
Master Bedroom

9: Loose receptacles/switches

All receptacles and light switches that are loose in their junction box should be tightened. Or the junction box should be secured if applicable.

Recommendation: Contact a qualified professional.

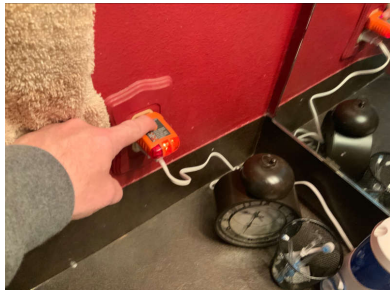
Master Bathroom

10: Not enough GFCI protection

GFCI protection was not present in all required locations. Recommend licensed electrician upgrade by installing ground fault receptacles in all locations.

GFCI protection is required within 6 of the sink. The 6 requirement is due to appliance cord length near the sink.

Recommendation: Contact a qualified electrical contractor.

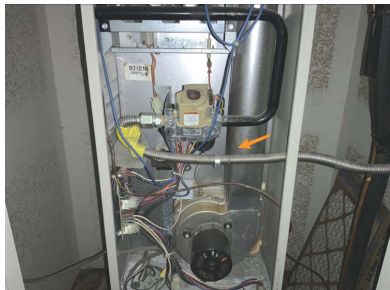
1: Flex line into cabinet

The gas supply flex connector was observed to be passing through the heating unit cabinet. Undercurrent mechanical installation standards, this is no longer an excepted practice. Only rigid black gas pipe is allowed to pass through the heating unit cabinet.

Recommendation: Contact a qualified professional.

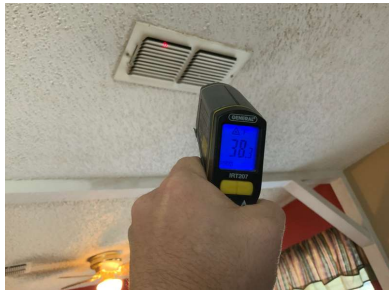
Average Temperatures at the supply registers: 38°

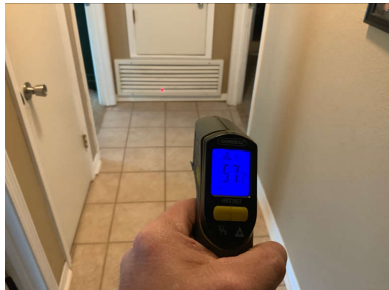
Temperatures at return registers: 57°

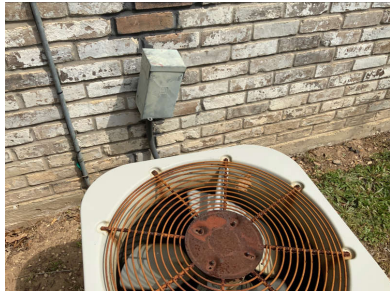
2: Disconnect box needs repair

The disconnect should not be mounted directly behind the condensing unit.

The disconnect box at this home is not fastened to the wall and should be repaired. The disconnect box as it is now could allow water into the box and it is just not safe at this time.

Recommendation: Contact a qualified HVAC professional.

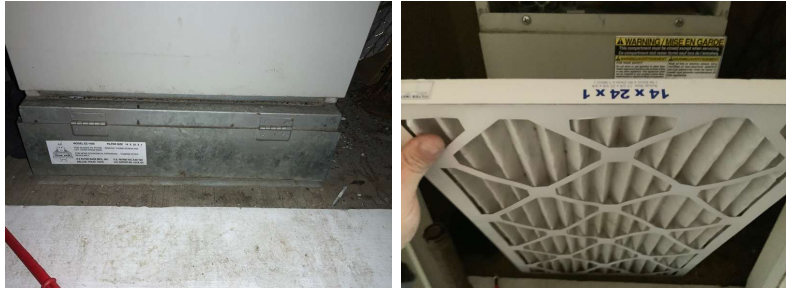
1: Duct cleaning

We recommend that you consider having the ductwork cleaned prior to living in the home to help cut down on allergens that may have accumulated in the ducts from animals or other things that the previous owners may have had in the home. This is fairly inexpensive and will let you start out with cleaner air

Recommendation: Contact a qualified professional.

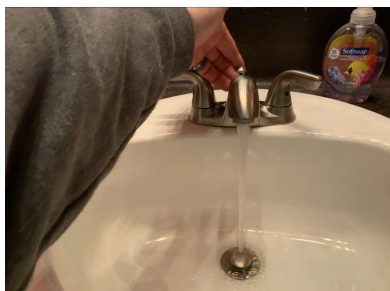
Master Bedroom

There are one or more drain stops that are in need of repair at bathroom sinks.

Recommendation: Contact a handyman or DIY project

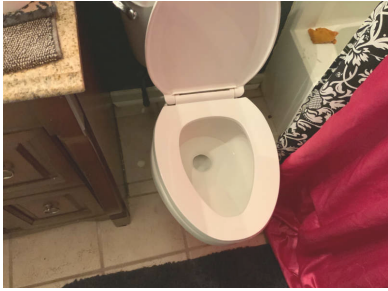
Hall Bathroom

There are one or more toilets in the home that are loose at the floor. When a toilet is loose at the floor it can damage the wax ring and cause leaks. We recommend that all toilets be tightened and that you take into consideration that the wax ring may need to be replaced before you tighten the toilet.

Recommendation: Contact a handyman or DIY project

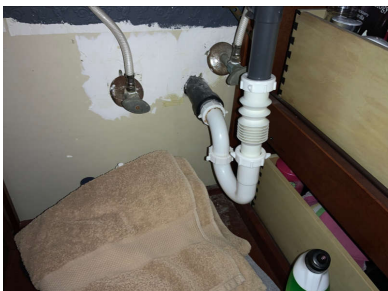
Hall Bathroom

Although, Accordion Drain line material is easy to use, it is not recommended for use in sinks because it is thin, easily torn, and the ridges on these piping materials are known to catch trash and clog easily.

Recommendation: Contact a qualified professional.

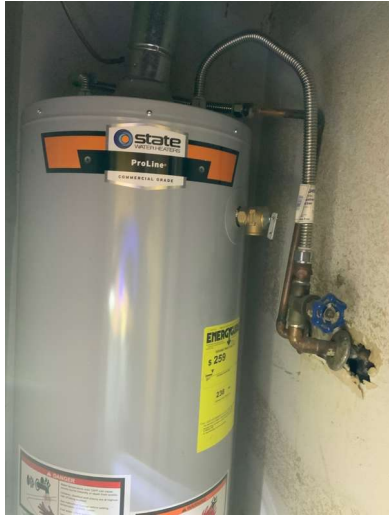
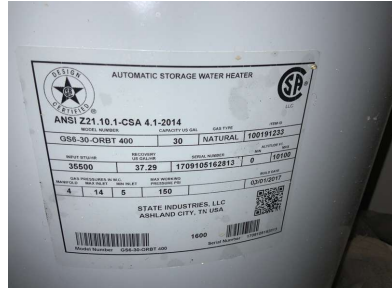
1: No Pan

There is not a drain pan installed under this water heater. We recommend that a pan be installed for safety to keep the floor and finish materials from being damaged if there was a leak in the water heater.

Recommendation: Contact a handyman or DIY project

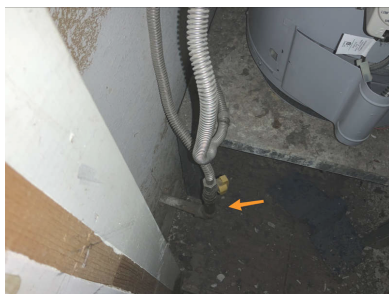
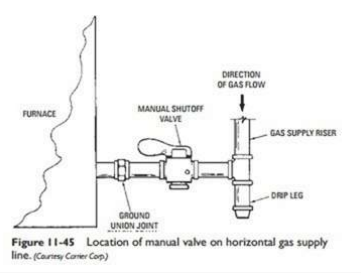
The water heater and/or furnace gas supply line is not equipped with a sediment trap just before the gas appliance connector. This condition does not meet current installation requirements and should be corrected.

G2419.4 (408.4) Sediment trap. Where a sediment trap is not incorporated as part of the appliance, a sediment trap shall be installed downstream of the appliance shutoff valve as close to the inlet of the appliance as practical. The sediment trap shall be either a tee fitting having a capped nipple of any length installed vertically in the bottommost opening of the tee as illustrated in Figure G2419.4 or other device approved as an effective sediment trap. Illuminating appliances, ranges, clothes dryers, decorative vented appliances for installation in vented fireplaces, gas fireplaces and outdoor grills need not be so equipped.

Recommendation: Contact a qualified plumbing contractor.

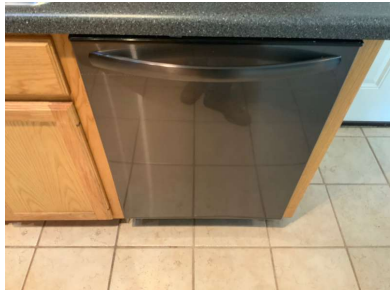
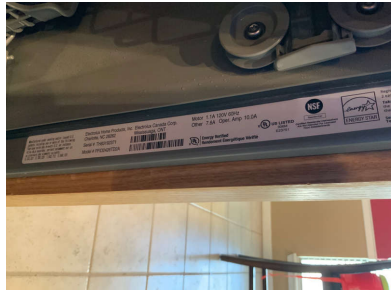
1: High loop missing

DISHWASHER HIGH LOOP MISSING

A "high loop" or "air gap" was not present for the dishwasher drain line at visible portions. A high loop or air gap prevents wastewater from siphoning back into the dishwasher during operation. The proper installation of the dishwasher drain line is recommended by a licensed plumber or other qualified person.

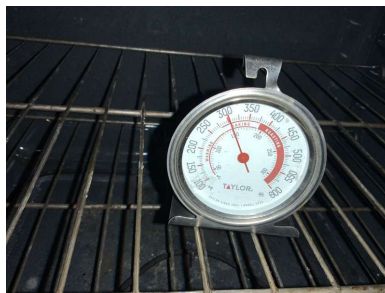
This oven was sitting at approximately This oven could use adjustments to recalibrate the temperature setting.

We recommend that you contact a qualified appliance technician to recalibrate the oven. If you wanted a **DIY solution** [Here is a link to a helpful video.](#)

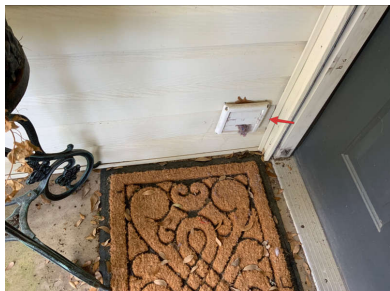
The dryer vent is in need of cleaning, there is a lot of lint build up on the screen of the dryer vent on the roof of the home. We recommend that the flue be cleaned prior to closing, as well as annually thereafter to help the dryer vent properly and more importantly reduce the potential for fire due to clogging the vent flue with lint.

Recommendation: Contact a qualified professional.
