RESIDENTIAL HOME INSPECTION

1234 Main St.
Wellington 6022

Buyer Name
09/25/2018 9:00AM

Inspector
Adam Collins
LBP; NZQA in Carpentry (advanced), Roofing
+64 210372132
inquest.kiwi@gmail.com

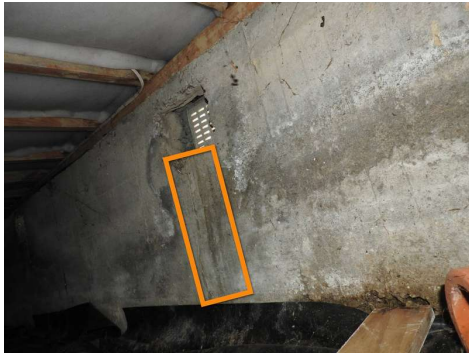
4.1.1 Perimeter wall - Concrete

CRACKING - HAIRLINE FRACTURE

There is a single crack in the foundation located near the underfloor access. The crack is detected on both sides of the wall in the same place. We don't see this as causing any future problems, everything is straight and level and well supported. If anything, some silicone applied here would help preserve the reinforcing steel from corrosion. Has not impacted verticality or alignment thus far.

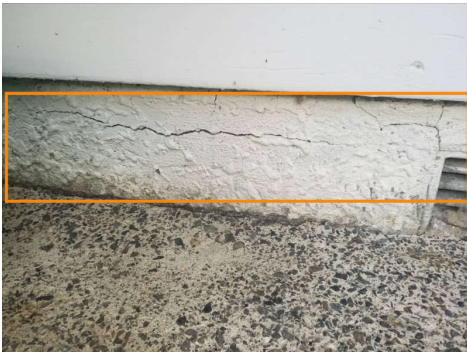
4.1.2 Perimeter wall - Concrete

CRACKING - SUPERFICIAL

The solid plaster coating in some isolated areas are showing some cracks, these are drumming when tapped. This is superficial, not structural cracking. if left, should not cause any future problems to the foundation itself.

Contact a stucco repair contractor

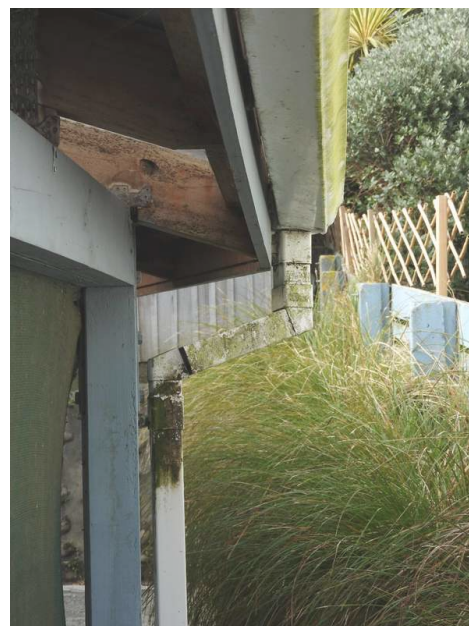
DAMAGED OR CRACKED

This type of defect can be easily fixed with the replacement of inexpensive components.

Recommendation

Estimated Cost

\$50 - \$150

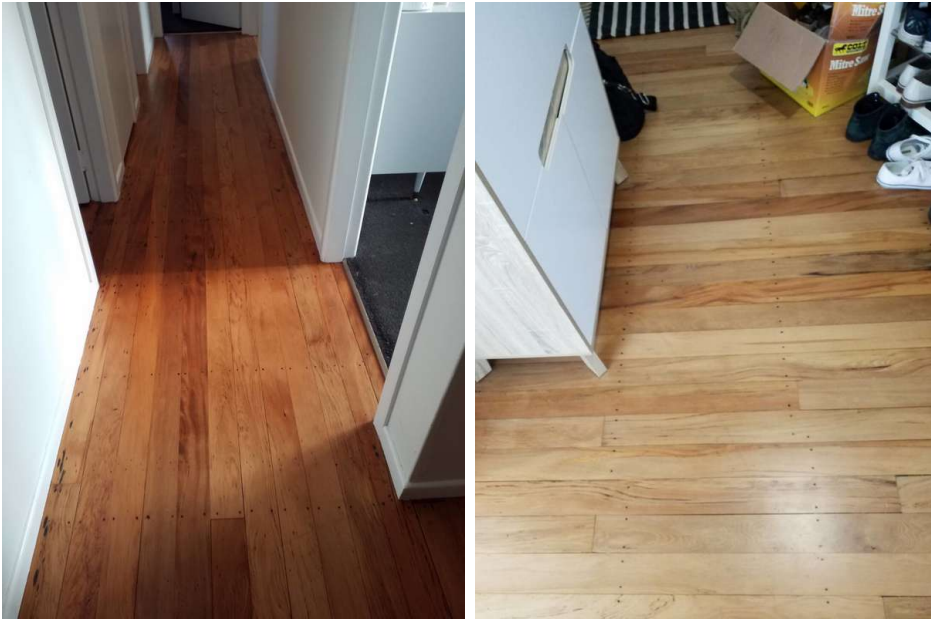
There are some creaky floorboards located in isolated areas.

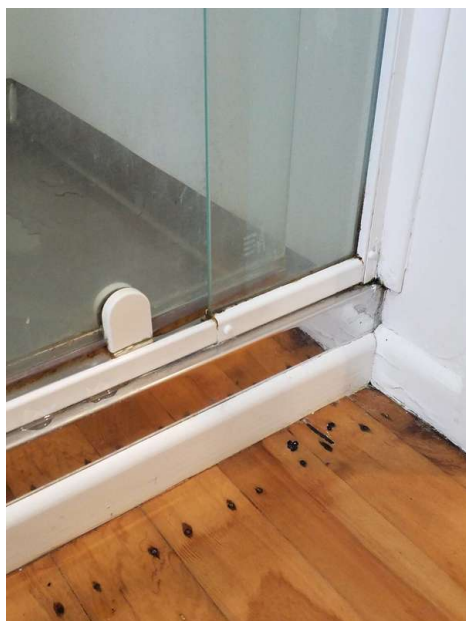
13.7.1 Shower

LEAKING - MINOR

Leaking in this section of the shower, best to get this repaired before it causes bigger problems. Easy fix and quite common for this type of product.

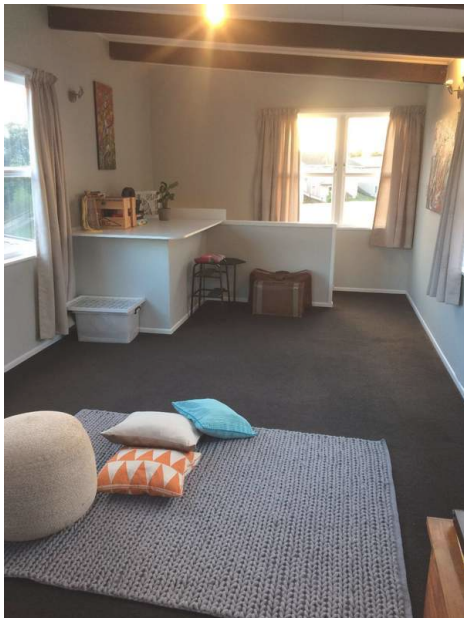
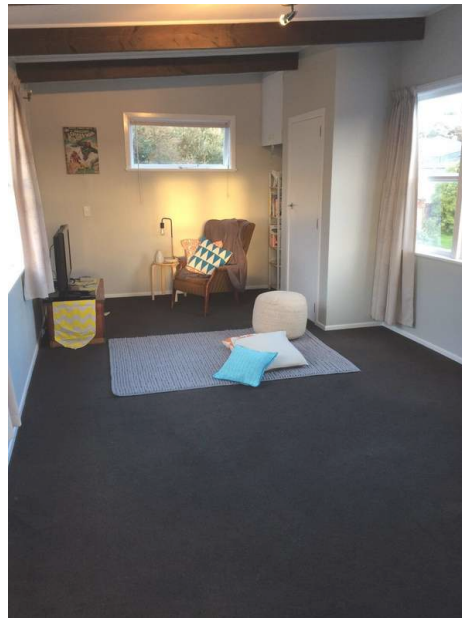
Comment: Some cracking in places due to the placement of sheet joins

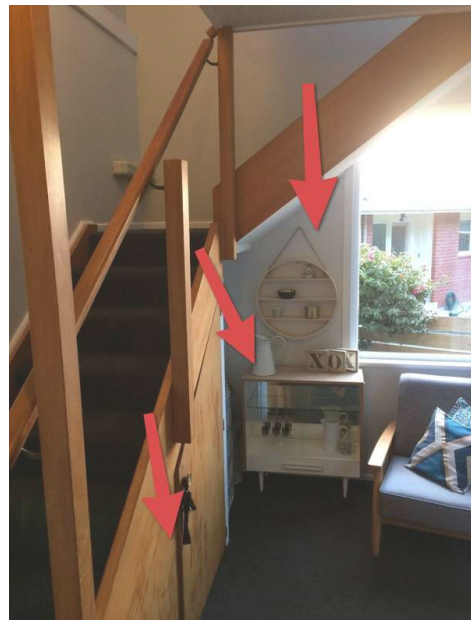
Maintenance or repair required to the balustrade or handrail here . The solution would be an inexpensive fix.

Estimated Cost

\$100 - \$350

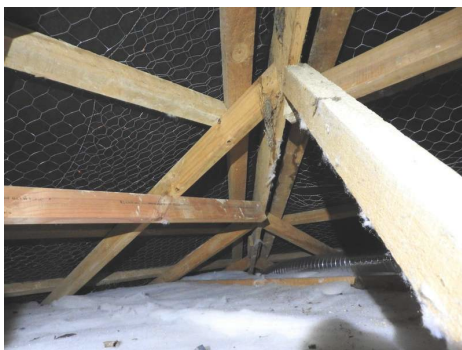
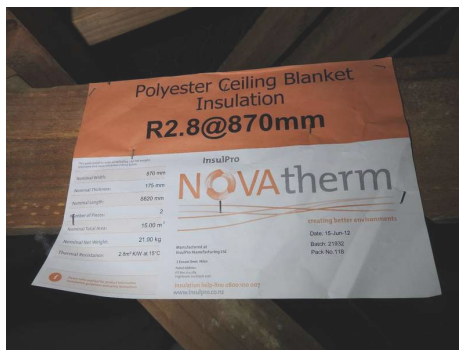
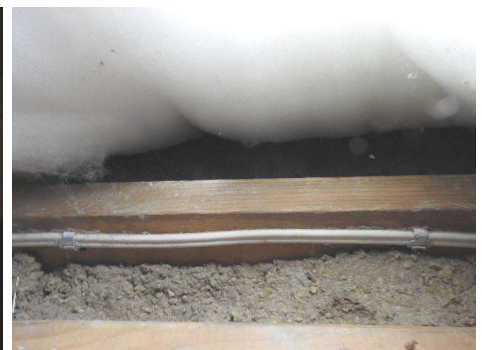
Polyester insulation is quite new, good coverage and appropriate thickness. It is laid out over the top of insulfluff. We have had an asbestos test sample taken, results returned from laboratory conclusive no asbestos fibers present. Full report attached at end of building report.
