BUILDING INSPECTION REPORT

1234 Main St.
Olmsted Falls OH 44138

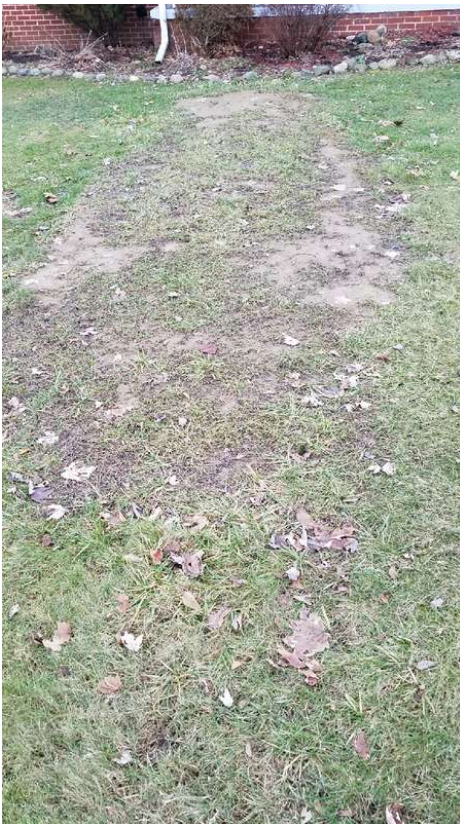
Grading & Vegetation: Lawn disturbed

I found out from a neighbor that the main sewer line to the street was damaged. It was dug up and repaired approximately 2 years ago.

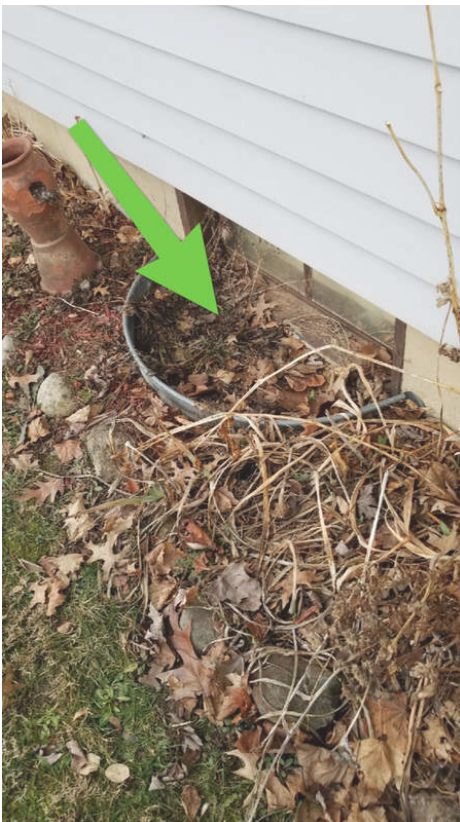
Window wells: Keep drains clear, window wells

As a maintenance item, it's important to keep the window well drains clear to prevent backups. A backup would allow water to accumulate around the bottom of the window and possibly enter the structure.

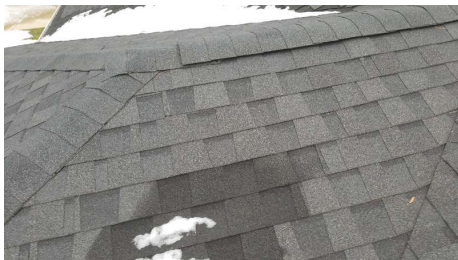
Shingles: Representative Shingle Condition

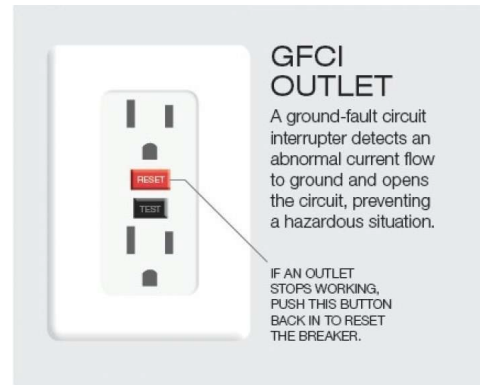
GFCI Example

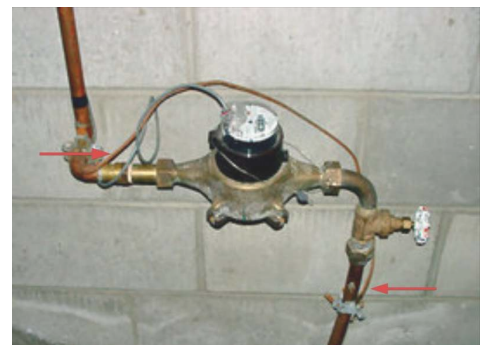
BONDING JUMPER MISSING AT WATER METER

A bonding jumper is not present at the water meter. This jumper allows the water meter to be removed and still provide a grounding path for the electrical system. Recommend installation by a qualified electrician.

Example of a bonding jumper at the water meter

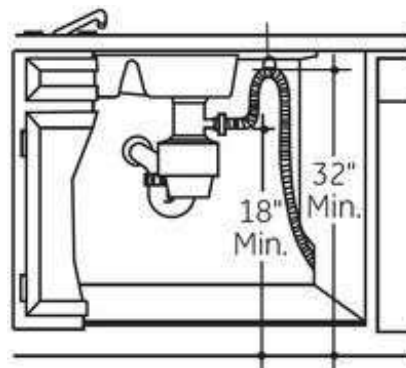
Example of a proper high loop

Contact a qualified plumbing contractor.
