RESIDENTIAL PROPERTY INSPECTION

1234 Main St.
Mt. Pleasant MI 48858

Buyer Name
05/14/2019 9:00AM

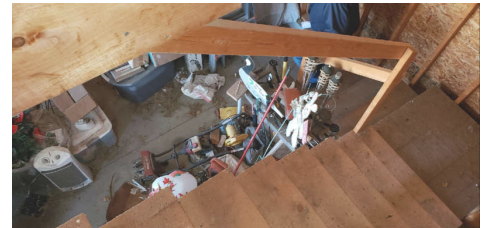
GUARDRAIL SPACING

There was spacing present on the guardrail at the top of the stairs in the garage that was greater than 4 inches. Current safety standards require that guardrails be designed as to not allow the passage of a 4 inch sphere through them. Safety upgrades should be considered here.

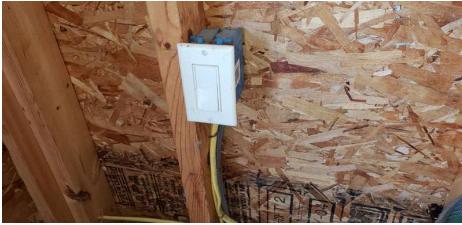
Switches, Lights: Unknown Switch in Garage

An unknown switch was present. I recommend consulting with the sellers as to its purpose.

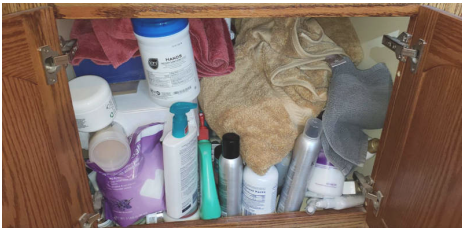
Master Bathroom

Undersink Plumbing - Bathroom: Heavy Belongings Under Sink(s)

A heavy amount of stored items were present in the cabinet(s). This may obscure visual accessibility of some areas; including plumbing components and cabinet floor/wall surfaces. The inspection of these areas is limited to visual portions only.

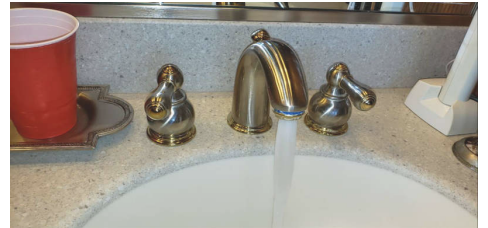
Master Bathroom

10.4.2 Sink(s)

Recommendation

Contact a qualified handyman.

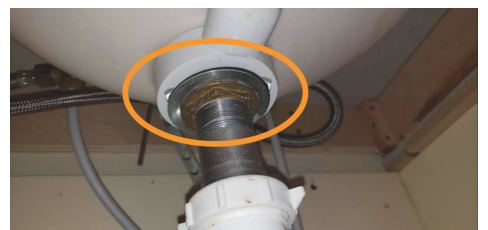
Right Sink Master Bathroom

10.5.1 Undersink Plumbing - Bathroom

Recommendation

Contact a qualified plumbing contractor.

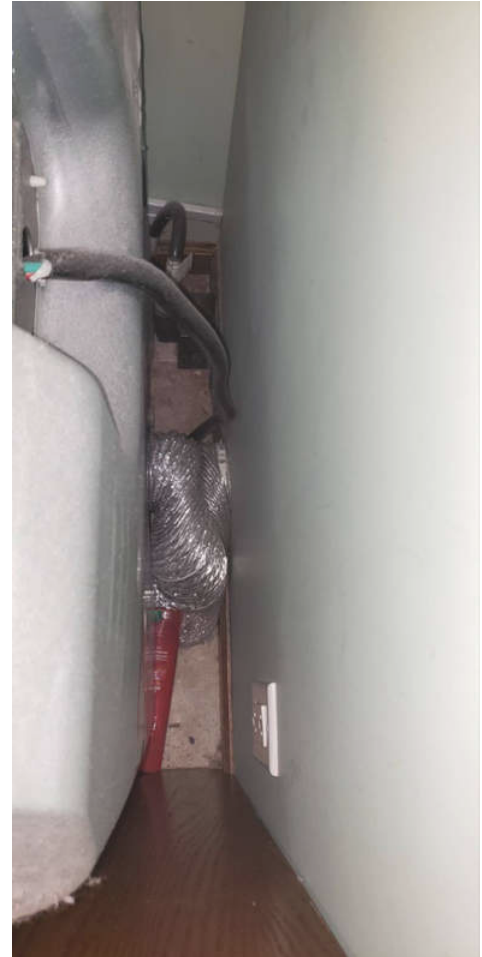
Marginal Defect

The dryer vent duct was pinched. Replacement of the vent with proper materials is recommended by a qualified person.

Contact a qualified professional.

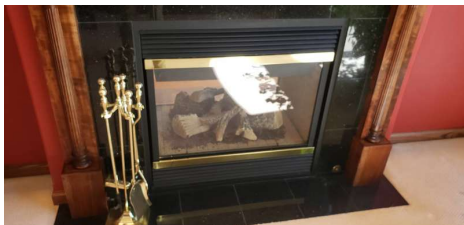
Fireplace(s): Pilot Light Not Lit

The pilot light for the gas logs was not lit at the time of inspection. Gas fireplaces are not tested for functionality if the pilot is not lit, as there are specific instructions for ignition that must be closely followed for safety. These lighting procedures vary from manufacturer to manufacturer. Gas Fireplace manufacturers highly recommend that the manual is given to the new owners so that safety precautions are followed. As well manufacturers recommend that gas fireplaces are inspected, and maintenance is performed annually. I recommend maintenance by a gas fireplace professional prior to using the unit.

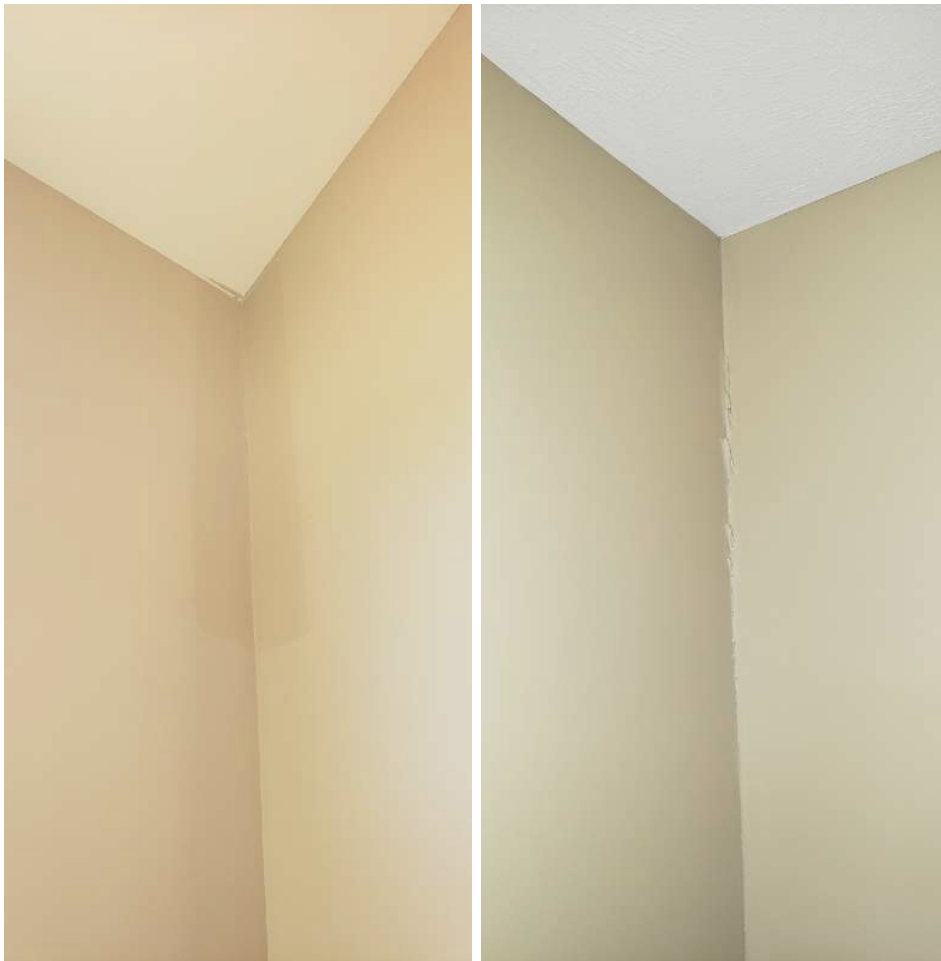
13.10.1 Ceiling Condition

-   13.10.1 Interior Areas - Ceiling Condition: Possible Moisture Staining/Damage Present

Contact a qualified professional.
