GOLDEN STAR RESIDENTIAL REPORT COPY

1234 Main St.
Spokane, WA 99205

Buyer Name
07/02/2019 9:00AM

Inspector
Aaron Storer

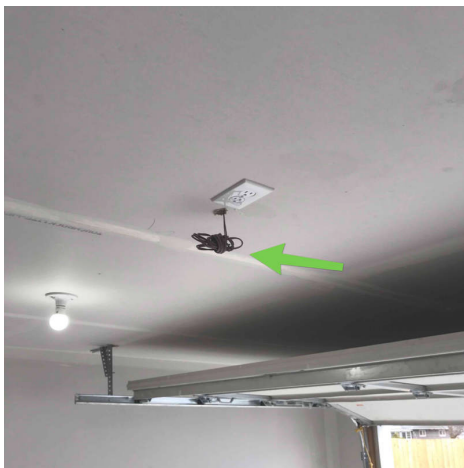
Automatic Garage Door Opener: Pre-Wired

There was no automatic garage door opener installed, but the home was pre-wired for future installation.

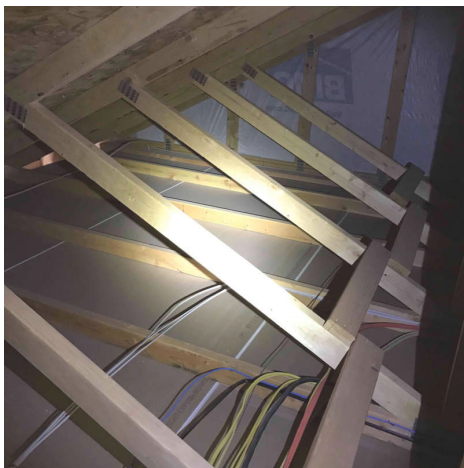
Garage Roof Structure: Garage Attic

The attic structure over the garage appeared to be in satisfactory condition. There was no insulation observed.

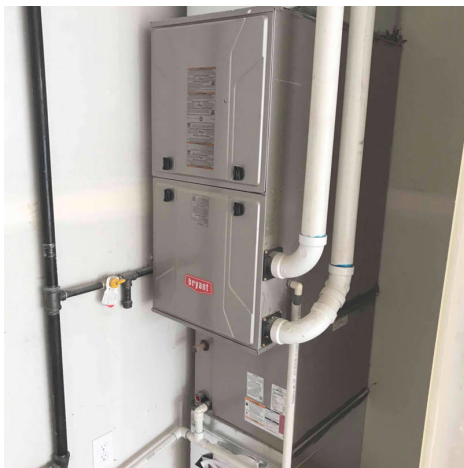
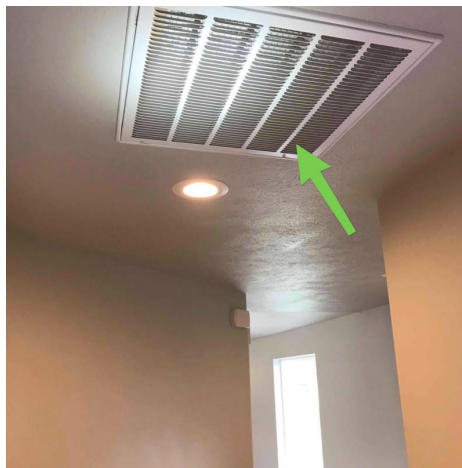
Heating Equipment: Furnace

The furnace appeared to be satisfactory and functioning properly at the time of inspection. Recommend servicing annually and changing the filter every 3-6 months. Filter was located in the hallway ceiling.

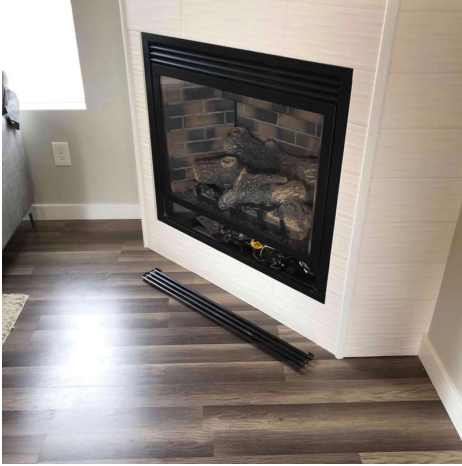
Fireplace: Fireplace

The metal gas fireplace insert appeared to be operating properly at the time of inspection.

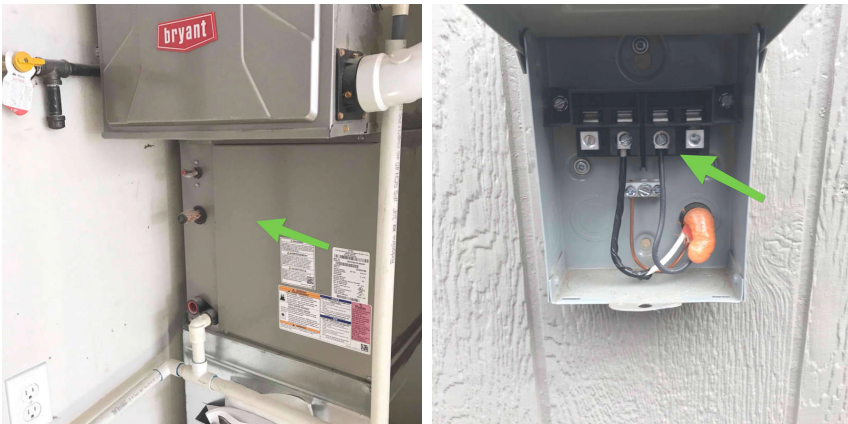
EVAPORATOR COILS

The evaporator coils are enclosed within the central heating and air conditioning system. This inspection does not entail dismantling the system for inspection. Evaporator coils not visible, not inspected. Any future condensing unit was not installed at the time of inspection.

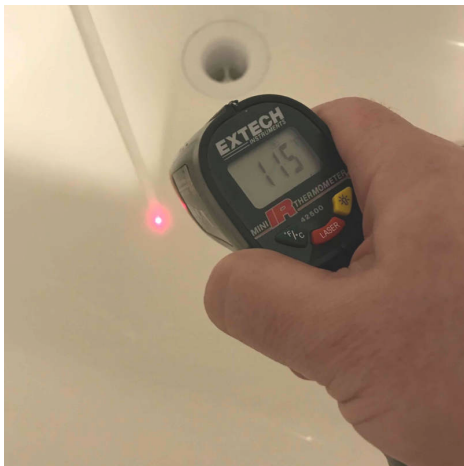
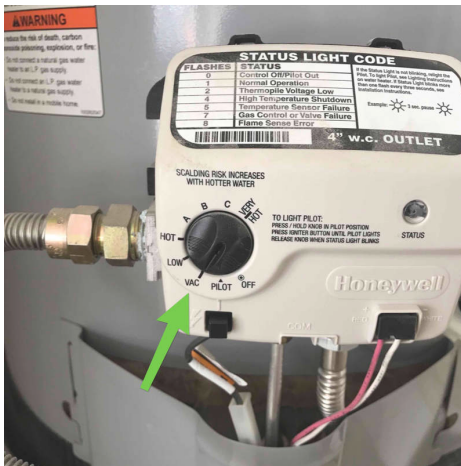
Water Temperatures

Satisfactory, Water temperatures were at or below 120 degrees Fahrenheit

The water heater was set to Vacation temperatures. Refer to operators manual for proper temperature setting. Most water heater manufactures recommend setting your water heater temperature at 120 degrees to help prevent scalding and to save energy. Scalding is a real concern if you have small children or elderly in your home. You may be surprised to know that while the EPA recommends setting your water heater at 120 degrees, OSHA recommends setting your water heater thermostat at 140 degrees under certain circumstances. Higher temperatures help rid your water of bacteria. [More information and video found here.](#)

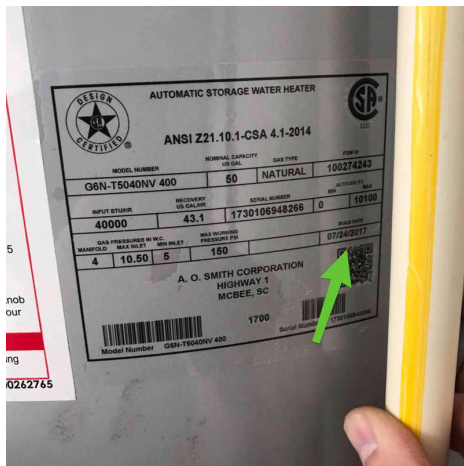
Water Heater Age

2 Years old

Recommend flushing & servicing your water heater tank annually for optimal performance.

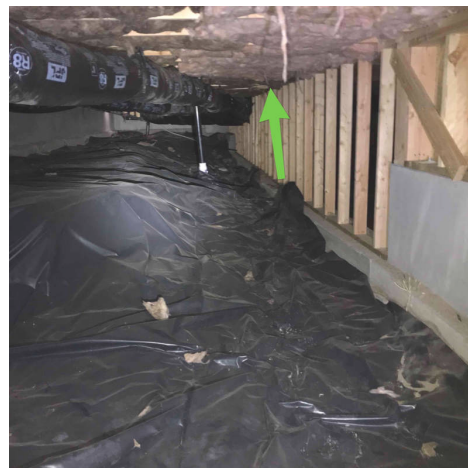
NOT INSPECTED - INSULATION

The sub floor was not visible due to insulation. Not inspected

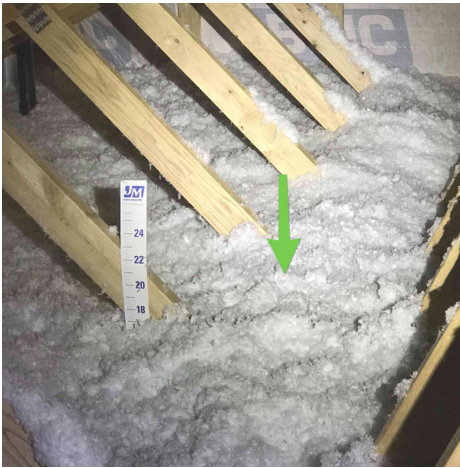
Attic Insulation: Attic Insulation

Attic insulation appeared to be adequate. Recommend monitoring for compressed conditions in the future.

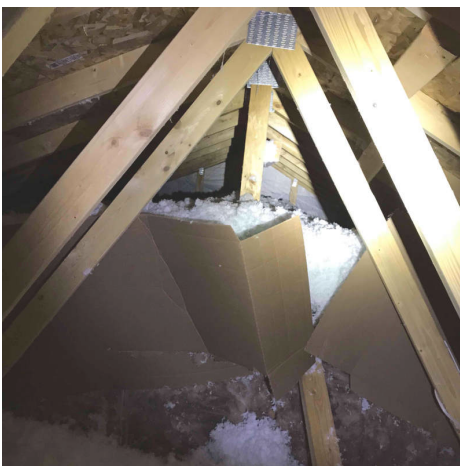
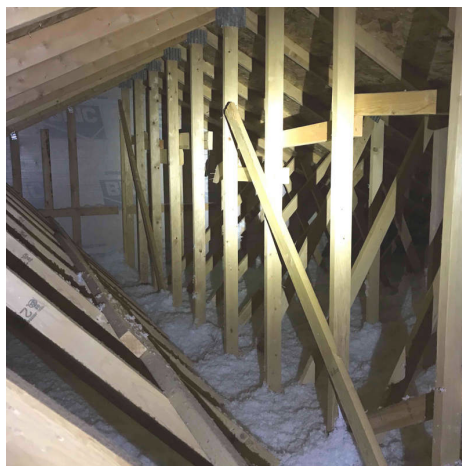
Attic Structure: Attic Structure

The attic structure over the main home and garage appeared to be in satisfactory condition.

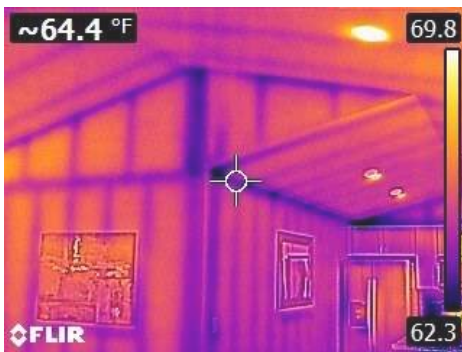
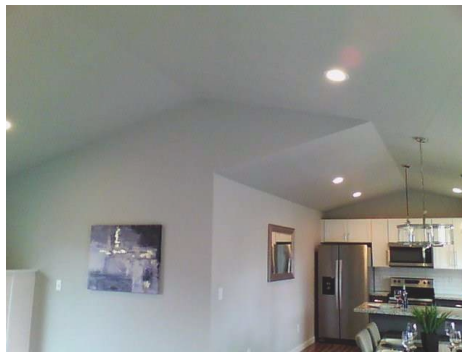
Air Infiltration Scan: Air Infiltration Satisfactory

Air infiltration of the home was minimal.

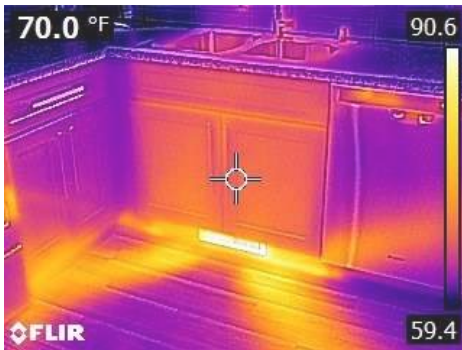
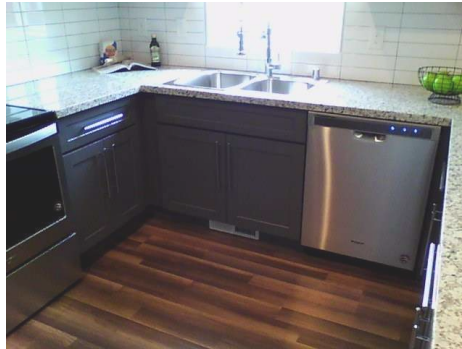
Heating System Scan: Heating & Cooling

The thermal scan of the registers and ducting indicate the ducting system was in satisfactory condition.
