RESIDENTIAL

1234 Main St.
Humble TX 77339

07/18/2018 9:00AM

PROPERTY INSPECTION REPORT

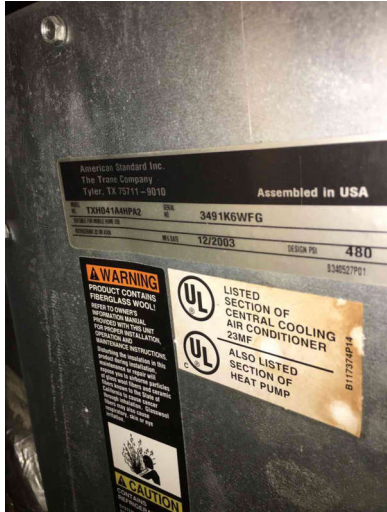
- A. Heating Equipment**
Brand: American Standard
Energy Source: Natural Gas

Type of System: Forced Air
