BLESS THIS NEST INSPECTIONS, LLC

PROPERTY INSPECTION REPORT

1234 Main St.
Margate Florida 33063

Buyer Name
02/18/2019 9:00AM

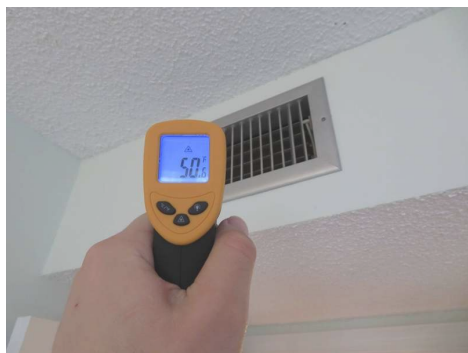
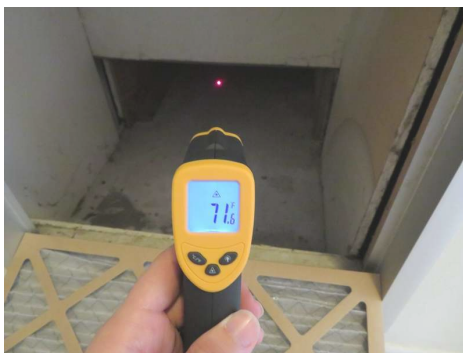
21 Degrees

This is the number of degrees the system is cooling (or heating) the house air. Normal range for this number is 14-22 degrees when operating the system during hot weather, lower when ambient temperatures are lower. The system functioned as expected when tested and appeared to be serviceable at the time of the inspection. As with all mechanical equipment, the unit may fail at any time without warning. The inspector cannot determine future failures.
