## RESIDENTIAL PROPERTY INSPECTION

1234 Main St.  
Fall Branch Tennessee 37656

Buyer Name  
02/23/2018 9:00AM

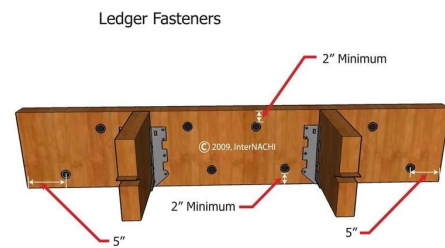
2.4.2 Porches / Decks

**LEDGER FLASHING MISSING**

Contact a qualified deck contractor.

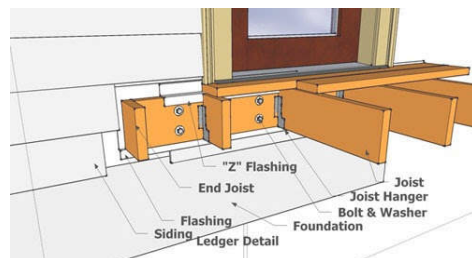
2.4.3 Porches / Decks

**LEDGER BOARD ATTACHED TO OR THROUGH VENEER**

Contact a qualified deck contractor.

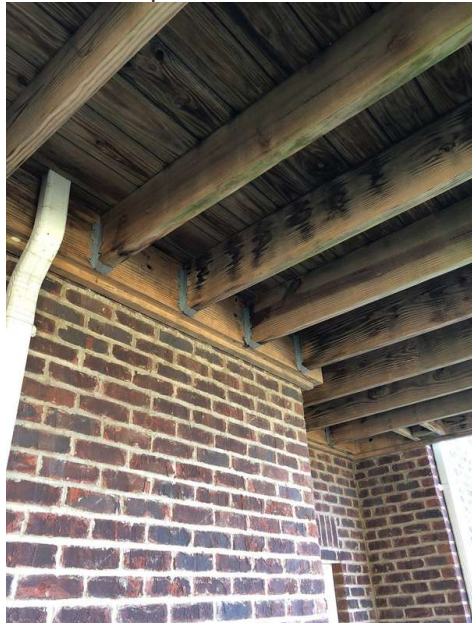
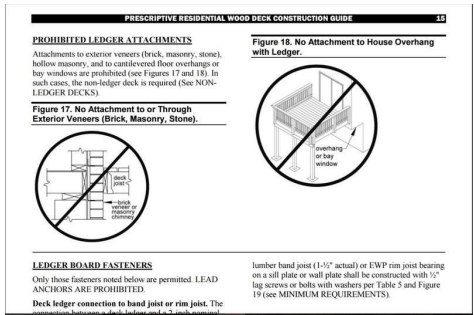
2.4.4 Porches / Decks

Maintenance Item, FYI, or Minor Defect

Contact a qualified professional.

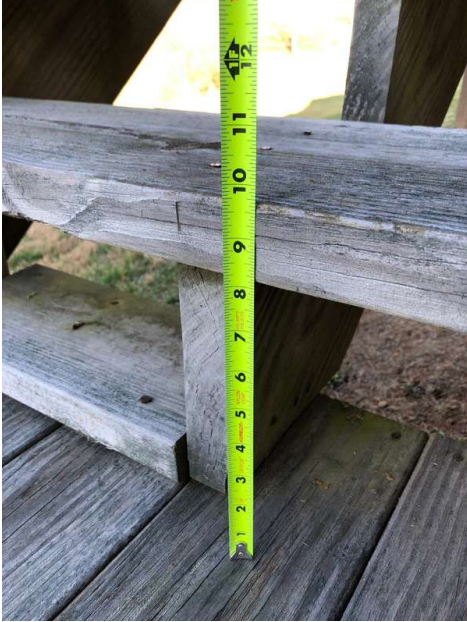
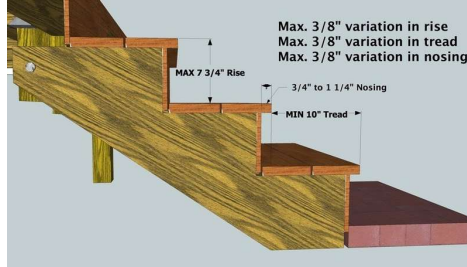
### 2.5.3 Stairs

## STRINGERS MISSING HANGERS

Contact a qualified deck contractor.

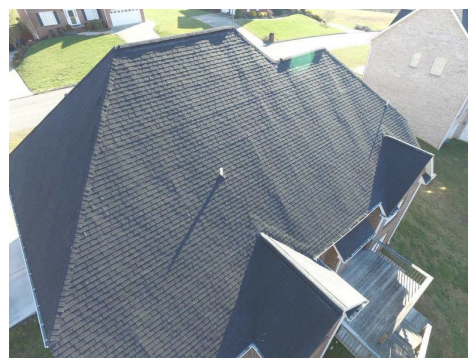
### 3.2.1 Vents / Protrusions

Maintenance Item, FYI, or Minor Defect

Contact a qualified handyman.

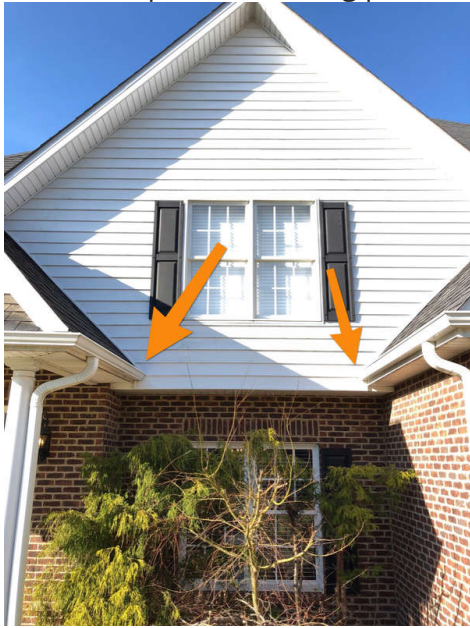
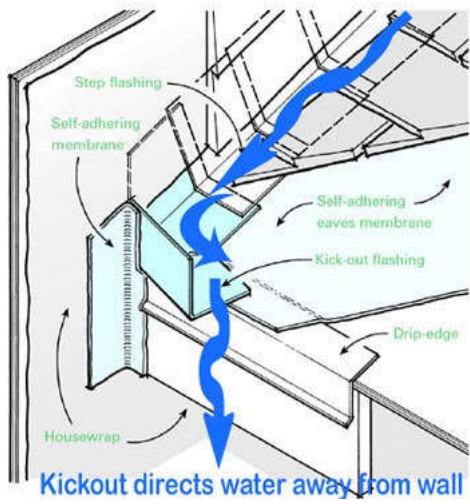
3.3.2 Flashings

**PROPER SIDEWALL FLASHING MISSING**

Contact a qualified roofing professional.

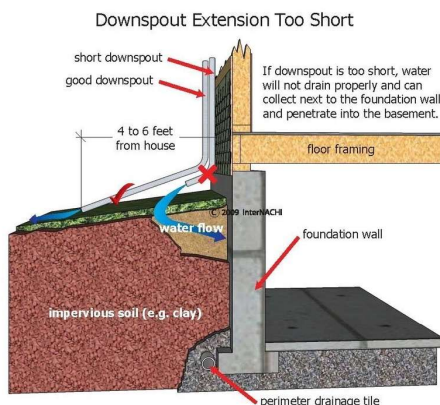
3.4.3 Gutters / Downspouts

Maintenance Item, FYI, or Minor Defect

Contact a qualified professional.

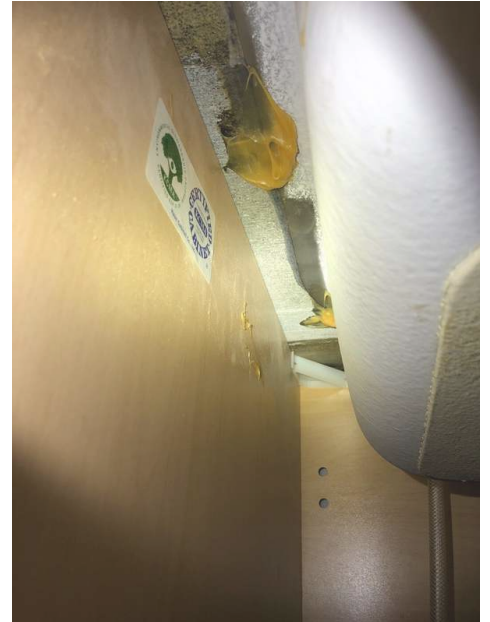
### 5.2.1 Sink(s)

#### **UNDERMOUNT SINK MISSING MOUNTING CLIPS**

The undermount sink was missing undermount clips. Currently the sink is relying on sealant to secure the sink to the countertop, and eventual failure of this sealant will allow the sink to fall. The installation of proper clips are recommended by a qualified person.

Contact a qualified professional.

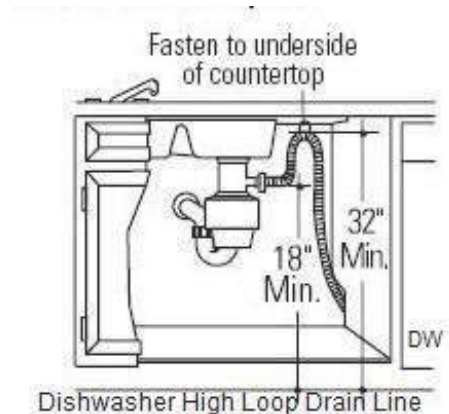
### 5.4.1 Visible Plumbing

#### **DISHWASHER HIGH LOOP MISSING**

A "high loop" or "air gap" was not present for the dishwasher drain line at visible portions. A high loop or air gap prevents wastewater from siphoning back into the dishwasher during operation. The proper installation of the dishwasher drain line is recommended by a licensed plumber or other qualified person.

Contact a qualified professional.

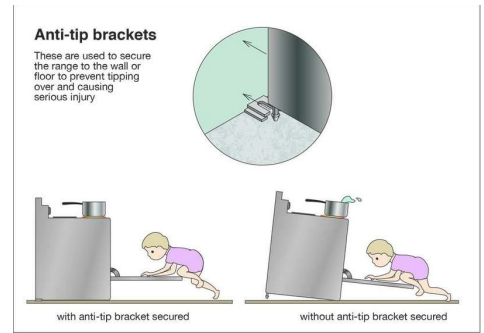
## 5.7.1 Oven/Range

**ANTI-TIP BRACKET MISSING**

An anti-tip bracket was not present for the the range. An anti-tip bracket prevents the range from tipping over, if weight is applied to an open oven door, such as a child stepping or sitting on the door. Ranges contain a warning label on the inside of the oven door with more information. This bracket can be purchased at home improvement stores for approximately ten dollars and the installation of this bracket is highly recommended.

Contact a qualified professional.

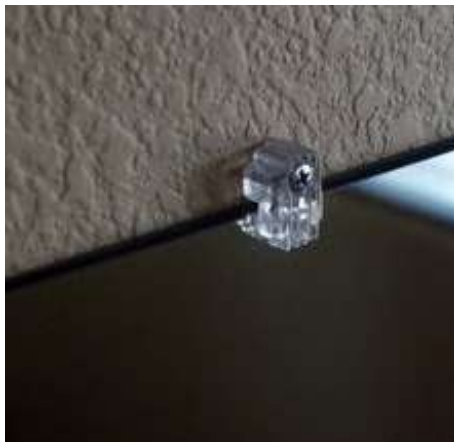
There were bathroom mirror(s) that were adhered to the wall(s). I recommend adding brackets to secure any mirrors that are adhered, in case of adhesion failure.

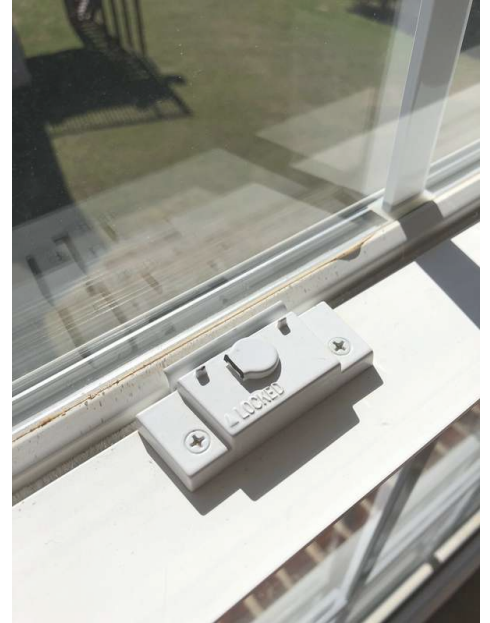
The window latches / locks were missing or damaged. Latches and locks are recommended for security. Have a qualified person to repair as needed.

Contact a qualified window repair/installation contractor.

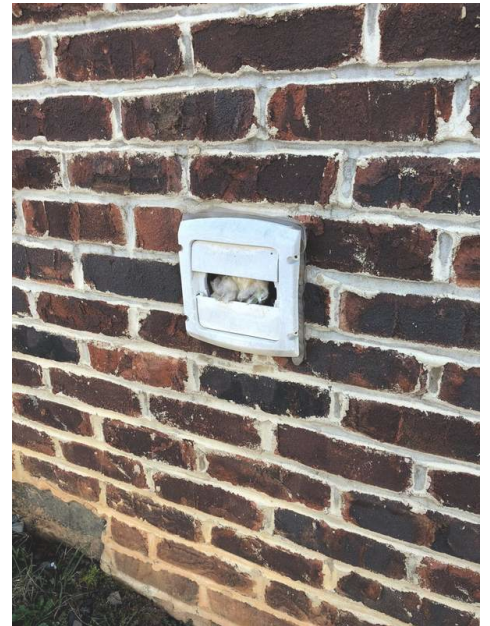
### 8.2.1 Dryer Vent

#### **MISSING LOUVERS**

There were missing louver(s) on the exterior vent cover. This can allow insect / wildlife intrusion into the duct. Replacement of the louver(s) or exterior cover is recommended by a qualified person.

Contact a qualified handyman.

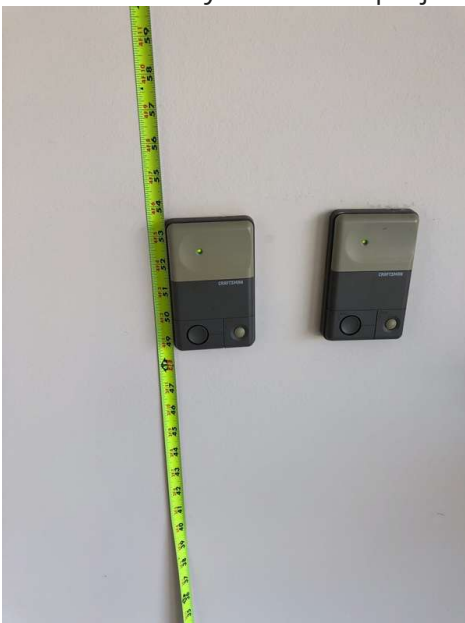
The garage door opener button(s) were within five feet of a standing surface. Opener buttons are recommended to be elevated at least 60" to prevent a child from operating the door. Raising the button to proper height is recommended.

Contact a handyman or DIY project

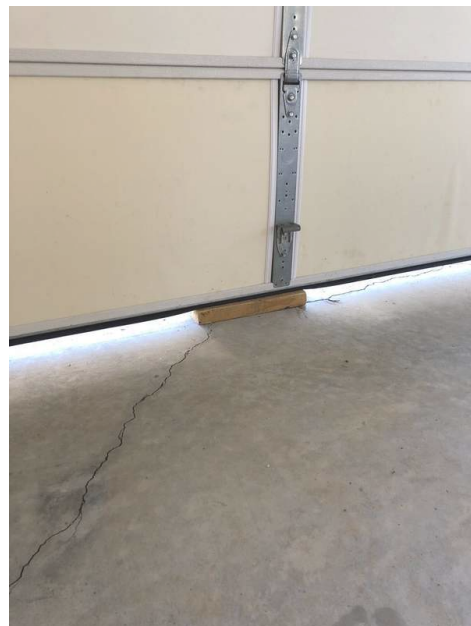
9.4.1 Garage Door Safety

**RESISTANCE TEST FAILED**

The garage door(s) did not auto reverse when met with resistance. DASMA testing procedures were followed, and the door did not auto-reverse when contacting a 2" X 4" laid on the ground under the door. Garage doors contain two safety mechanisms to prevent someone from being injured or pinned under a closing door; photoelectric eyes and the ability to auto reverse when met with resistance. This is typically an adjustment of the "Force Close" setting on the rear of the opener (if present). Recommend repairs as needed by a garage door company.

Contact a qualified garage door contractor.

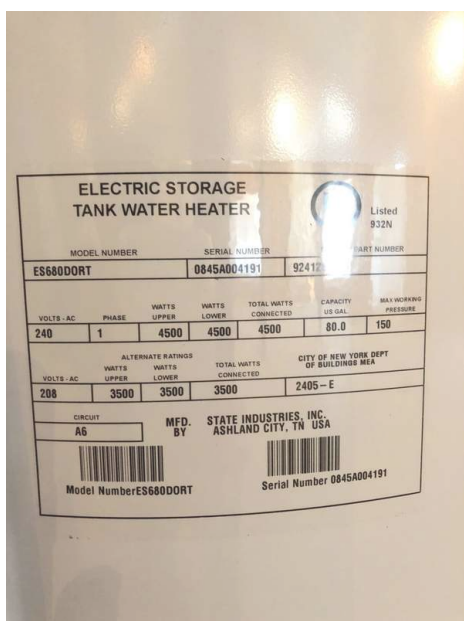
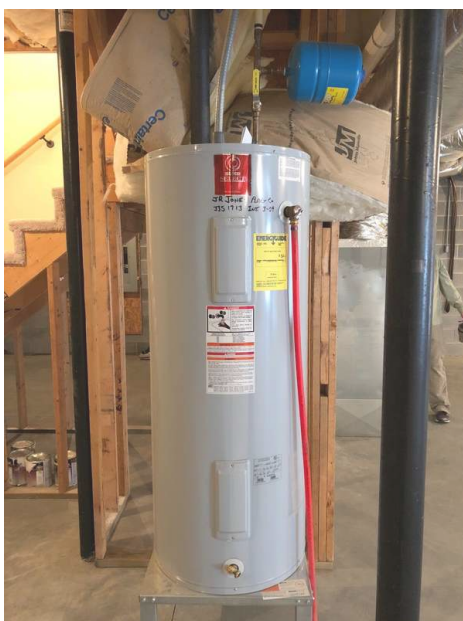
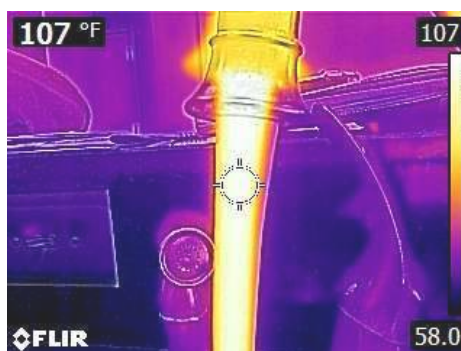
The water heater produced hot water at the time of inspection. No reportable deficiencies were observed with the unit unless otherwise noted in this report.

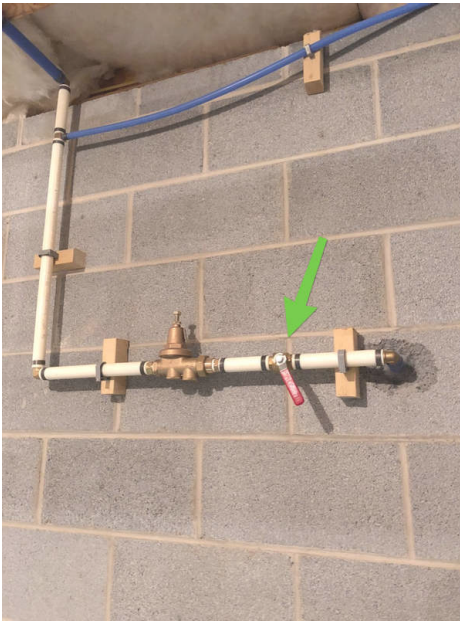
The shut off valve appeared to be in satisfactory condition at the time of inspection. No deficiencies were observed unless otherwise noted in this report. The valve is not operated to test it's functionality.

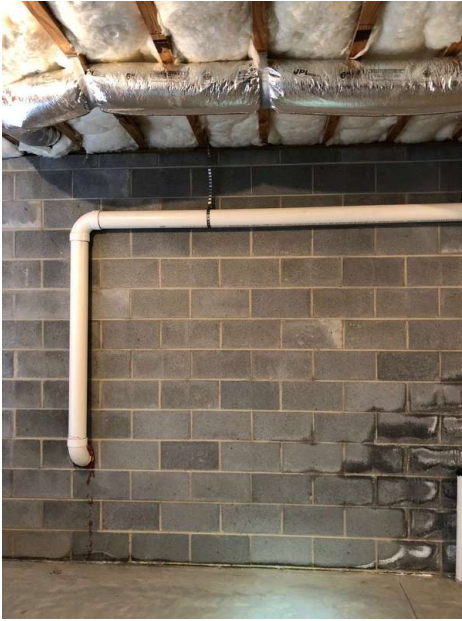
Visible portions of the (DWV) drain, waste, and vent pipes were inspected looking for leaks or indications of other deficiencies. No reportable conditions (significant defects) were visibly observed unless otherwise noted in this report.

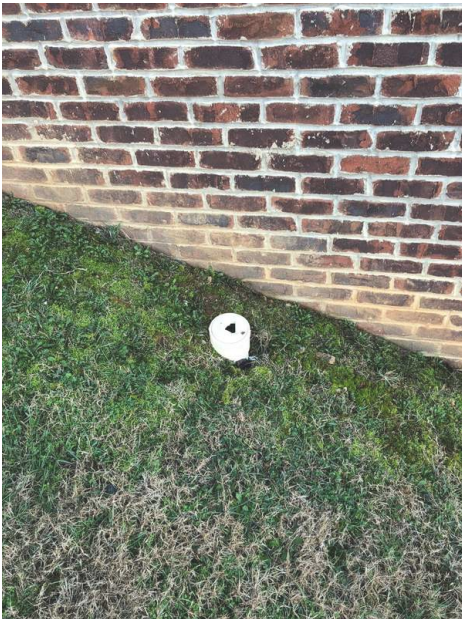
A sewer cleanout was present. Sewer cleanouts are reported on with regards to their presence only and are not attempted to open or verify any other information.

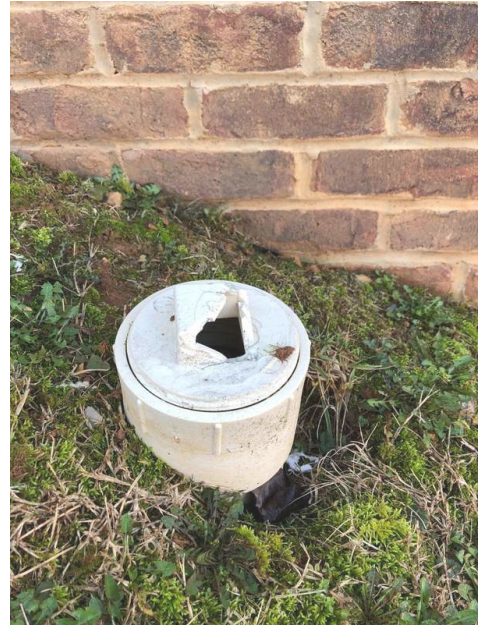
### **SEWER CLEANOUT DAMAGED**

The sewer cleanout pipe cap was damaged. Replacement as needed is recommended by a licensed plumber.

Contact a qualified plumbing contractor.

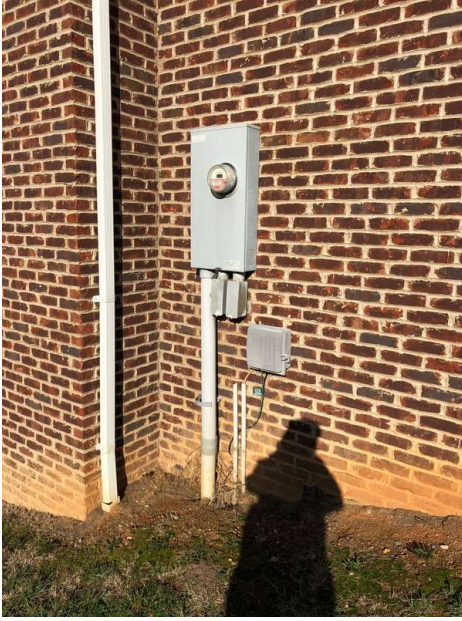
Power was supplied to the home via an underground service lateral. The meter and conduit appeared to be in satisfactory condition. No deficiencies were observed unless otherwise noted in this report.

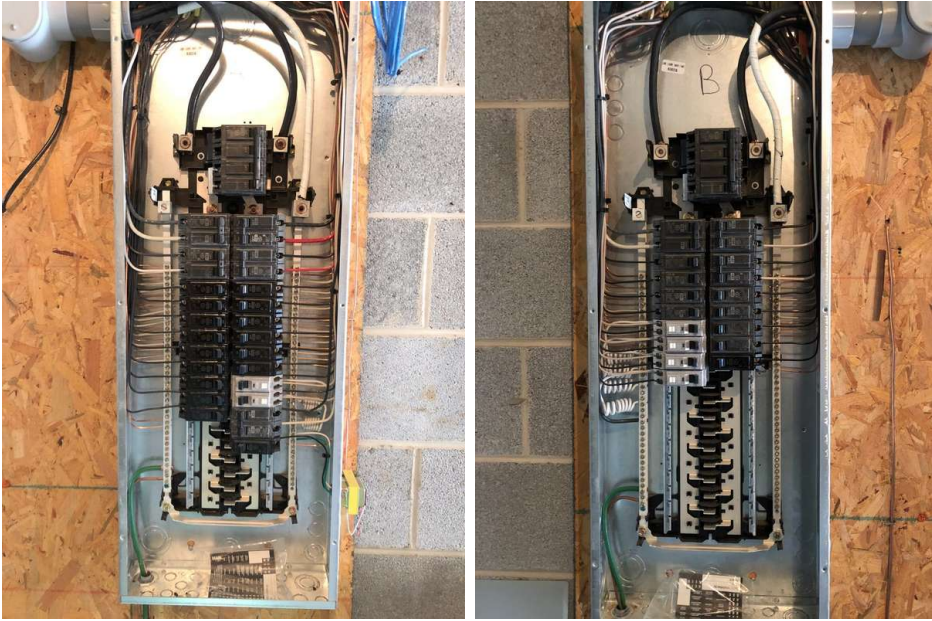
The main electrical panel (called service equipment when it contains the service disconnect) was inspected looking for any wiring deficiencies or damage that may be present in the panel. No indications of reportable conditions were present at the time of inspection unless otherwise noted in this report.

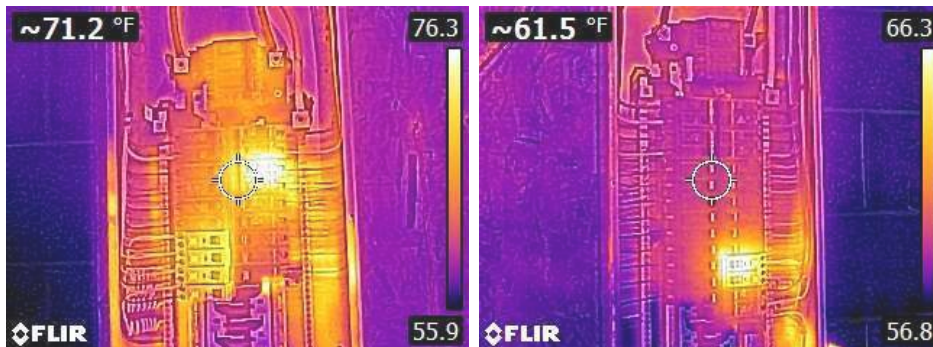
No hot spots or anomalies were observed in the electrical panel, under current loading conditions, during the inspection.

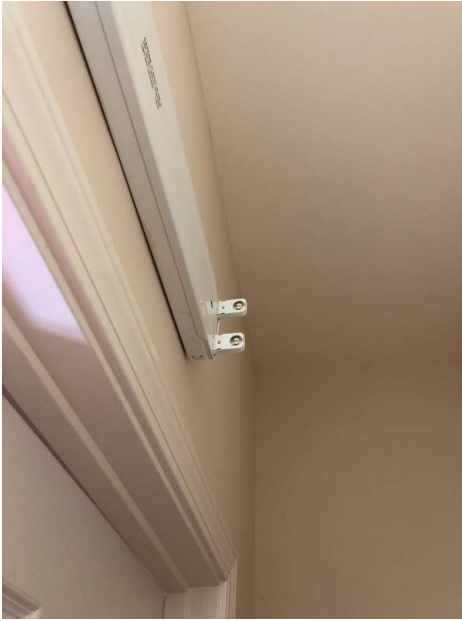
The referenced area(s) did not have a light bulb installed, and therefore the fixture(s) were not able to be tested for functionality. I recommend confirming proper operation prior to closing.

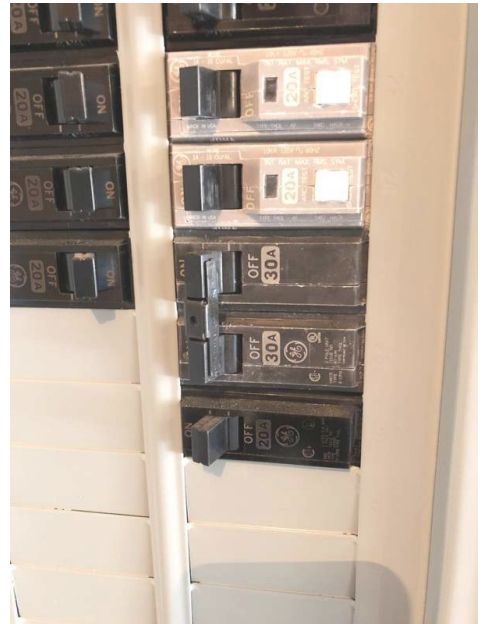
### 13.7.1 Breakers

One exterior HVAC unit was overfused with a breaker larger than the maximum designated sized breaker as found on the exterior unit's data tag. The installation of the proper sized breaker as needed is recommended by a licensed electrician.

Contact a qualified electrical contractor.

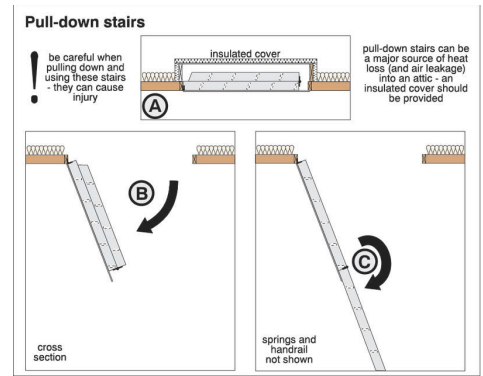
14.2.1 Attic Access

The attic opening above the pull down stairs was not insulated. This can affect the energy efficiency and "comfort" level of the home. I recommend adding an insulated cover over the access.

Contact a qualified professional.

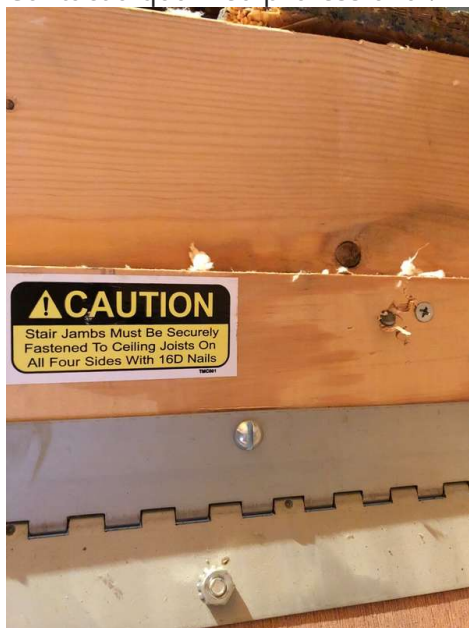
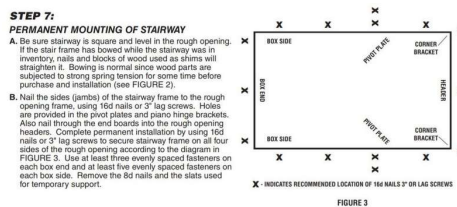
**STAIRS IMPROPER FASTENERS**

The pull down stairs were secured to the framing with improper fasteners. Pull down stair manufacturers highly recommend using 16d nails, as screws do not have the sheer strength to support the ladder and weight of a person. Proper securement of the stairs is recommended by a qualified person.

Contact a qualified professional.

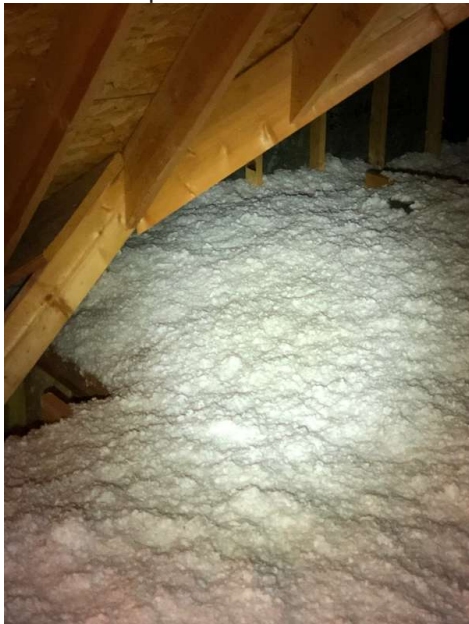
**SPARSE COVERAGE IN AREAS**

Some areas in the attic had less than the recommended amount of insulation present. Uniform insulation coverage is recommended for energy efficiency and comfort. The installation of additional insulation to achieve an R-39 rating throughout the attic is recommended by an insulation contractor.

Contact a qualified insulation contractor.

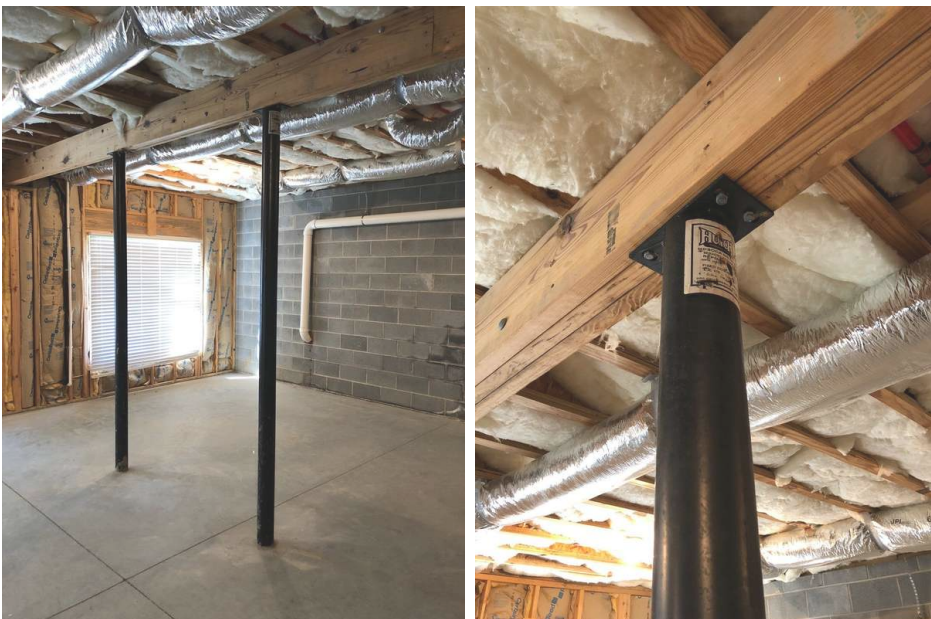
Columns were present that supported the overhead floor structure. The column(s) appeared to be in satisfactory condition at visible portions, at the time of inspection. No deficiencies were observed unless otherwise noted in this report.

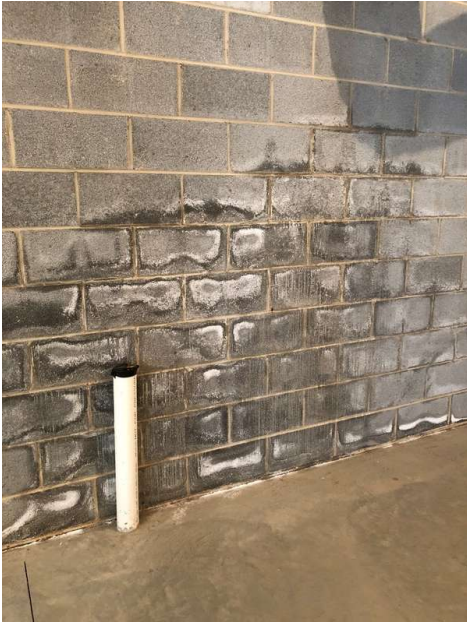
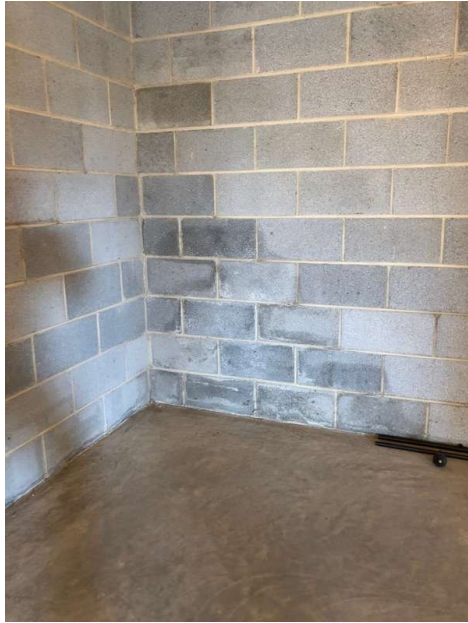
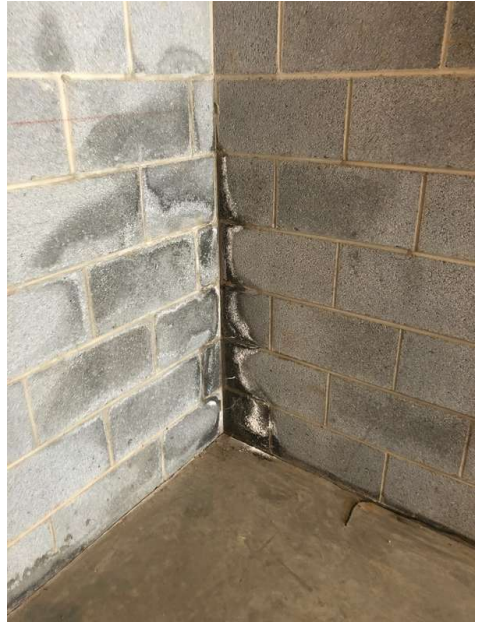
#### **ELEVATED MOISTURE CONTENT PRESENT**

Moisture intrusion / elevated moisture content was present on the foundation wall(s) in the areas of inadequate connections of downspouts to drain tubes, and from the downspout drain tube termination point on the right side of the home. These inadequate connections and termination point are presumed to be the sole cause of the moisture, but can not be wholly confirmed. Repairs to these connections and termination point are recommended. If a concern, evaluation is recommended by a foundation contractor with repairs made as needed to prevent moisture infiltration through the foundation walls.

Contact a foundation contractor.

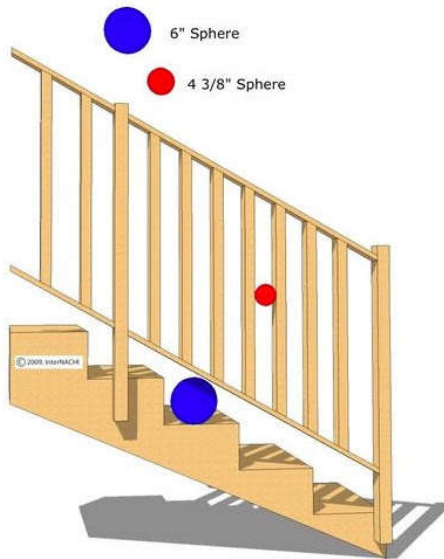
**STAIR RAILING NOT PRESENT**

Vertical stair railing was not present on the basement steps. Vertical stair railing with no more than 4 3/8 inch spacing between the balusters, is recommended for safety.

Contact a qualified professional.
