HOME CHECK INSPECTION SERVICES, LLC.

COLEEN AMSTEIN'S CUSTOM INSPECTION REPORT

1234 Main St.
Johnson City Tennessee 37604

03/05/2019 9:00AM

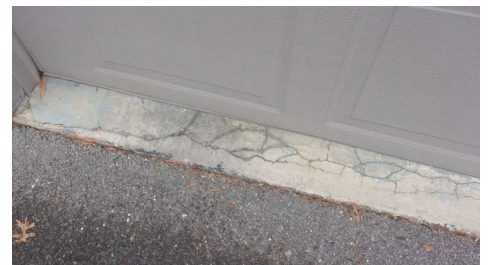
2.1.1 Driveway

SURFACE DAMAGE / PITTING

There is some cracking / damage to the concrete garage floor apron where it abuts the exterior asphalt driveway.

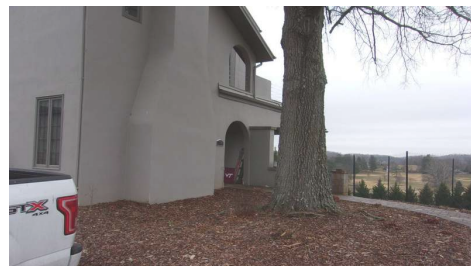
TREES CLOSE TO FOUNDATION

There is a tree at the left front of the home in close proximity to the home. Overtime tree root systems can cause structural damage. The root systems for trees differ, with some roots extending out 2 to 3 times the drip line or about 1.5 times the height of the tree. Recommend consulting a Tree Service for their recommendation.

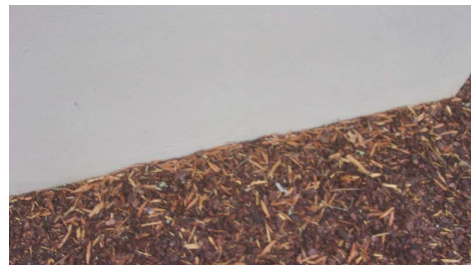
GROUND CLEARANCE

There is inadequate clearance between the home's exterior cladding and the soil grade. The recommended minimum ground clearance between exterior cladding and the soil is 6-8 inches, with 2 inches minimum required between cladding and hardscape. With the soil against the stucco there is always the chance of water wicking up from the soil into the stucco itself. With the soil in the flower beds flat to negatively sloped, at this time, additional soil may be needed or removed to correct the negative grade.

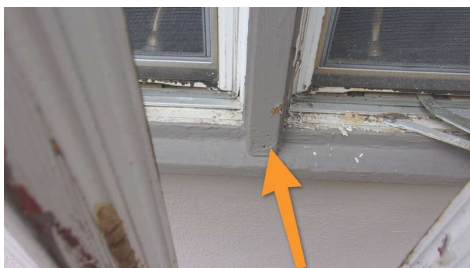
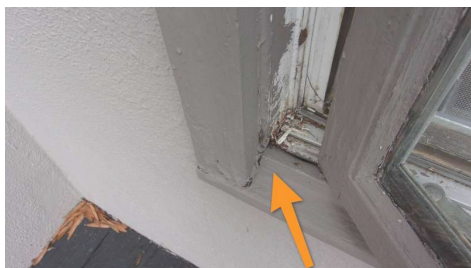
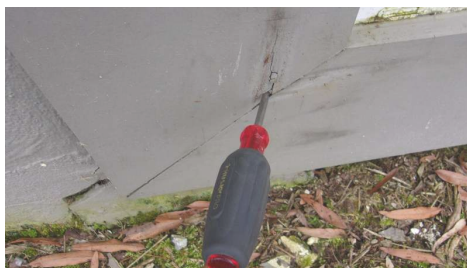
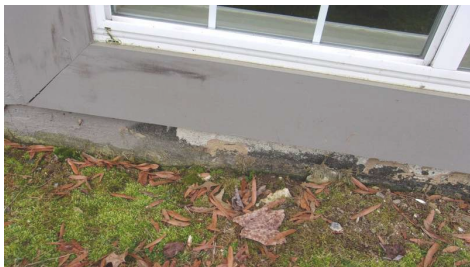
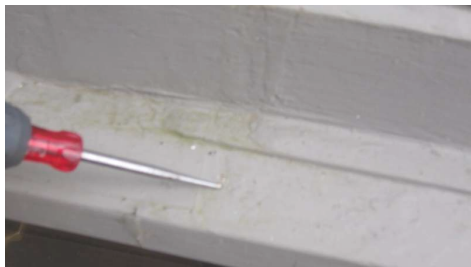
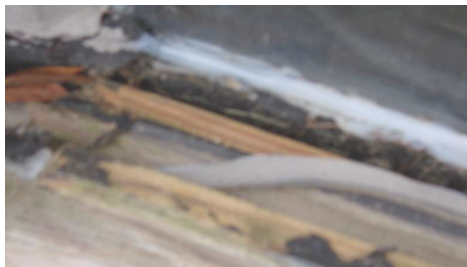
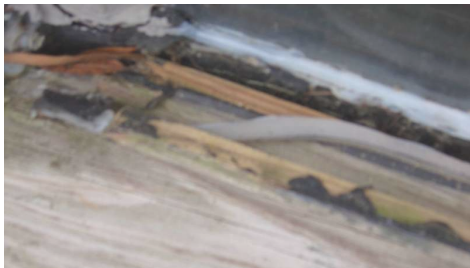
3.1.4 Cladding, Flashing & Trim

There areas around the home where there is visible wood rot / damage.

1. Exterior window casings and sills.
2. Lower back window trim.

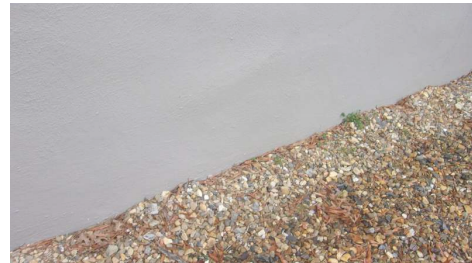
3.1.5 Cladding, Flashing & Trim

MISSING SWEEP CREED

There is no visible weep screed at the base of the exterior stucco cladding. A weep screed is a type of building material used along the base of an exterior stucco wall. The screed serves as a vent so that the moisture can escape the stucco wall finish just above the foundation. It additionally acts as a barrier for moisture wicking up the foundation toward the stucco.

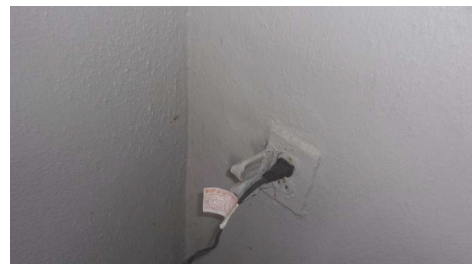
NO GFCI PROTECTION

All exterior outlets should be Ground Fault Circuit Interrupters (GFCIs). GFCI protection was required in 1971 by the NEC but it is unknown when the city adopted the code. Although homeowners are not required to upgrade their home's each time new codes are approved (every three years). There are certain codes that are for personal safety and these changes will be recommended when needed. Recommend installing GFCIs on exterior outlets.

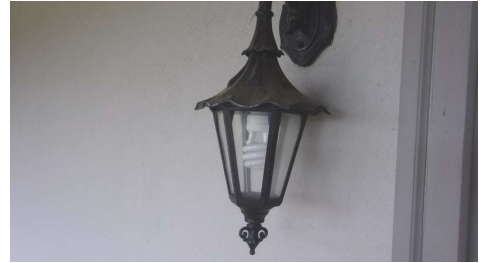
LIGHTING

At the time of the inspection the exterior light for the main level back patio door (mid house door) did not come on through the normal use of the light switch just inside the door.

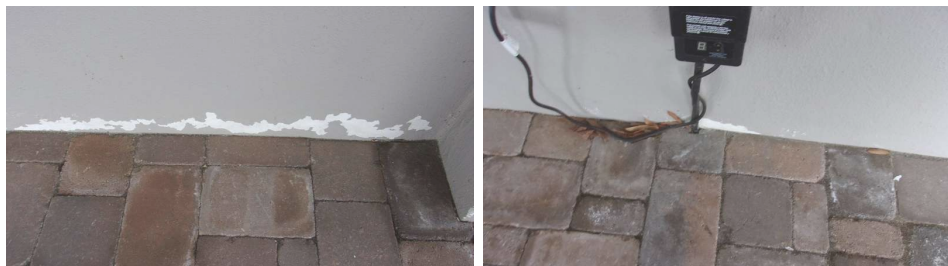
PAINT CHIPPING

There is some paint chipping of the stucco on the exterior wall to the right of the front door as well as on the second level balcony.

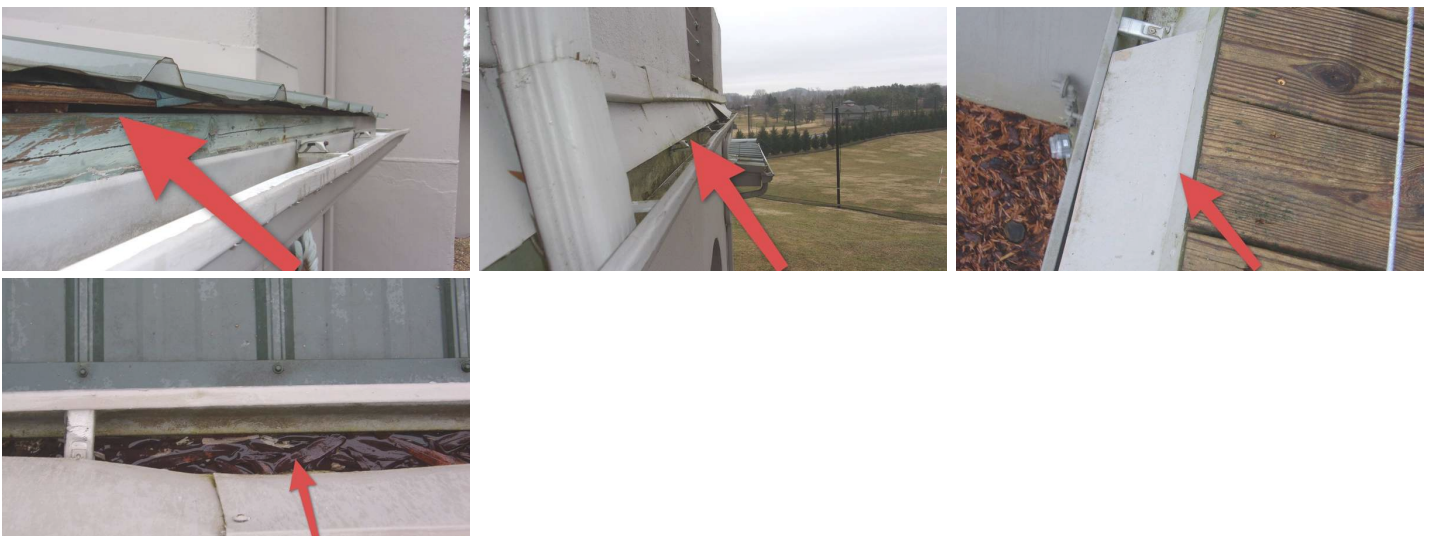
Drip edge flashing should extend at least 1/4 of an inch below the roof sheathing and extend at least 2 inches onto the roof deck. Drip edge pieces should overlap at least 2 inches.

Recommend evaluation by a Roofing Professional and their recommendation for correction followed.

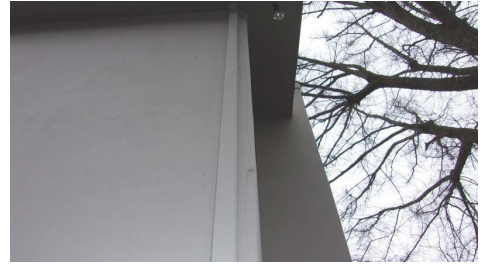
4.3.1 Vegetation

TREE LIMBS IN CLOSE PROXIMITY TO ROOF

There are tree limbs in close proximity to the roof. It is recommend that limbs be cut back 8-10 feet from the roof and the chimney.

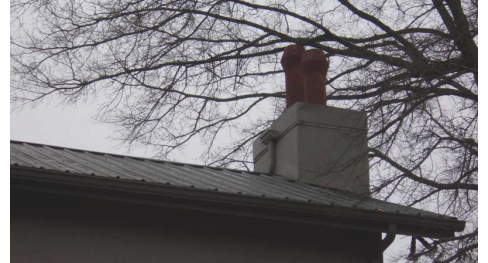
4.4.1 Chimney

CHIMNEY SPARK SCREEN ARRESTOR MISSING

No chimney spark screens appear present on the chimney flues as viewed from the ground. Also a good indicator that the flues do not have a spark screens is fact that leaves and debris fell into the fireplaces when the fireplace dampers where inspected. With out a spark screen or cap debris, leaves, and water can / may enter the chimney.

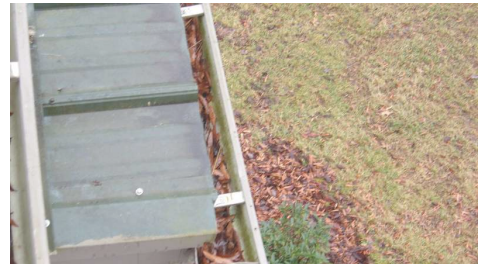
4.5.1 Drainage Systems

DEBRIS IN GUTTERS

Debris has accumulated in the gutters. Recommend periodically scheduled cleaning to facilitate water flow and / or the installation of gutter guards to prevent the build up of debris.

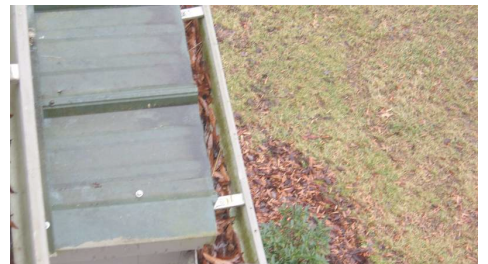
4.5.2 Drainage Systems

NO GUTTER SCREENS / GUARDS

There are no screens of the gutters.

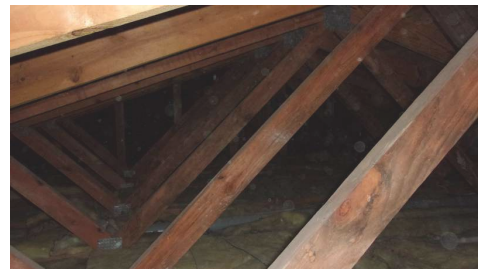
ENTIRE ATTIC NOT ACCESSIBLE

Upon entering the attic area one can move from side to side in this area. There is an attic area over the left side of the house but the design of the trusses makes movement through this area difficult. This side area was not entered or inspected.

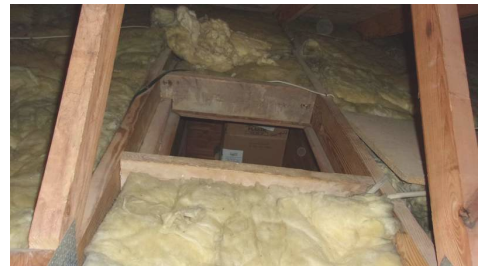
5.1.1 Access

ACCESS SIZE

The attic access ceiling panel is smaller than the standard panel size of 22.5 x 30. It is located in the upper floor back right bedroom closet.

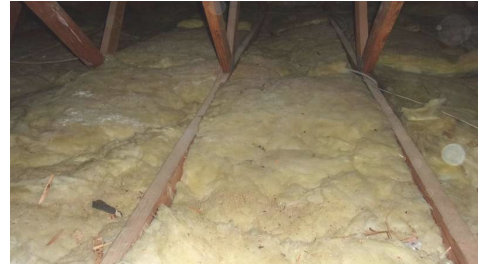
**CEILING TRUSSES EXPOSED**

The ceiling trusses in the attic are visible above the insulation. It is recommend that these trusses be covered with insulation to help reduce thermal bridging, which is heat transfer through uninsulated wood members. Recommend a qualified attic insulation contractor install additional insulation.

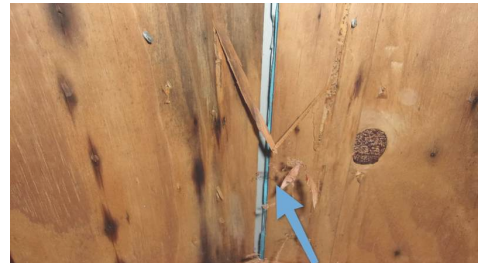
**RIDGE VENTING AREA**

The attic has ridge venting through the metal cap on the ridge of the roof line. The roof sheathing is normally cut back about 2 inches to allow air flow from the soffits / eaves up through the roof venting. The visible sheathing at the ridge is cut back less than this 2 inches.

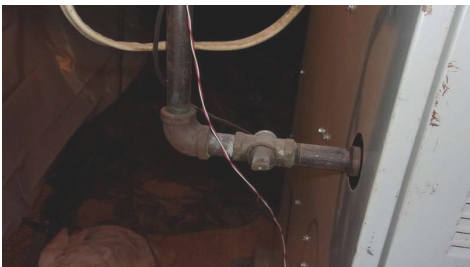
NO DIRT LEG

There is no dirt leg on the gas line to the appliance. Recommend installation.

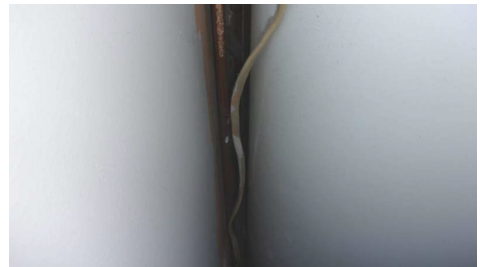
There is no water heater electrical disconnect located at the water heater. One is required for the protection of a service person when repairing or replacing the unit. However, since the water heater is in the same room as the electric panel the shut in the panel will suffice.

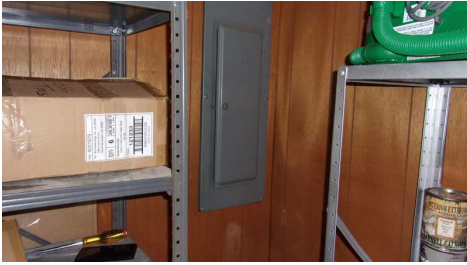
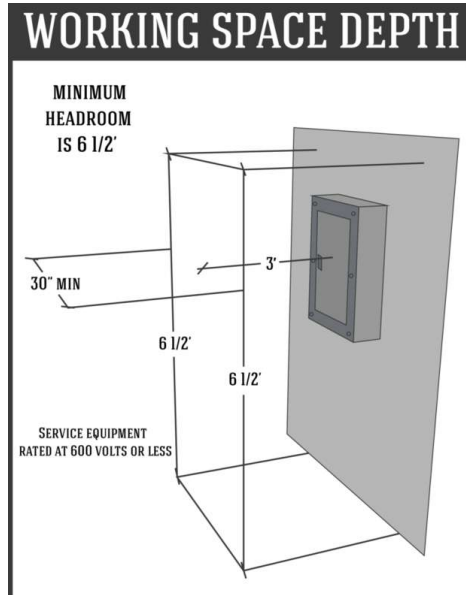
There is no lighting for the Main Service Panel. Should be lighting for each panel. The Main Service Panel requires unobstructed space around the panel.

Panel should not be located in closets bathrooms and cabinets or near flammable liquids. If the only way to reach the panel requires leaning on grounded appliances such as washers, dryers, freezers, do not inspect the panel.

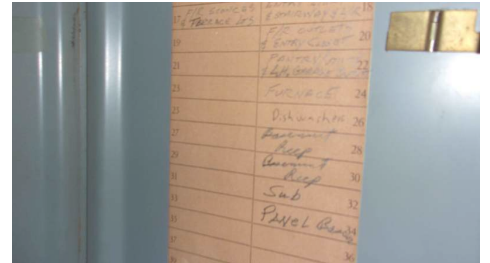
8.4.2 Main Service Panel

INCOMPLETE OR MISSING DIRECTORY

The service panel directory is missing or incomplete. All service panels should have a complete Breaker / Fuse Directory. A directory will allow a specific circuit to be disconnected without shutting off the homes main disconnect. The inspector has no way of confirming the accuracy of the directory, only whether it is missing or appears incomplete. For personal safety a complete circuit directory is required. A licensed electrician should be contacted about developing a panel directory.

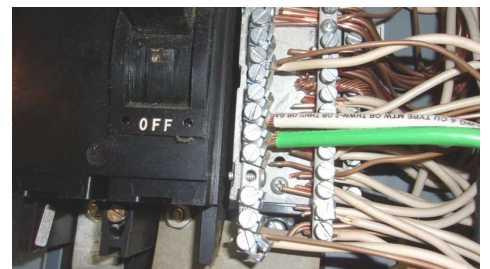
8.4.3 Main Service Panel

BUS BAR BONDING SCREW

There is no visible grounding screw (green) to verify the grounding of the neutral / ground bus bars to the panel. I recommend a licensed electrician be consulted and their recommendation for correction be followed.

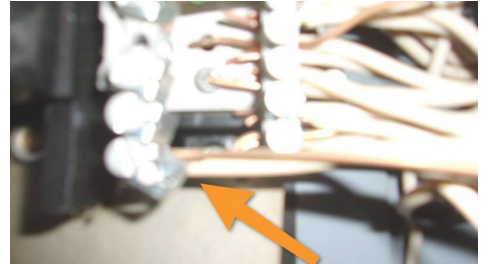
Neutral (white) wires are not to be doubled up where they are secured to the neutral / ground bus bar. One neutral wire only under a screw on the bus bar. This is not the case in this panel. Recommend evaluation and correction by a licensed electrician.

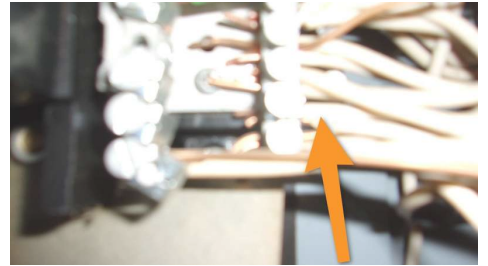
8.4.6 Main Service Panel

NEUTRALS AND GROUNDS TOGETHER

In a service panel neutral (white) wires and ground (bare) wires are to be separated where secured to the neutral / ground bus bar. In this panel there are neutral and ground wires together, under the same screw, on the bus bar. This needs to be corrected by a licensed electrician.

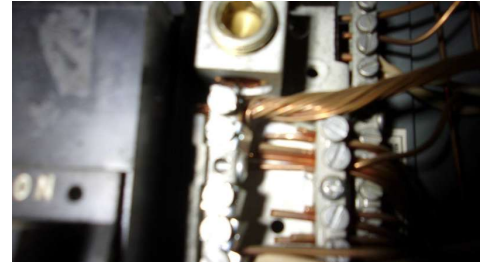
There is a stranded ground wire where not all of the wire strands are under the ground screw. Recommend correction.

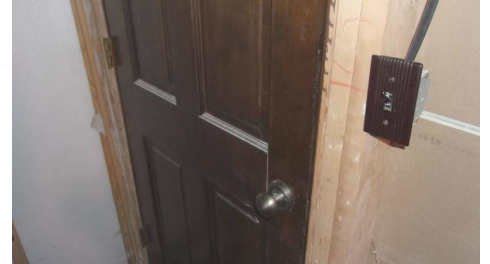
**DOOR NOT WEATHER STRIPPED**

The crawlspace door does not latch properly. It additionally has no weather stripping, threshold, etc. Since this door separates conditioned from unconditioned space sealing this door properly is recommended.

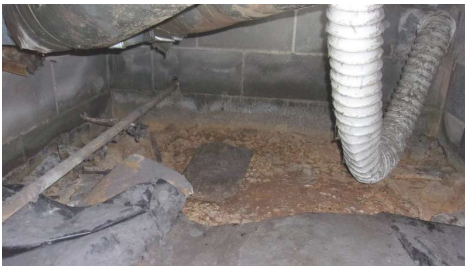
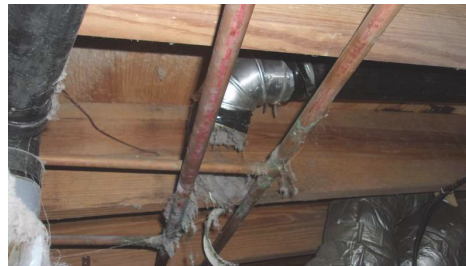
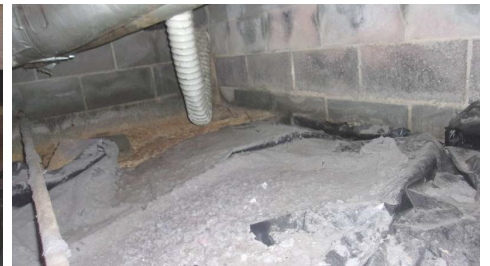
The dryer vent is not properly exhausted to the home's exterior. The vent line that goes through the floor from the dryer is damaged and currently the hot moist air and lint is being discharged into the crawlspace. This needs to be corrected.

Also the dryer vent is flexible plastic. This type of line tends to trap lint in the line. A solid smooth lined vent pipe is recommended.

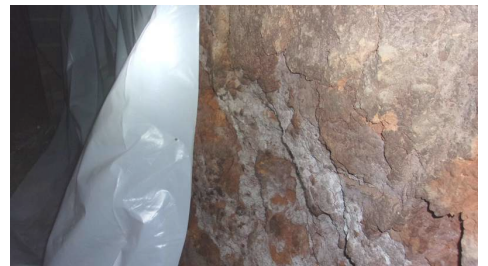
ON THE CRAWLSPACE FLOOR

There are signs of a mildew like substance on the crawlspace soil. This is normally the result of moisture escaping from the soil. The proper installation of vapor retarder over the soil is recommended. In addition to having the mildew like substance treated or removed.

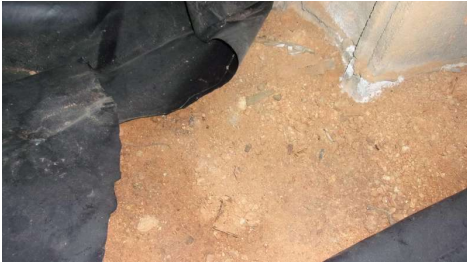
Vapor barrier is improperly installed. This can result in unwanted moisture. Typically a vapor barrier or retarder should be at least 6 mil plastic that completely covers the soil; free of holes and tears; and all seams overlapped at least 6 inches and taped / sealed. The vapor retarder should be cleanly cut around foundation walls and columns or be extended up and be secured / sealed to the walls and columns. Recommend repair.

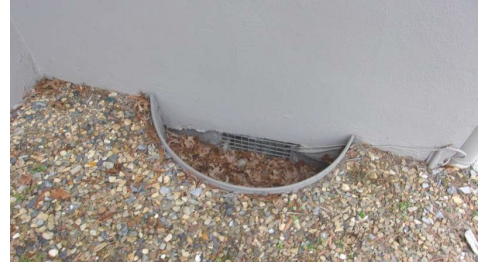
VENTILATION AMOUNT

The home's crawlspace lacks the standard recommended amount of venting. At this time there is one crawlspace vent on the back side of the house. If the crawlspace has a full / complete / correctly installed vapor barrier / retarder one square foot of venting is required per 1500 sq. ft. of crawlspace. If the crawlspace does not have a full / complete / correctly installed vapor retarder, as is the case here, then one square foot of ventilation is required per 150 sq.ft. Recommend this be corrected by adding mechanical venting and adding / correcting the vapor retarder.

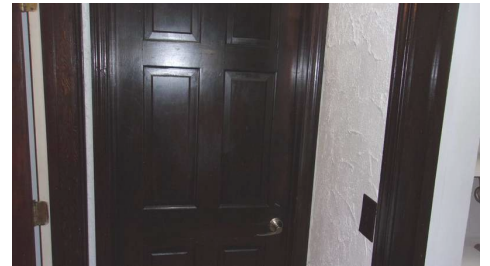
The door separating the garage and home is not a fire rated door. This firewall door must be at least 1 3/8-inch thick, metal / steel, or a 20-minute fire-rated solid wood door. Since this door has decorative panels it does not meet the 1 3/8 inch parameter.

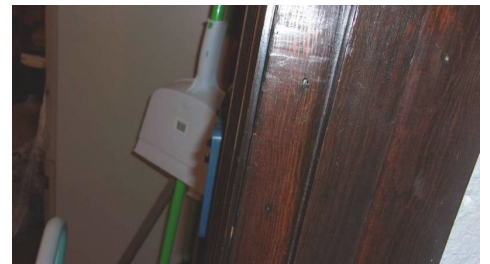
To help prevent air movement between the home and the garage the garage living space door should have sound weather stripping, a sound threshold and a door base sweep.

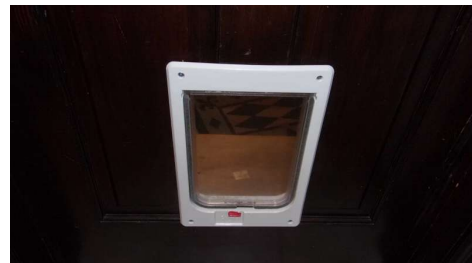
PET DOOR

Pet doors in the door between the garage and the living space are not permitted. Having one eliminates the required fire safety standard.

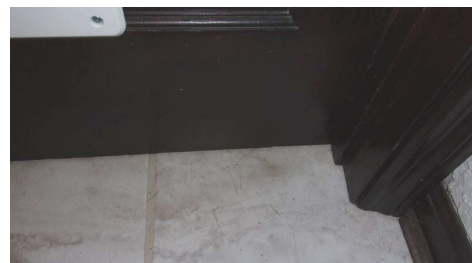
NO DOOR SWEEP

There is no door sweep or threshold at the base of the door to help eliminate the movement of air / fumes.

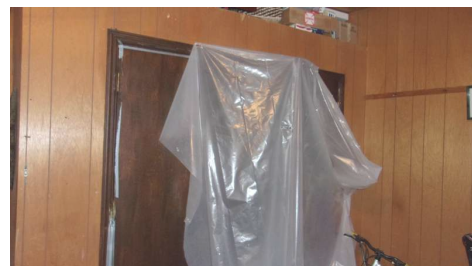
DOOR TO LAUNDRY ROOM

The door at the back of the laundry room, through the garage, is a solid wood door but needs to be treated as a firewall or fire rated door. Self closing, fire rated, weather stripping, sweep, etc. As is it is now it is allowing air from the garage into the home (fumes) and is significantly negatively impacting the home's energy efficiency.

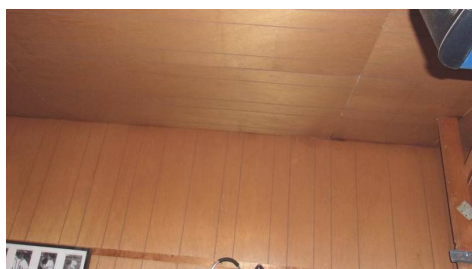
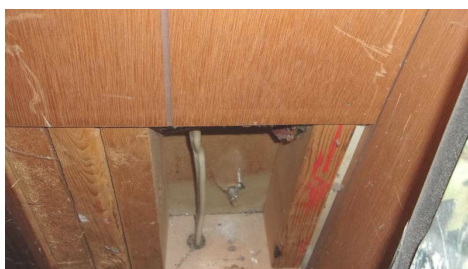
GENERAL DAMAGE

The garage walls are paneling with some loose seams. The floor is painted with common chipped paint. There is hole in the wall to the right of the laundry access (from the garage) around some plumbing lines.

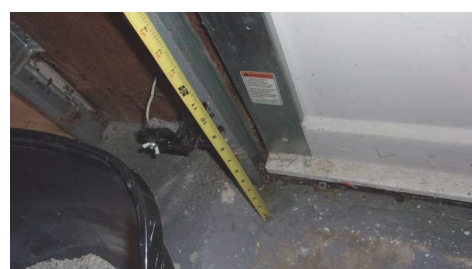
AUTO REVERSE SENSOR GREATER THEN 6 INCHES FROM FLOOR

The electronic eye auto reverse on either side of the right side garage door (from the outside) needs to be no greater than 6 inches above the floor. Recommend correcting.

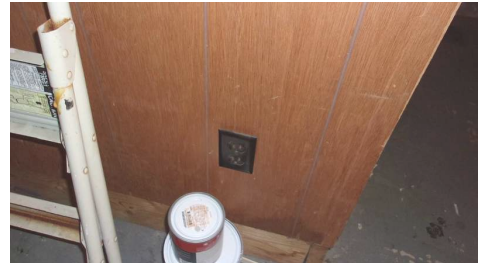
The single electrical outlet in garage (that was visible) should be at least three feet above the floor because a spark from this outlet the can be a source of ignition for gas fumes.

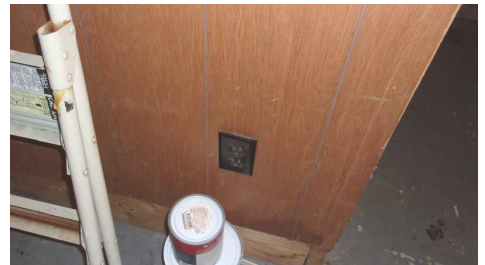
There is no GFCI protection on the single outlet visible in the garage, by the living space door. Ground Fault Circuit Interrupter (GFCI) protection is required on all 120 volt receptacles in garages and grade level areas of unfinished accessory buildings as of 1971. GFCI protection is not required for receptacles in the garage ceiling nor for dedicated receptacles that serve an appliance that is not easily moved.

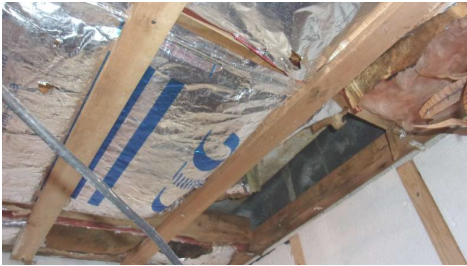
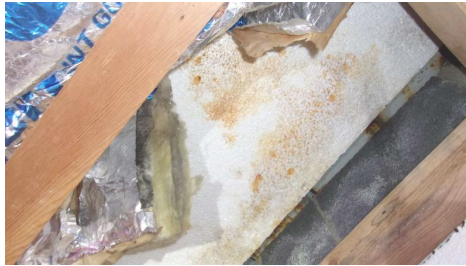
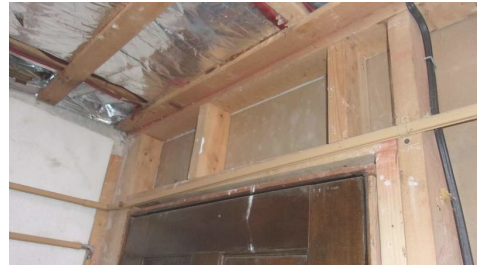
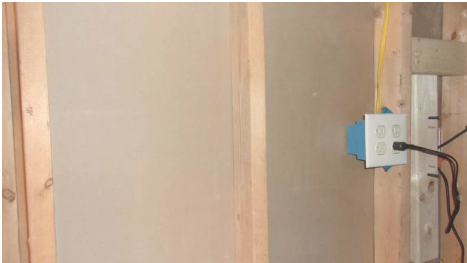
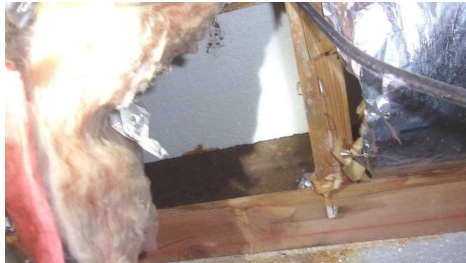
In the back closet of the lower living area the following is noted.

1. This is unconditioned space and the back of the walls between the living area and the closet are not insulated.
2. The ceiling is insulated but the insulation is upside down (paper goes up toward living area) and the insulation is not pressed up against the ceiling. This leaves a gap between the insulation and the flooring that allows air flow thus makes the insulation useless.
3. The door is not weather stripped, has no threshold or sweep to help prevent the movement of air between the two spaces.

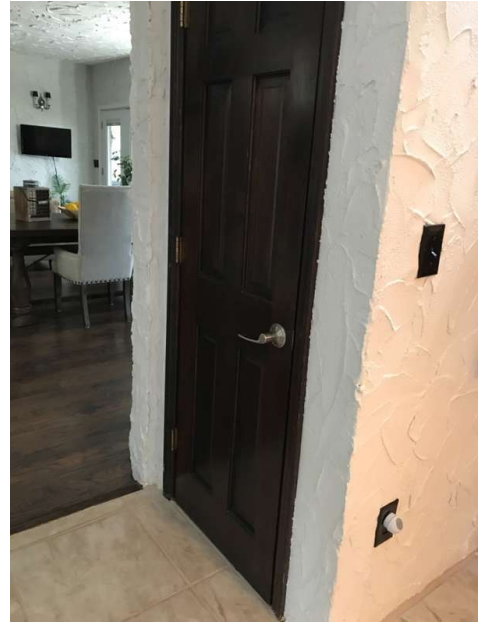
This door doesn't latch. Recommend repair or readjusting the latch and / or strike plate.

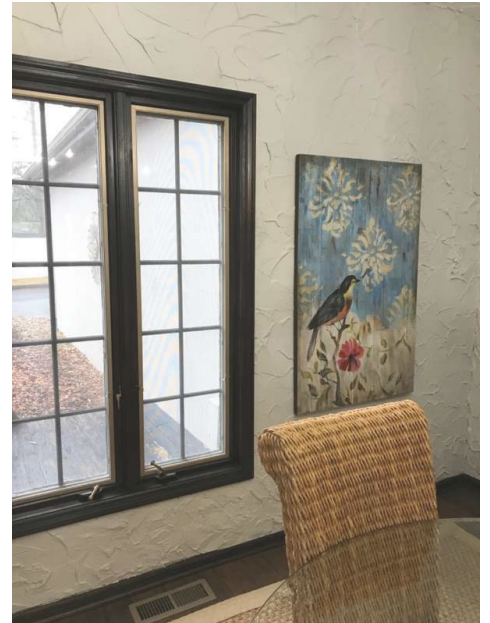
Some windows are difficult to open. Windows should be secure in the casings but easy to open.

The right side window in the dining room does not close fully with the crank and the hinges are not operating correctly.

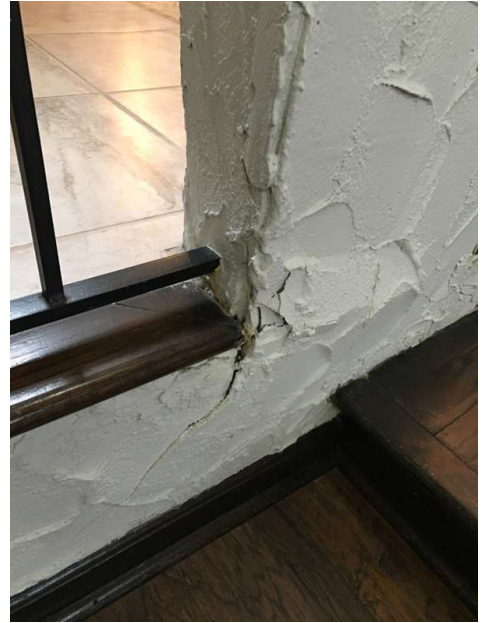
MAJOR CRACKS

There is major cracking visible in this rooms walls / ceiling. They may indicate soil movement or insufficient wall support resulting in wall sagging. Cracks of around a 1/4 of an inch with visible displacement (up or down / in or out) around the cracks are considered to be of structural concern and should be evaluated.

Located at base of railing where wood trim plate meets the wall at the step down from the foyer into front living room.

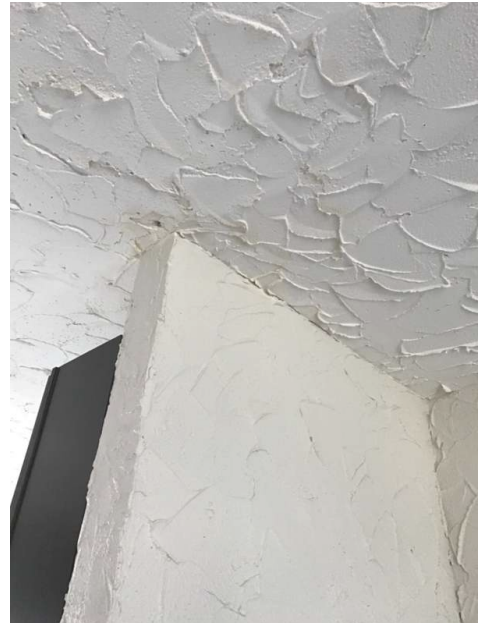
MOISTURE STAINS / DAMAGE

There are stains on the walls/ceilings that appear to be the result of moisture. The source of moisture may / may not have been corrected. There was / was not a sign of moisture in this area, at the time of the inspection, as tested for with a thermal imaging camera.

If there was no corresponding moisture intrusion point identified then it is recommended that this area be monitored in order to detect continued or further damage. This area is below the upper level bathroom.

This is located where the back main level living room meets the kitchen (close to the stove).

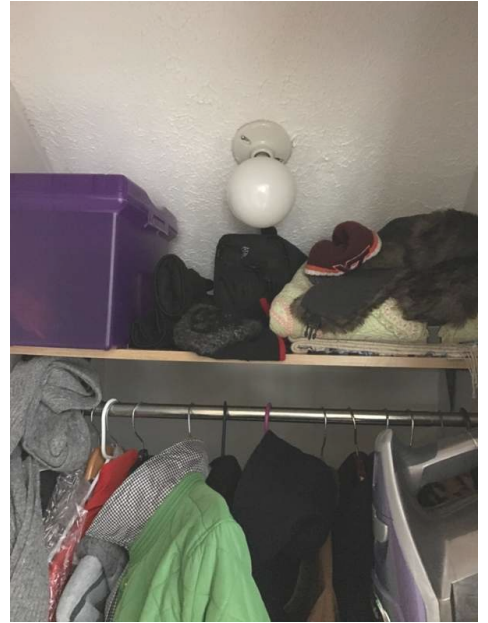
CLOSET LIGHT FIXTURE CLEARANCE(S)

The closet lighting does not meet today's safety clearance standards. Although not an issue when the home was constructed, the lack of standard clearances is considered a safety issue. Recommend adherence to today's standards.

Recessed (totally enclosed) incandescent, fluorescents or LED lighting fixtures in closets shall be no closer than 6 inches from a closets defined storage area. Storage area height is roughly defined as the highest of 6 feet from the floor, the height of clothes hanging rod or the height of a shelf above the clothes hanging rod.

Surface mounted lights shall be at least 6 inches from a closets defined storage area. Storage area height is roughly defined as the highest of 6 feet from the floor, the height of clothes hanging rod or the height of a shelf above the clothes hanging rod.

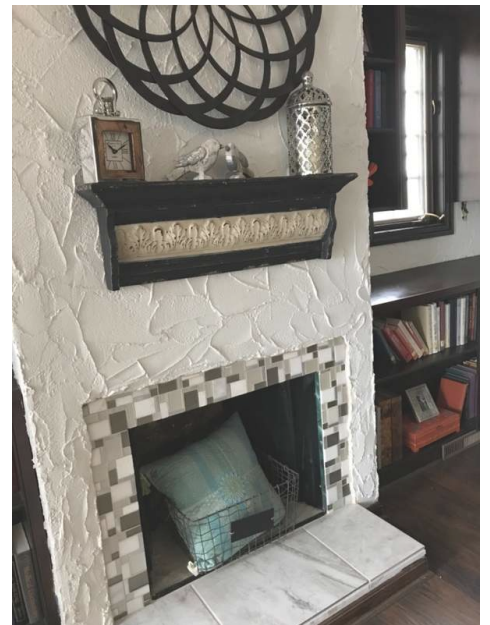
MASTER BEDROOM

Master bedroom fireplace does not appear to be in use at the time of inspection. Recommend inspection by a licensed professional before use .

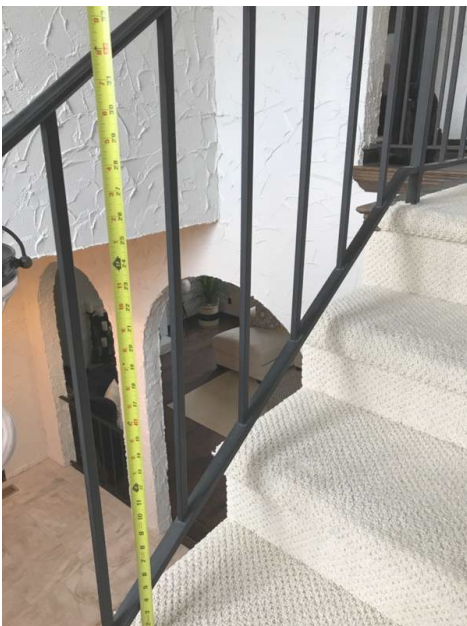
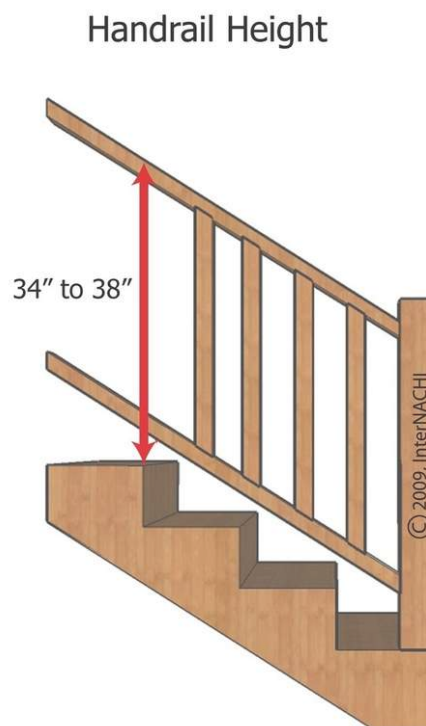
The stair railings are 32 inches high. They do not meet the recommended building standard railing height of 34 to 38 inches. This is considered a safety issue, recommend addressing.

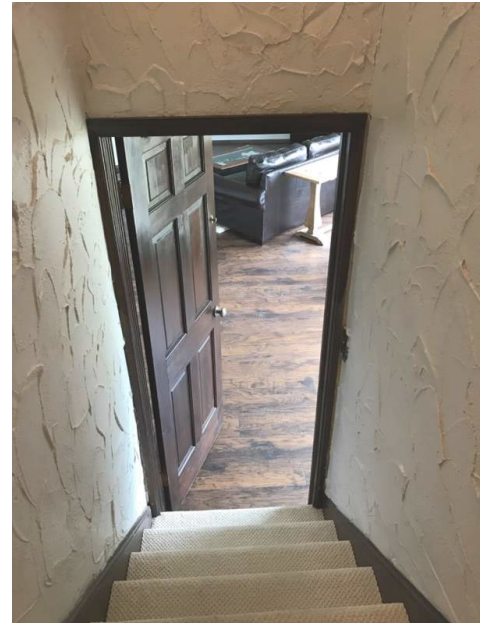
**STAIRWAY HEAD ROOM**

The headroom above these steps is less than the minimum standard of 6 feet 8 inches. Care should be taken so a taller person doesn't smack their head.

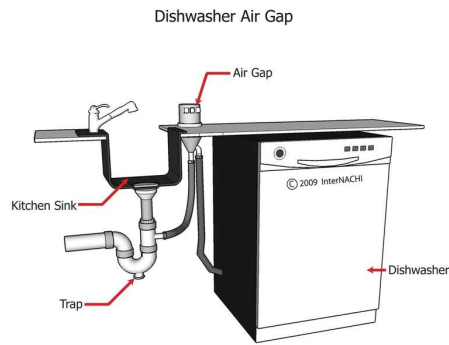
The dishwasher drain line should either connect to an air system at the top of the sink or be installed so it has a loop in the line that touches the under side of the counter top. This air gap system or high loop will help prevent drain water from the sink draining into the dishwasher. Recommend correcting the line positioning to create this high loop.

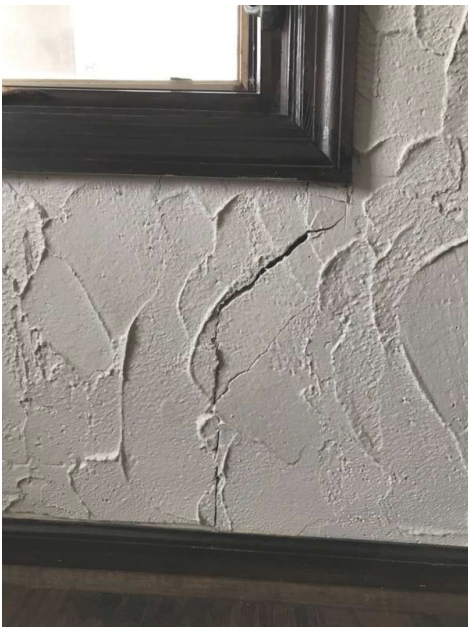
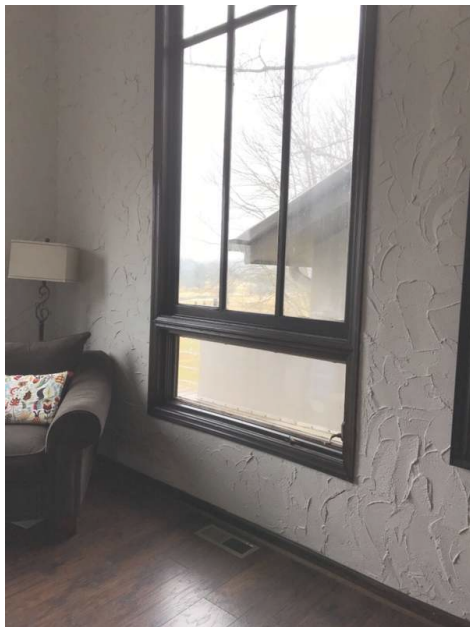
There is major cracking visible in the bedrooms walls. They may indicate soil movement or insufficient wall support resulting in wall sagging. Cracks of this size with visible displacement around the cracks are considered to be of structural concern and should be evaluated by a structural engineer.

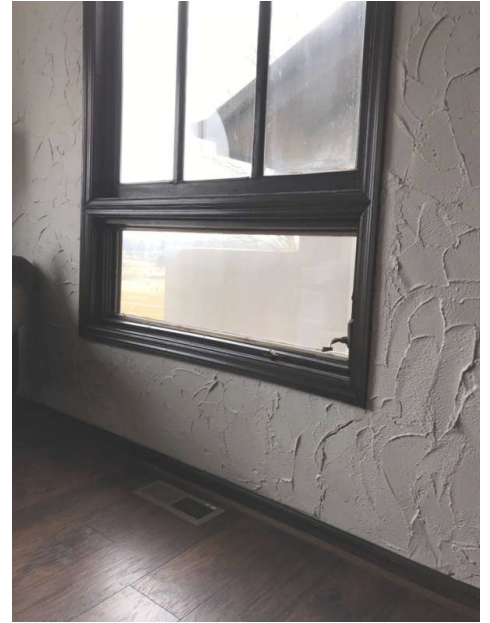
The bottom casement window under the cathedral window in the seating is difficult to open. This is not an egress concern as there is an operable exterior door in the master bedroom .

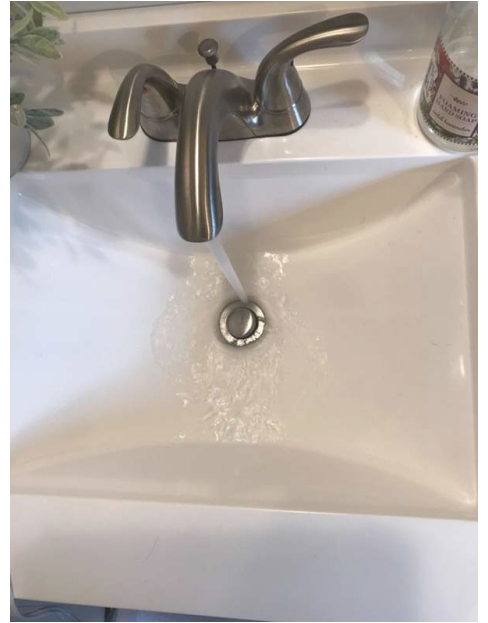
Just a heads up that the sink does not have a water overflow hole. So caution should be taken when filling the sink with the stopper closed.

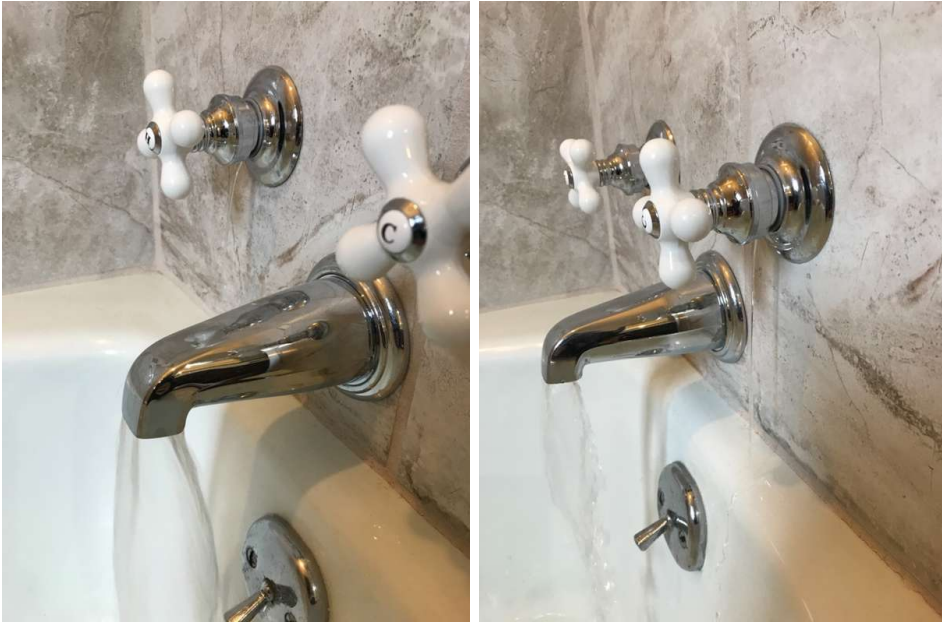
There is water leaking from both the hot and cold faucets. Replacement or repairs are recommended.

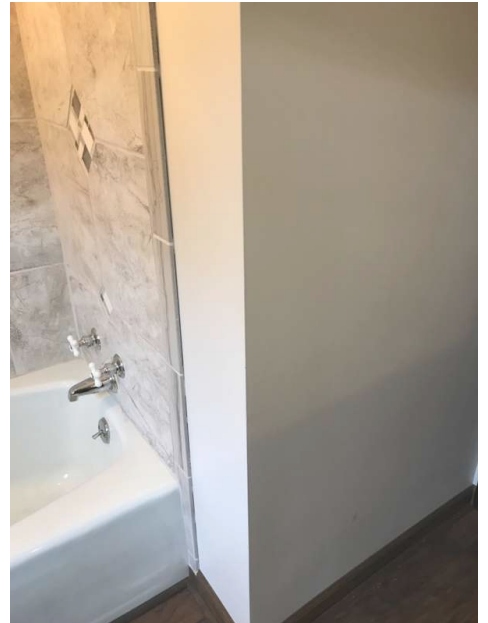
Common building standards are to install a wall panel in the wall behind the shower faucet to allow access for faucet repair or replacement. One has been installed in this case.

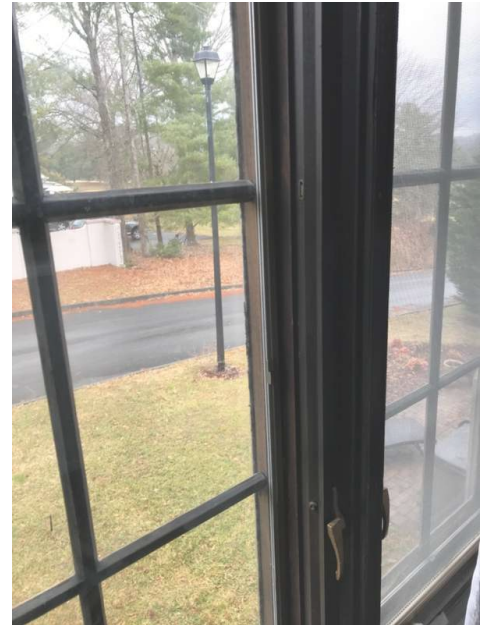
There are window screens or storm windows missing. They may be in storage. Recommend addressing with the homes current owner to see if the are locateable.

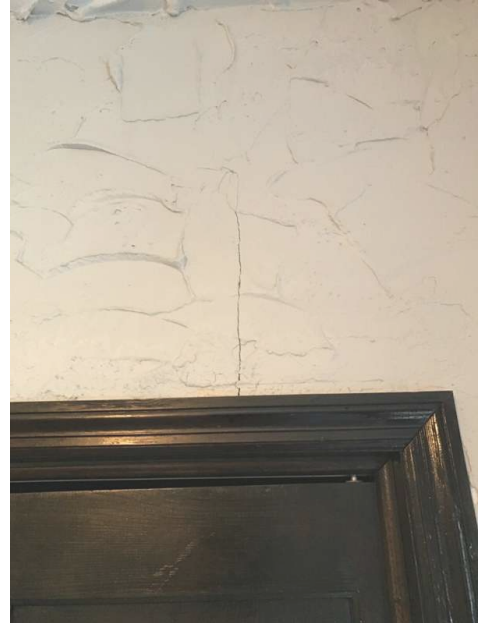
There are minor cracks in the walls /ceiling. Cracks at the corners of doors and windows are not uncommon. They may be due to long-term settlement or from the shifting / shrinking of a door or window header. Joint cracks can be the result of expansion and contraction of framing or structural stress.

Located on the right side above the closet door.

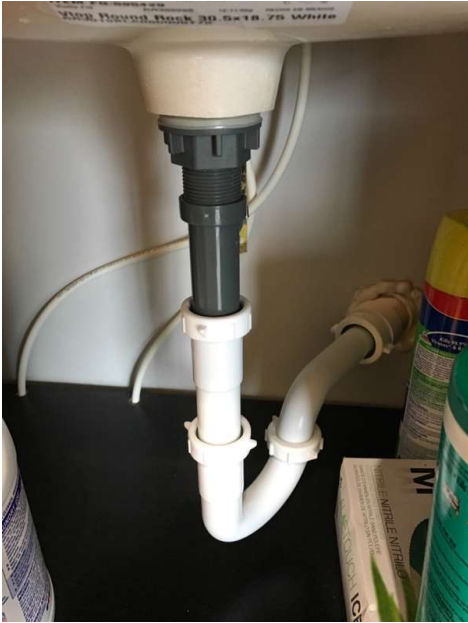
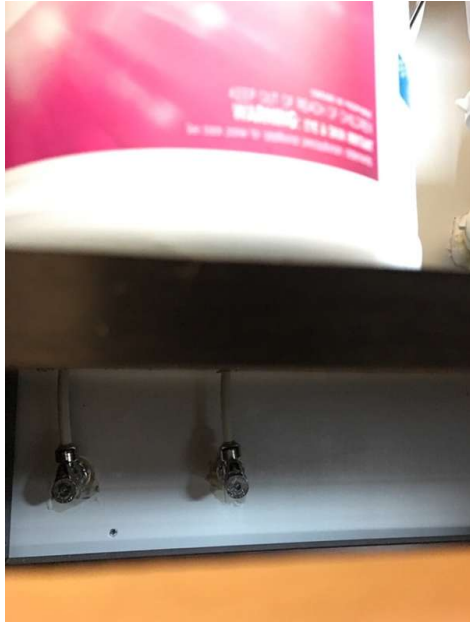
There are no shut off valve to the supply lines .
