RED CARPET HOME INSPECTIONS

RED CARPET HOME INSPECTIONS - SFH/TH/DUPLEX

1234 Main St.
Haymarket VA 20169

Buyer Name
02/24/2019 9:00AM

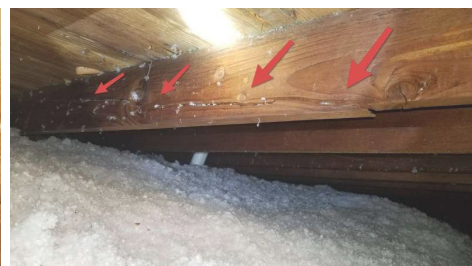
Rafter is splitting very badly and needs to be evaluated by a roofing professional

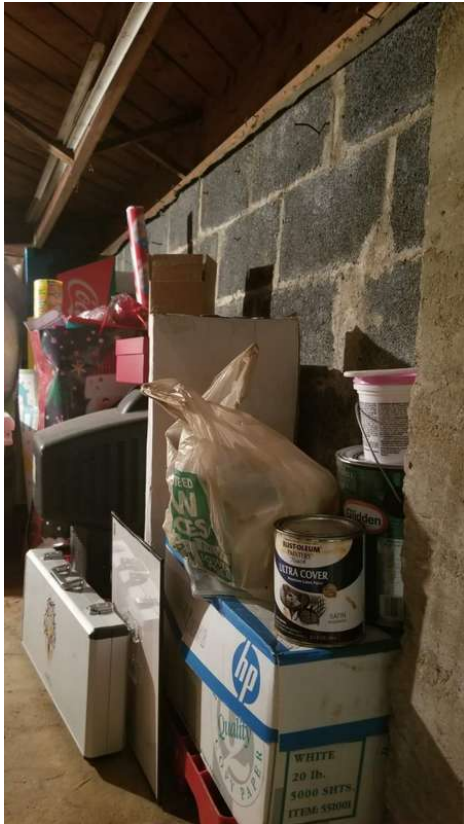
20% of foundation is masonry block

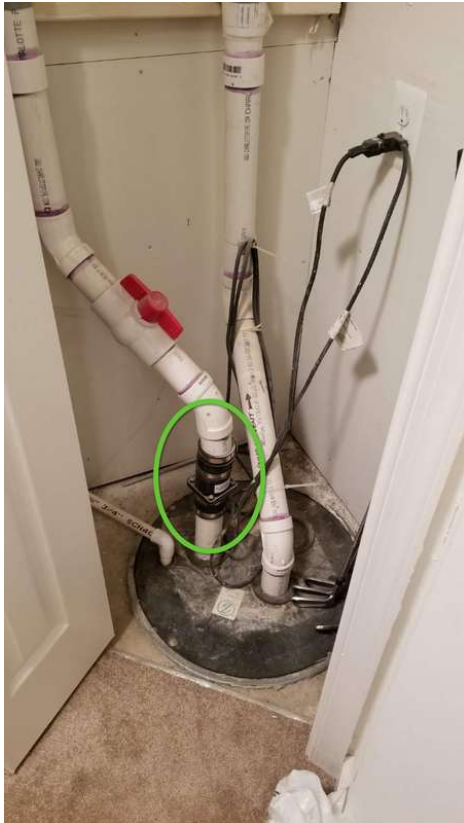
Green circle= Check valve installed

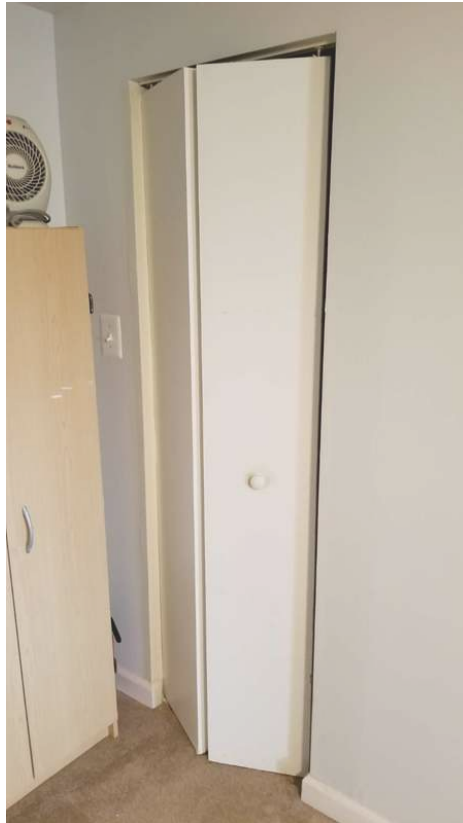
Door leading to sump pump

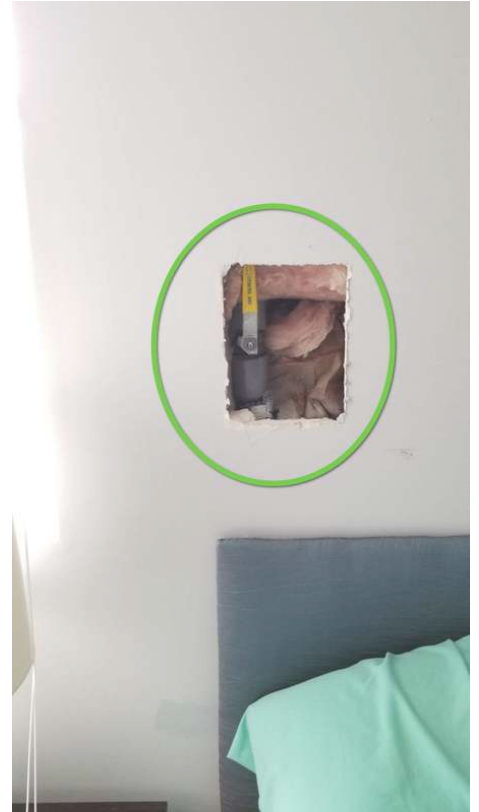
Water main shut off valve

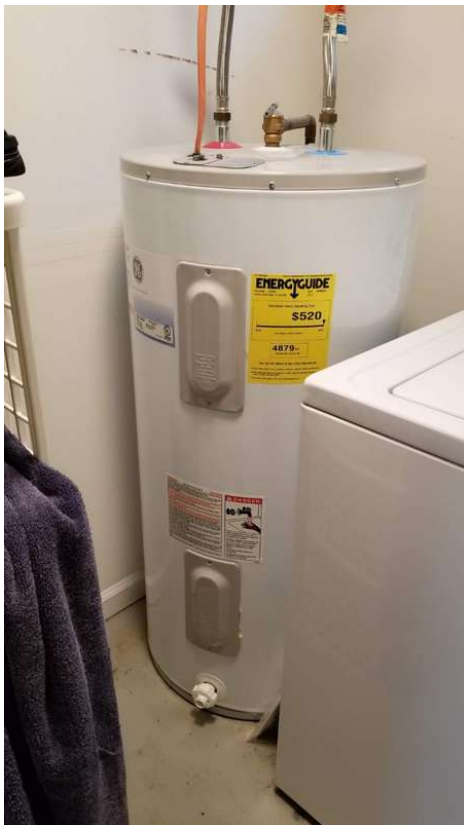
I recommend flushing & servicing your water heater tank annually for optimal performance. Water temperature should be set to at least 120 degrees F to kill microbes and no higher than 130 degrees F to prevent scalding.

Hot water heater GE Model #
GE50M06AAG MFG date = 5/2011
Capacity = 50 gals

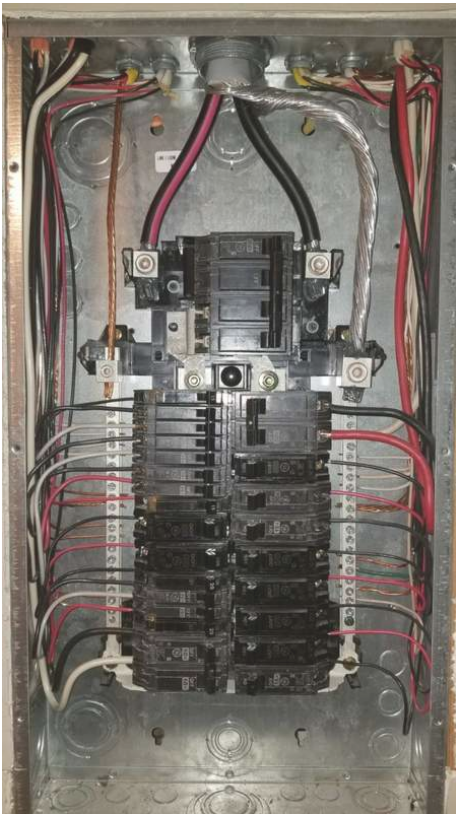
Circuit breaker panel with cover removed

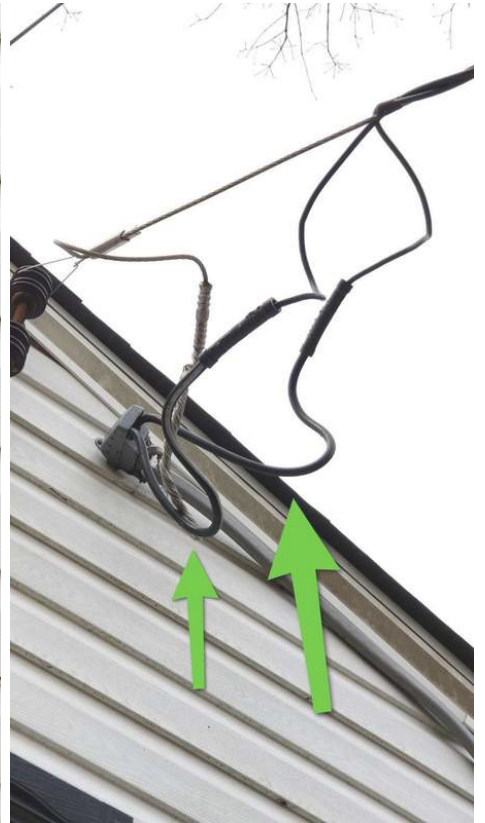
Service mast drip loop present

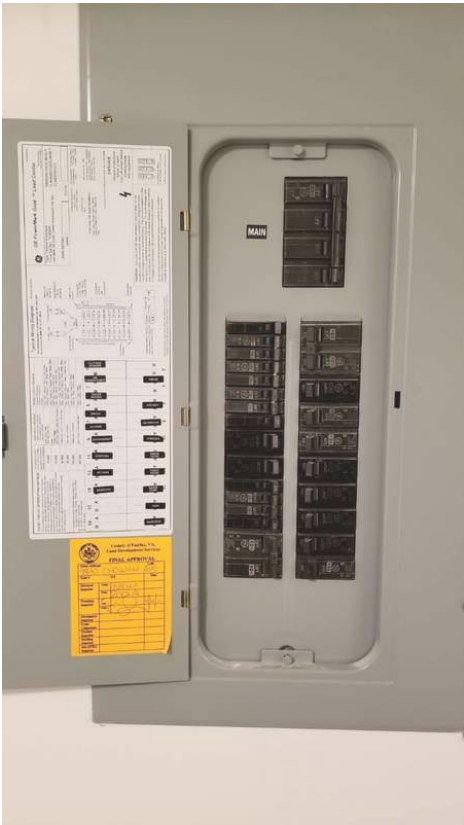
GE 200 Amp Circuit Breaker Panel

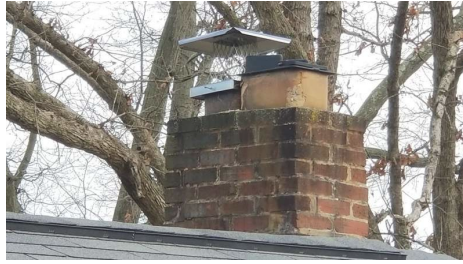
Exterior chimney crown with chimney cap

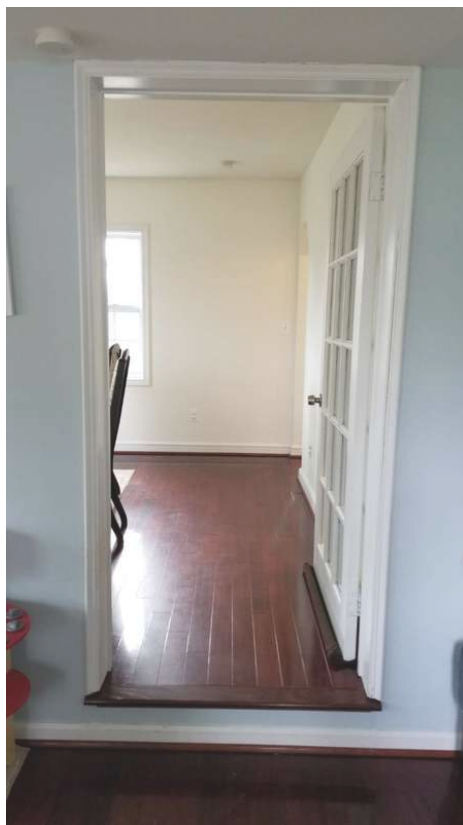
Door leading to the interior of the house

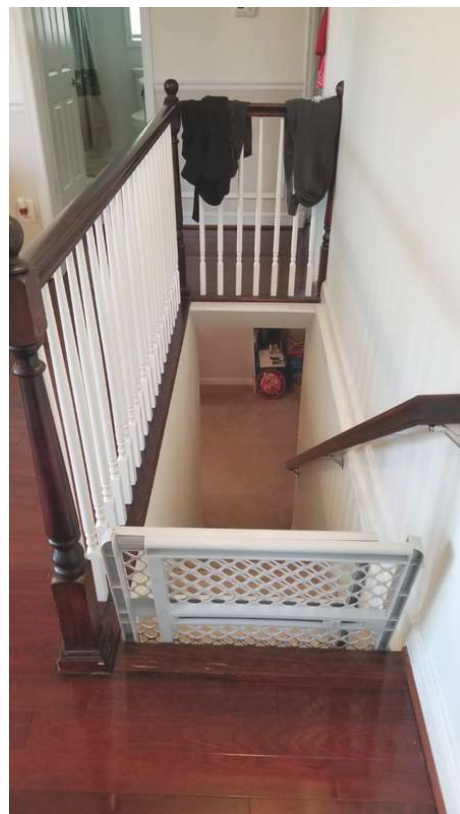
Stairs leading down to the Basement

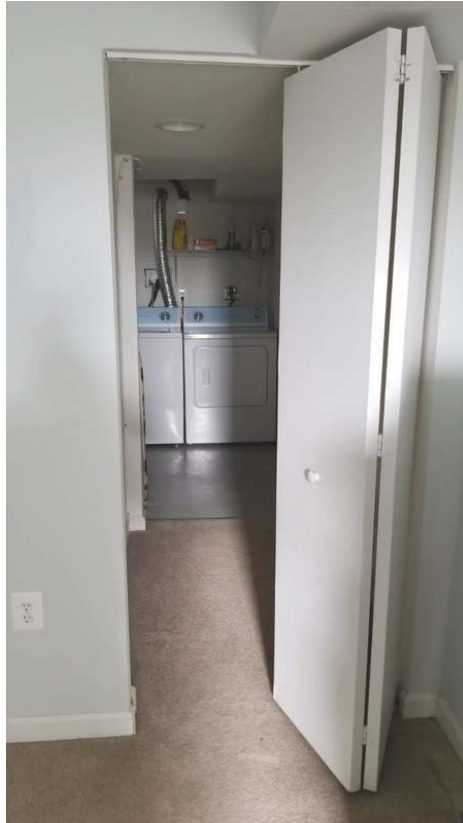
Laundry room door located in the
master bedroom
