KIRWYND REAL ESTATE SERVICES

DEFAULT TEMPLATE

1234 Main St.
South Farmington NS B0P1W0

01/23/2018 9:00AM

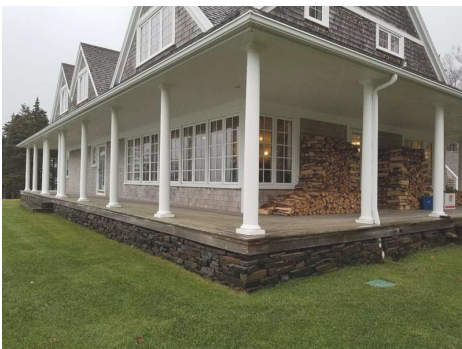
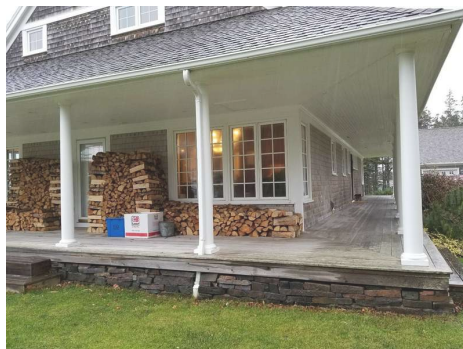
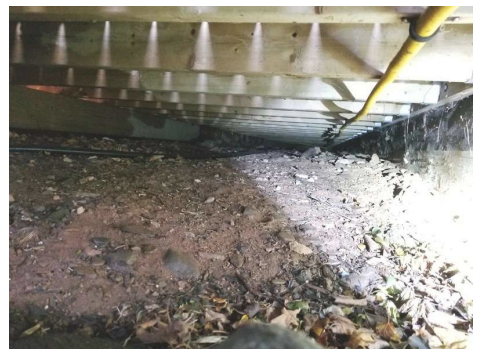
Stoop, Steps: Mostly OK

At the time of the inspection, few deficiencies were observed in the condition of the verandah. Notable exceptions will be listed in this report. Inspection of this area typically includes evaluation of the visible foundation, general structure, attachment to the home, walking surface and stair components.

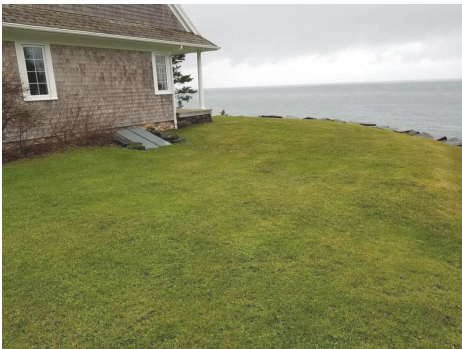
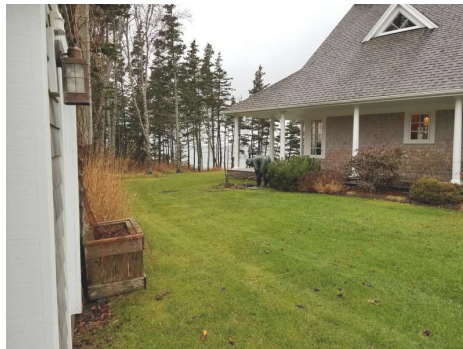
Grading & Surface Drainage: Mostly OK

The exterior drainage appeared to generally slope away from foundation. Notable exceptions will be listed in this report.

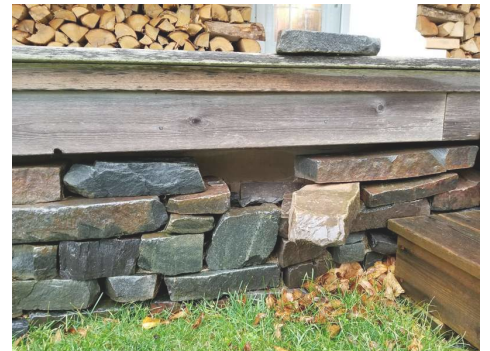
Stoop, Steps

NOT VISIBLE

The deck substructure inspection was excluded due to limited access because of low height or obstructions.

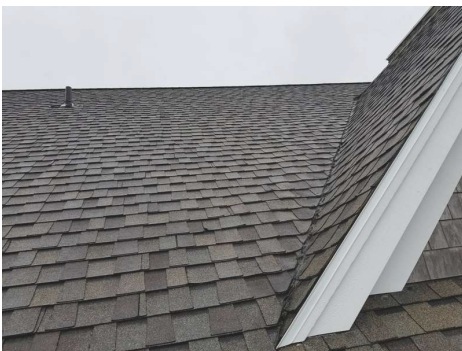
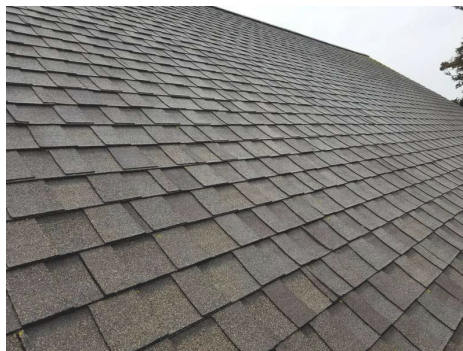
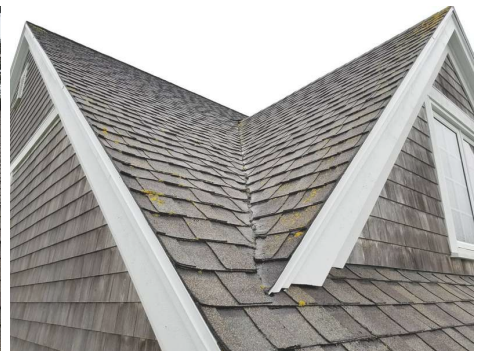
Roof Covering: Material

Laminated Fiberglass Asphalt Shingles

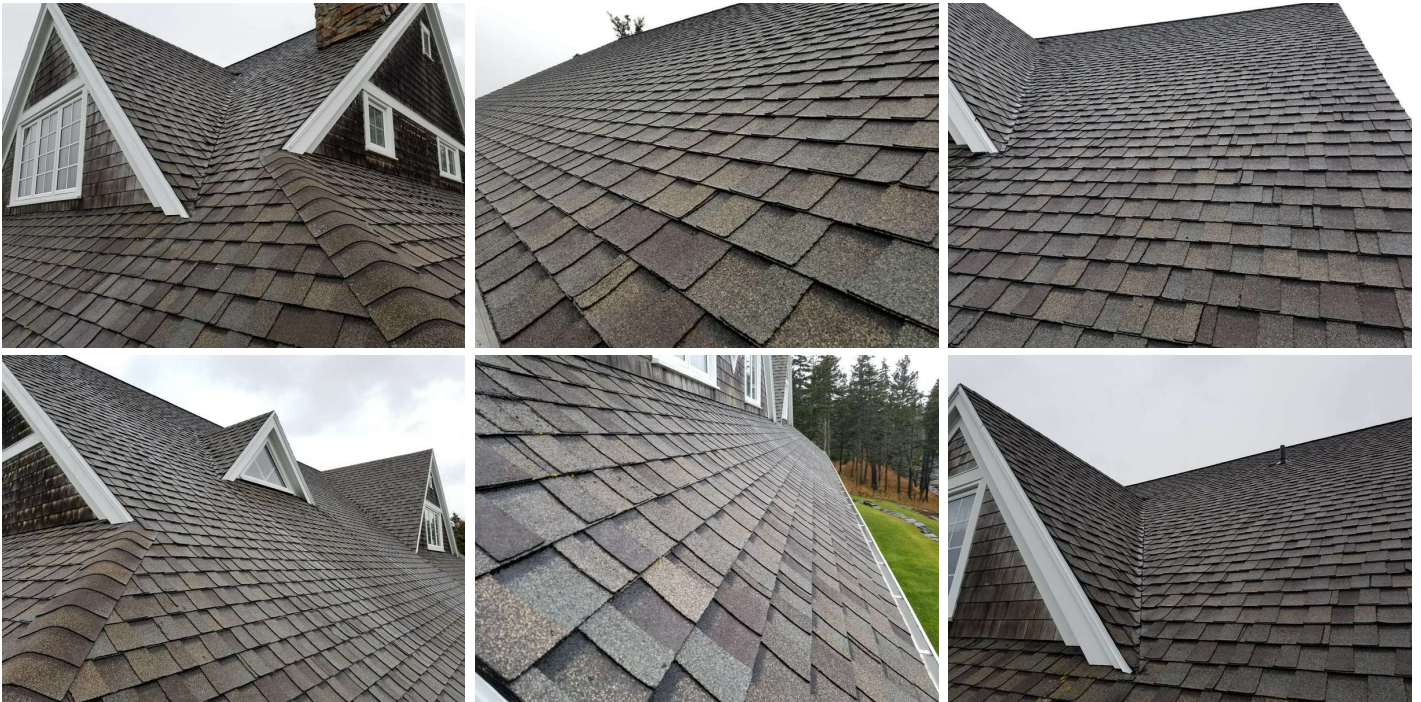
Roof Covering: Last Third

The roof covering material appeared to be in the last third of its life cycle. It would be prudent to begin to budget for replacement of the roof covering. With proper maintenance and spot repairs, the need to replace these shingles should be expected to arise within the next 3 +/- years.

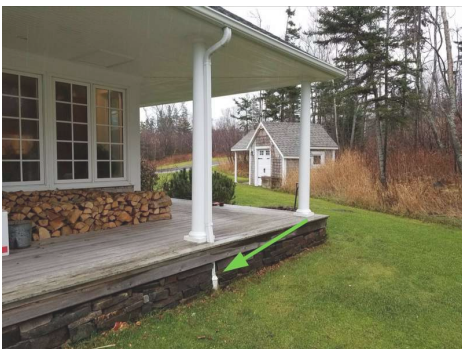
Roof Drainage System: Monitor Drainage

There were downspout connected to underground drainage lines. A couple of times a year, check the connection between the downspouts and the underground pipes in a heavy rain storm to be sure that the water is going into the pipe and not backing up and overflowing near the house. If backup is noted, the pipe will need to be cleaned out to remove the obstruction. Basement moisture can often be attributed to the overflow from this type of drainage system when it becomes clogged. Running strong stream of water from a garden hose can both test the ability of the water to flow through the system and be of assistance in pushing debris out of inaccessible portions of the downspouts and sub surface drains.

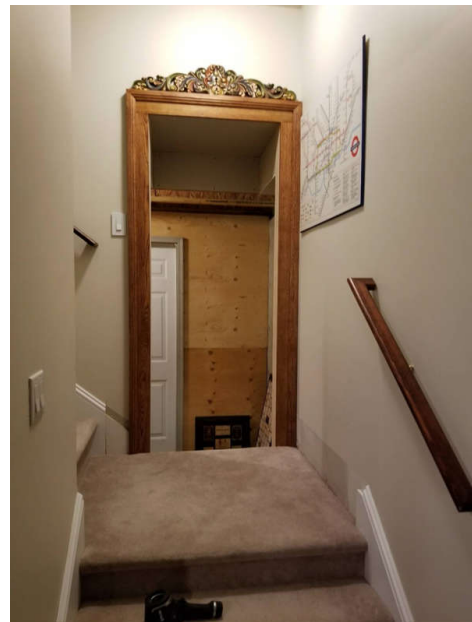
MISSING TRIM

Missing trim was noted at a finished area of the home. Replace missing trim as desired to improve appearance.

Contact a qualified handyman.

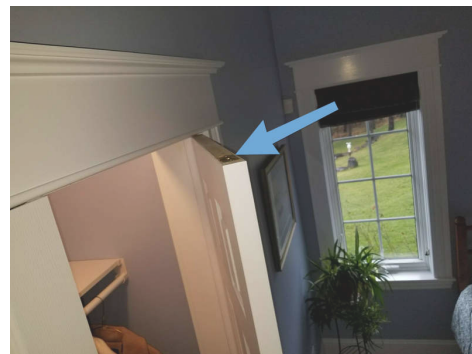
6.4.1 Doors

MISSING HARDWARE

There were doors that had missing hardware needed for the door to properly latch. You should have appropriate hardware installed.

Contact a handyman or DIY project

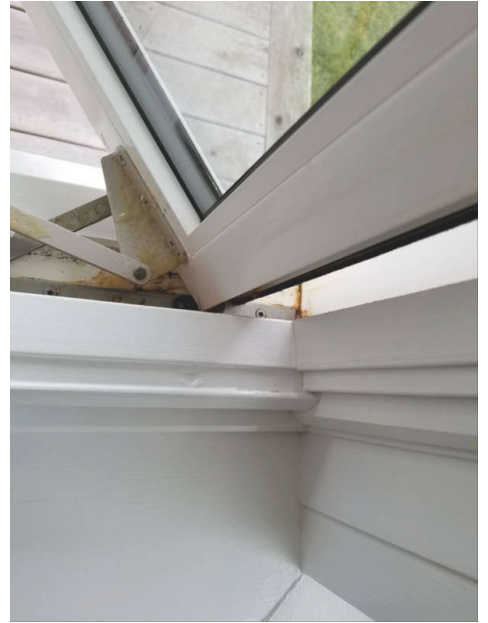
6.5.1 Windows

MINOR CORROSION

As is typical of homes with significant exposure to salt air. A small area of rust staining was visible at metal window operator hardware. Keeping these components well lubricated will help to extend their useful lifespan and resist deterioration.

Recommended DIY Project

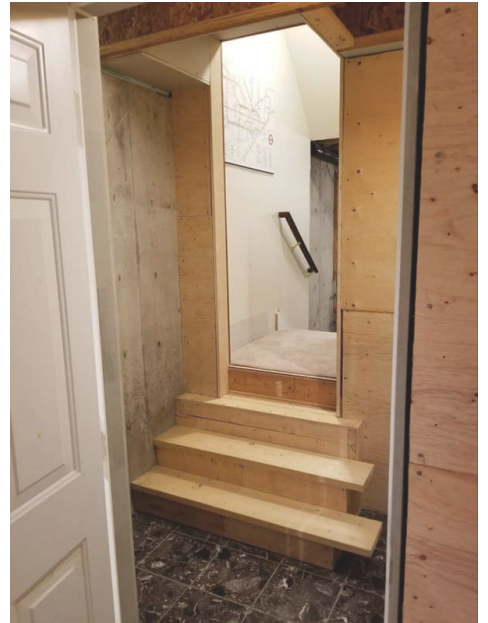
6.6.1 Stairways and Railings

MISSING HANDRAIL

Although a staircase had more than two risers, no handrail was installed. Recommend a handrail be installed to comply with modern safety standards.

Contact a qualified carpenter.

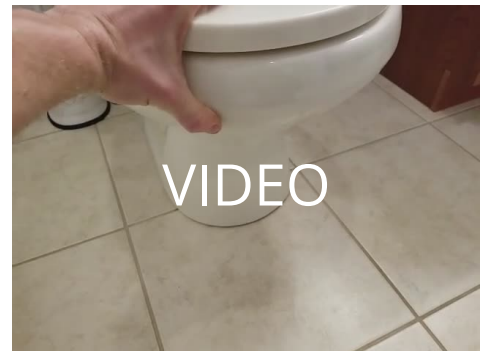
LOOSE TOILET

A loose toilet was observed. The wax ring seal inside the unit must have a snug, secure fit in order to keep from leaking. Properly resealing and re-securing this toilet is advised to prevent water leakage and damage to the sub-flooring beneath the fixture. Repairs may involve re-setting the toilet on a new wax seal.

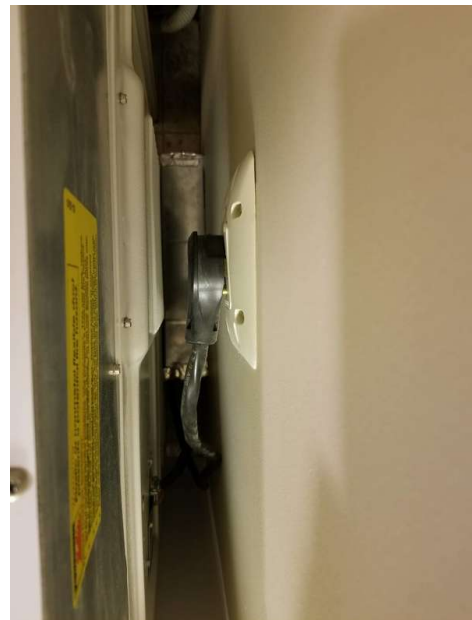
Dryer Vent

NOT VISIBLE

The transition ducting behind the dryer was not visible to inspect. It should be verified that it meets UL2158A standard and the pipe to its termination be properly cleaned.

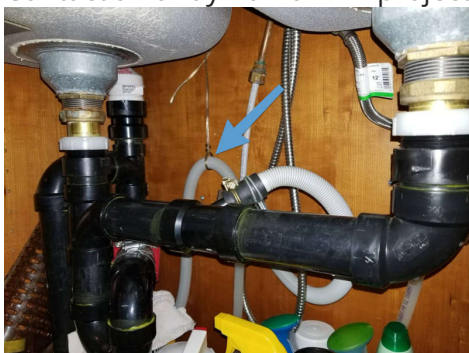
The dishwasher had no high loop installed in the drain line at the time of the inspection. The high loop is designed to prevent wastewater from contaminating the dishwasher. Recommend having the drain properly secured to the underside of the counter top.

Contact a handyman or DIY project

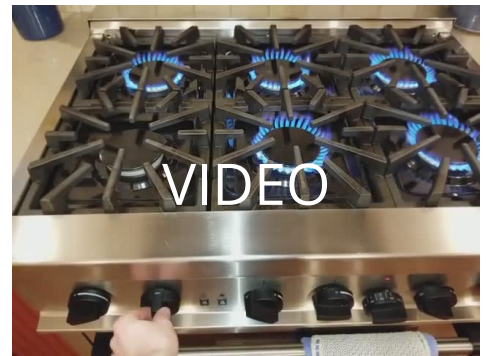
8.3.1 Ranges, Ovens, Cooktops

BURNER INOPERABLE

There were that burners did not operate properly when tested. Recommend repair by a qualified appliance technician.

Contact a qualified appliance repair professional.

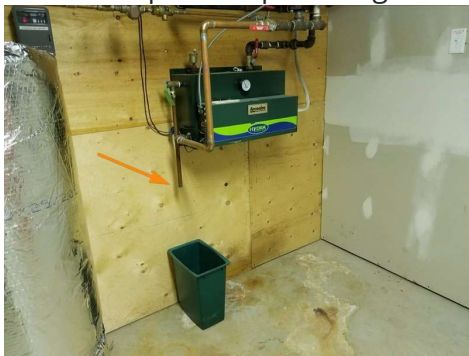
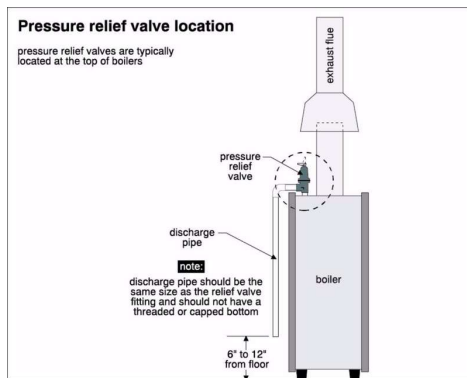
The temperature pressure relief valve's discharge tube was too short. This safety valve releases water (and thus relieves pressure) if either the temp or pressure in the tank gets too high. The TPR valve discharge tube must terminate within 6" above the floor in order to ensure any potential blow-off is directed away from occupants. Recommend extending TPR discharge tube with 3/4" copper pipe to within 6" off the floor.

Contact a qualified plumbing contractor.

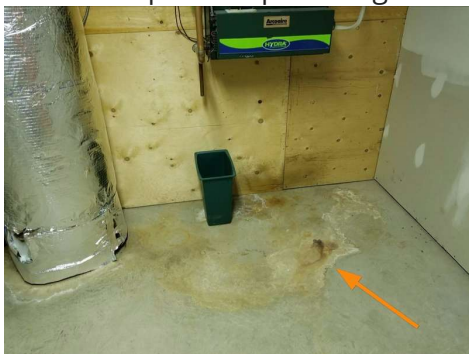
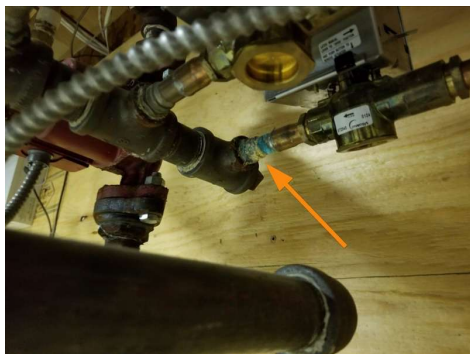
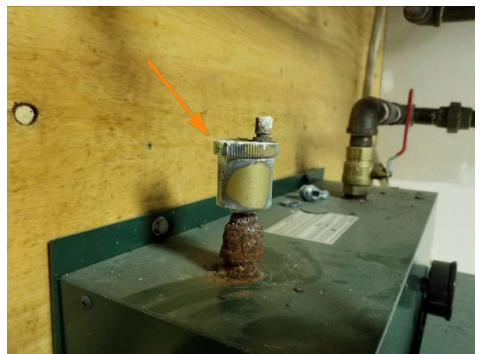
9.3.2 Heating System

Evidence of a past over temperature or pressure event was evident by staining on the basement floor below the TPRV discharge tube, while this may have occurred during the life of the previous boiler, a bucket below the tube indicates some leaking may still occur and may need to be addressed. Signs of past leaking and corrosion were also noted at the air vent and one fitting. It is advised that the boiler and associated components/fittings be reviewed, serviced and repaired as necessary as part of good maintenance practices to help prevent the potential for damage from leaking.

Contact a qualified plumbing contractor.

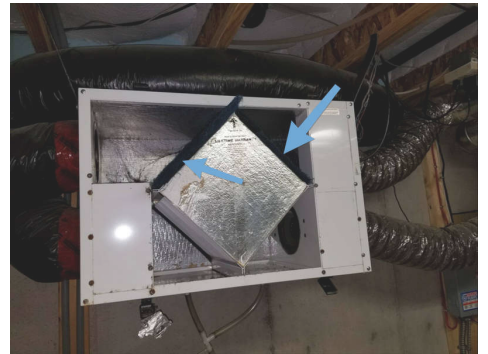
9.6.2 Air Exchanger

The air exchanger filters were in need of cleaning in order to guarantee efficient operation of the ventilation system. Recommend inspection and cleaning of these filters with every change of season.

Contact a handyman or DIY project

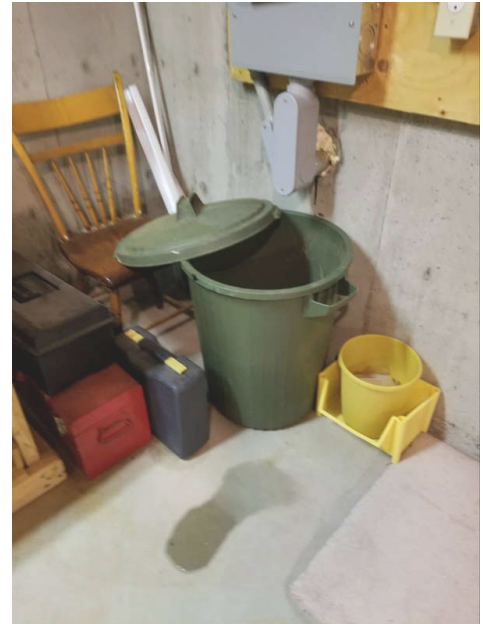
10.4.1 Branch Wiring

LEAKING CONDUIT

The conduit through which the feeders powering the electric service panel were housed, has filled with water and began leaking into the basement interior. Recommend repair as necessary to help prevent the potential for damage to the home or its contents which may arise from moisture intrusion.

Contact a qualified electrical contractor.

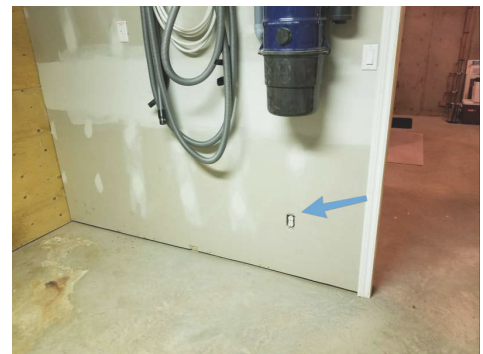
10.5.1 Lighting, Fixtures, Outlets & Switches

MISSING COVER

Missing outlet cover plates were observed. This condition leaves energized electrical components exposed to touch, creating a potential shock hazard. Recommend all cover plates be installed for personal safety.

Recommended DIY Project

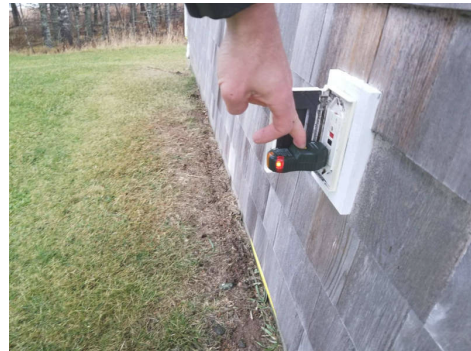
hazard from unprotected receptacles at wet locations. Recommend correction by a licensed electrician.

Contact a qualified electrical contractor.

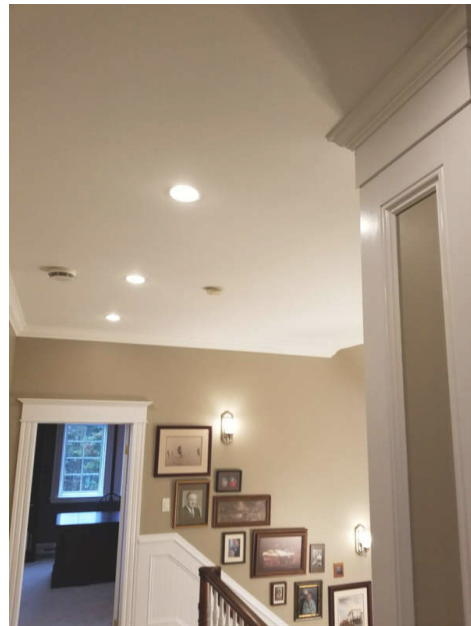
10.8.1 Smoke Detectors

There were smoke detectors which were older and may not be functional. Although testing of smoke detectors lies beyond the scope of the General Home Inspection, it is recommended that you have any older smoke detectors tested and maintained, upgraded or replaced as needed.

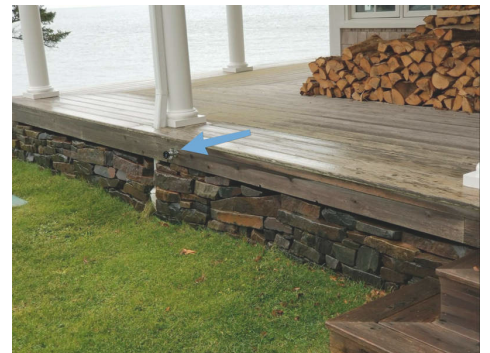
WEST EXTERIOR

An exterior hose bib was turned off at an interior shut-off and was not able to be tested. You should have the shut off valve turned on and test for to ensure it is functioning.

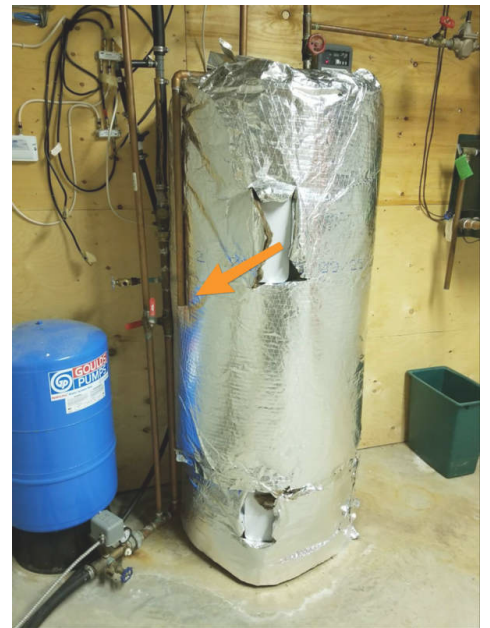
11.8.1 Water Heater

The water heater was past its typically expected life span. Some corrosion was observed within the unit near the element. As water heaters may fail at any time, and often without any warning, it is advised that the water heater be replaced at this time, prior to it's failure. The client should be aware that significant flooding can occur if the water heater fails. If replacement is put aside until a later time, it is recommended that a catch pan with drain, or a water alarm be installed by a qualified person to help prevent damage in the case of water leaks.

Recommend extending TPR discharge tube with 3/4" copper pipe to within 6" off the floor.

Contact a qualified plumbing contractor.
