SARANAC LAKE INSPECTION SERVICES

RESIDENTIAL REPORT

1234 Main St.
Saranac Lake NY 12983

Buyer Name
03/15/2018 9:00AM

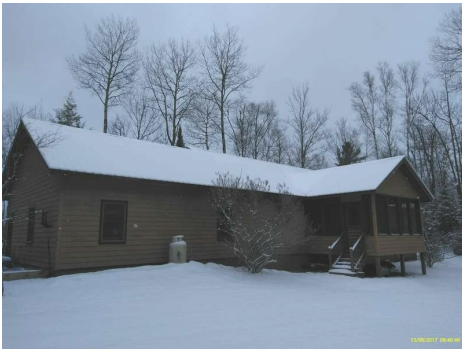
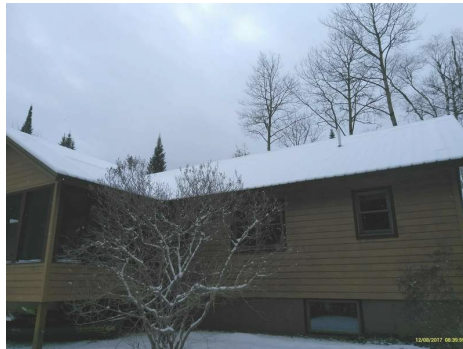
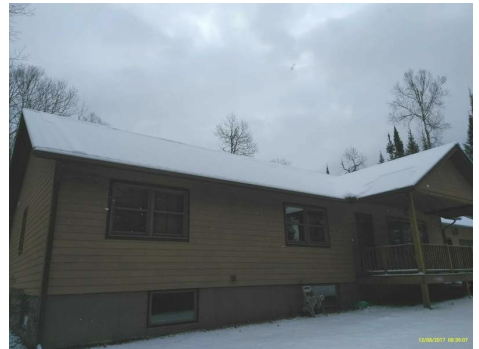
General exterior photos

Snow cover prevented a full visual evaluation of the roof coverings at the time of the inspection. The condition of the roof coverings must be excluded from this report.

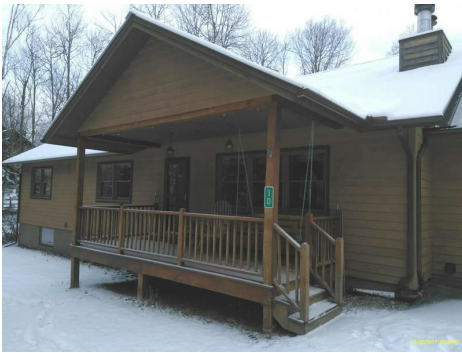
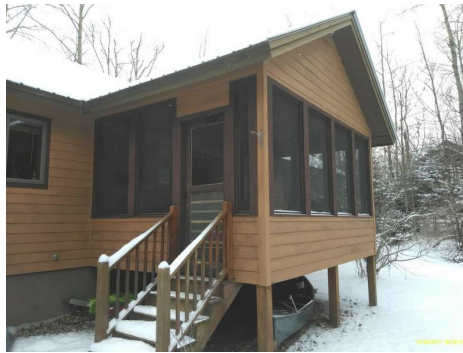
Front Porch, Back porch

The deck ledger boards for both the front and back porches did not have adequate fasteners. Proper fasteners have the strength to prevent a deck from pulling away or dropping. Recommend a qualified contractor to repair as needed.

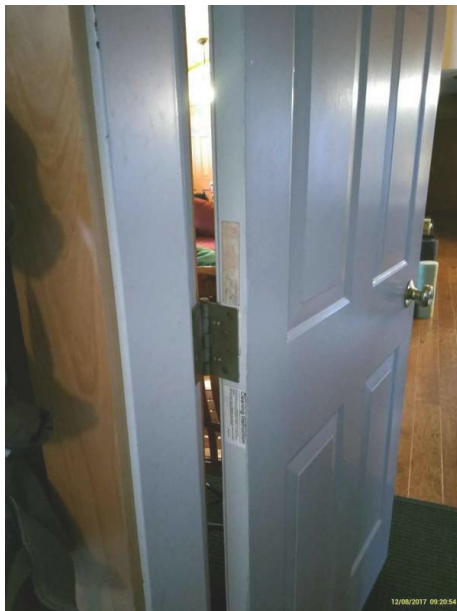
Occupant Door (From garage to inside of home): Fire Rated

The entrance door to the house did not fully self close at the time of the inspection. While equipped with proper hinges, they did not provide adequate force to fully close the door. A self closing door is important in slowing the spread of fire from the garage to the rest of the house, and preventing carbon monoxide from running vehicles from entering the house. Recommend a qualified contractor to repair as needed.
