YOUR INSPECTION REPORT

1234 Main St.
Buzzards Bay MA 02532

Buyer Name
02/26/2019 9:00AM

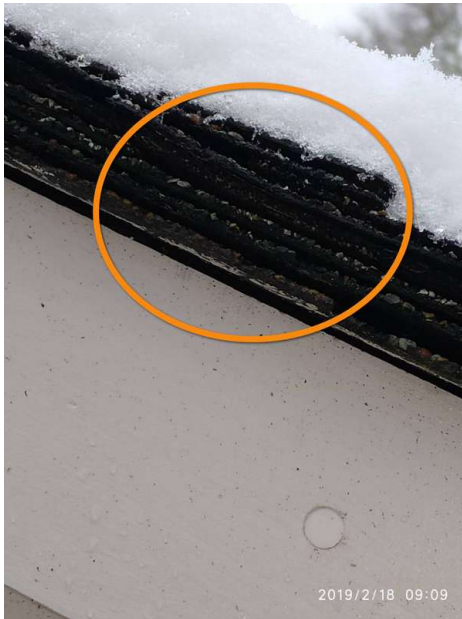
Main Roof Covering: 25-30 year shingles

Average life expectancy of this type laminated architectural asphalt shingle is 25 to 30 years.

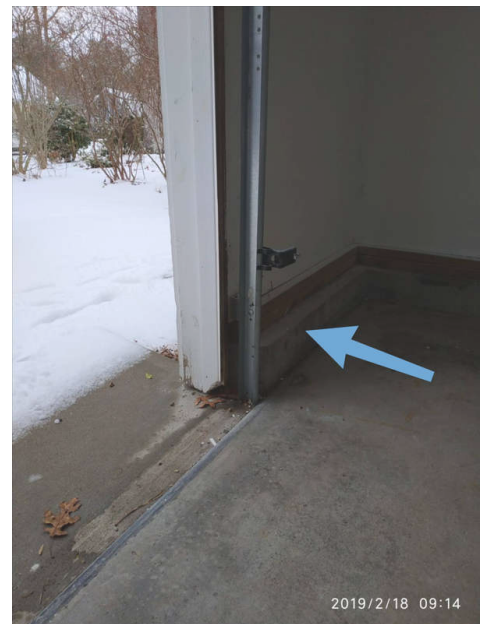
5.4.2 Garage Doors/Openers

NO RESISTANCE REVERSAL

Recommendation

Contact a qualified garage door contractor.

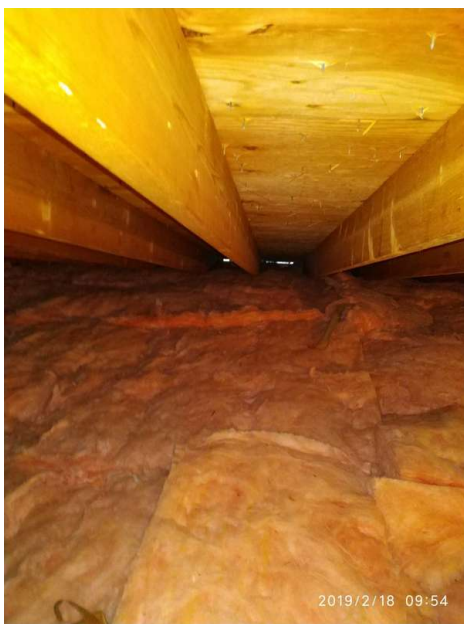
Attic Ventilation: Drip edge vent information

Dwelling uses drip edge venting (in place of soffit venting) to allow air into the attic. Often this is due to a lack of soffit area as used in some construction styles. This works well as providing adequate free vent area for attic ventilation, however, with this system it is crucial that the gutters be kept clean and debris free and are properly pitched to not pool water. Standing water and/or moisture from debris is readily drawn into the attic with this system, causing numerous moisture based problems as a result.

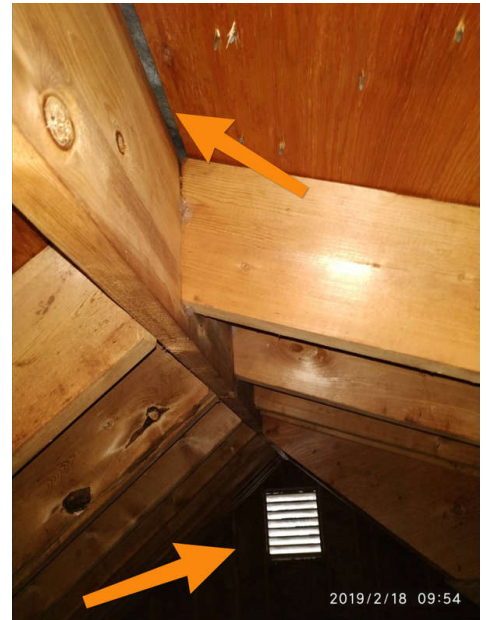
7.6.1 Attic Moisture Penetration

HISTORIC WOOD

Recommendation

Contact a qualified carpenter.

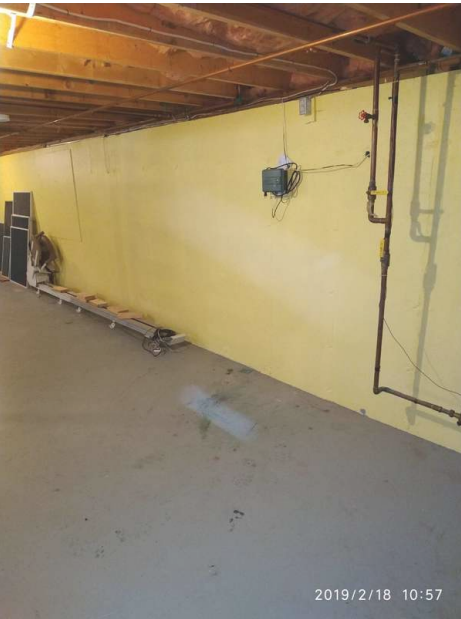
Basement Ceiling/Sub Floor: Insulation limitation

Basement insulation prevented observation of the rim joist, sills and sub floor.

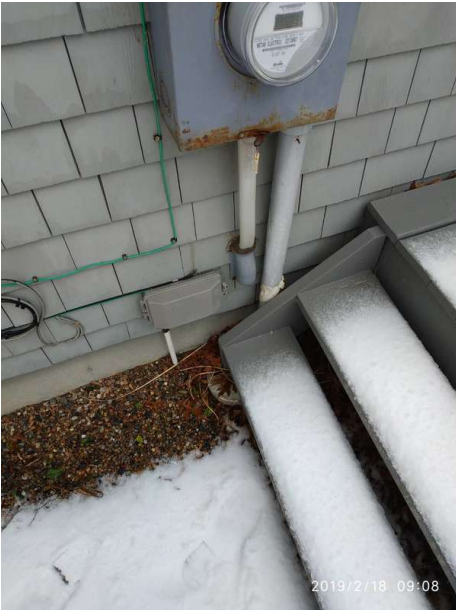
Service and Grounding Equipment: Grounding (External)
Not Observed

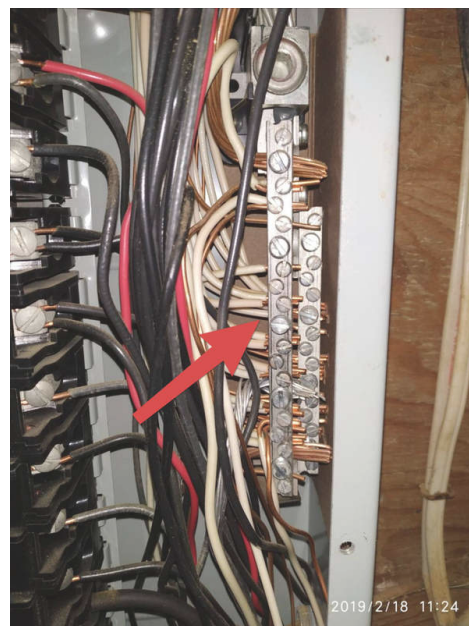
9.2.4 Main Distribution Panel

PIGGY BACK MULTIPLE

Recommendation

Contact a qualified electrical contractor.

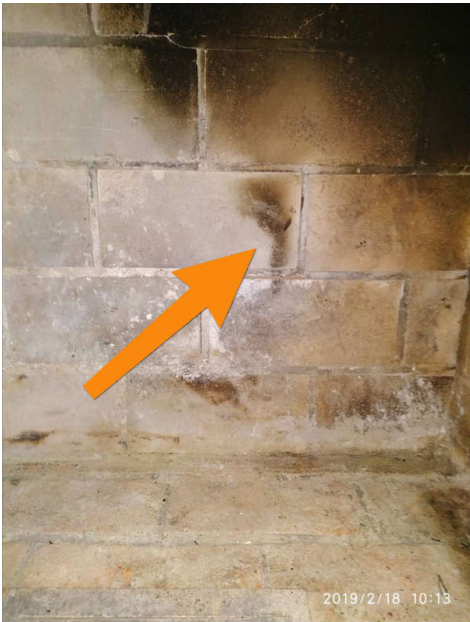
12.1.2 Fireplaces

SOOT ACCUMULATION

Recommendation

Contact a qualified masonry professional.

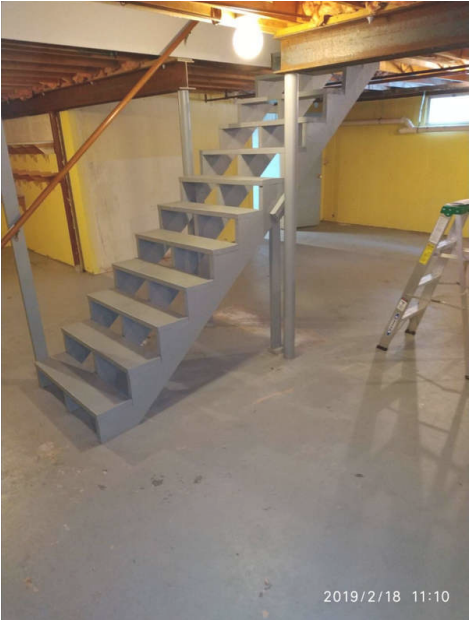
13.5.1 Steps, Stairways, Balconies and Railings

Recommend installing guardrails on open side of staircase for safety.

Contact a qualified carpenter.

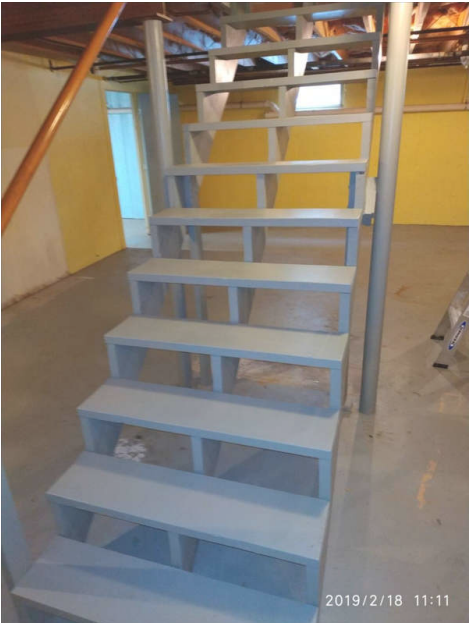
13.5.2 Steps, Stairways, Balconies and Railings

Recommend closing open risers for safety. Children can easily fall through these areas.

Contact a qualified carpenter.

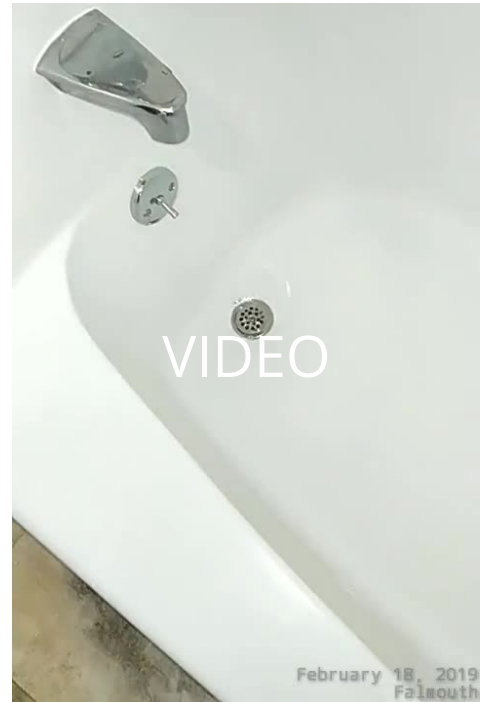
The bath drained slowly at time of inspection. Suspect a clogged trap. Recommend cleaning trap and/or repair.

Contact a qualified plumbing contractor.

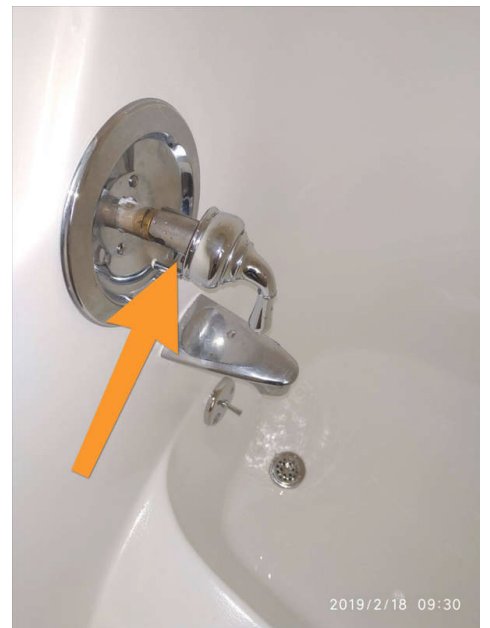
15.4.2 Bathtub/Shower combination

The shower valve is faulty and should be replaced

Contact a qualified plumbing contractor.

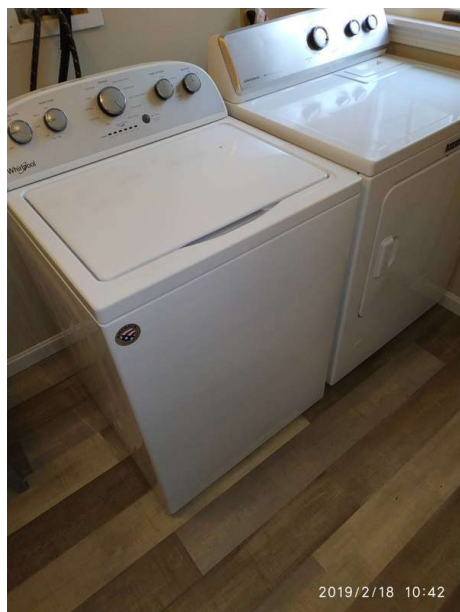
**Washing Machine and Dryer
Installation: Laundry Pan**

None

Recommend installing a safety pan beneath washing machine with a drain line terminating in a conspicuous location. A burst hose can cause considerable water damage.
