TIGER HOME AND BUILDING INSPECTIONS 970-468-0960

PROPERTY INSPECTION REPORT

1234 Main St. Eagle CO 81631

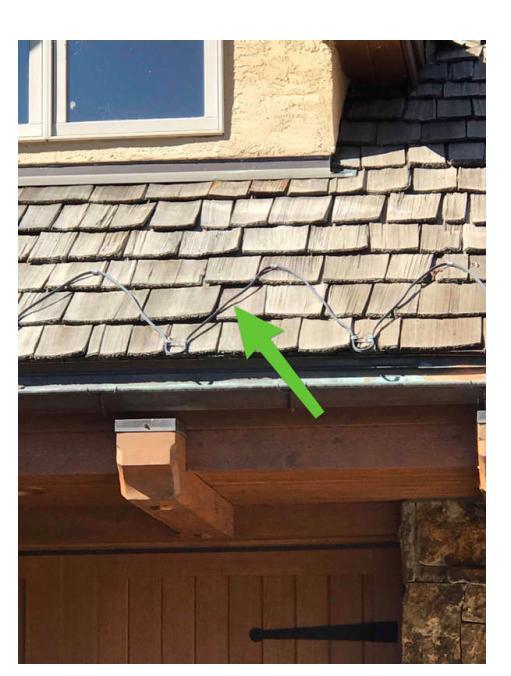
Heat tapes were installed at the lower edges of one or more roof sections. Heat tapes are electrically heated wires that are installed to prevent ice dams, and may be an indication that ice dams have been a problem previously. Ice dams form when snow melting on a warm roof refreezes at the cold, lower-roof edges. Resultant leaks often cause damage to the structure. For example, water-stained ceilings, loosened roof shingles, sagging and ice-filled gutters, peeling paint, and damaged drywall or plaster. Snow melting on the roof is usually caused by a warm attic, which in turn is caused by substandard ceiling insulation, a substandard air seal between living spaces and the attic or roof structure, and/or substandard ventilation in the attic or roof structure. Please note any other comments in this report regarding substandard attic or roof structure insulation or ventilation. Monitor the roof surface after snow falls and during subfreezing temperatures. If ice dams form, then recommend that a qualified contractor repair as necessary.

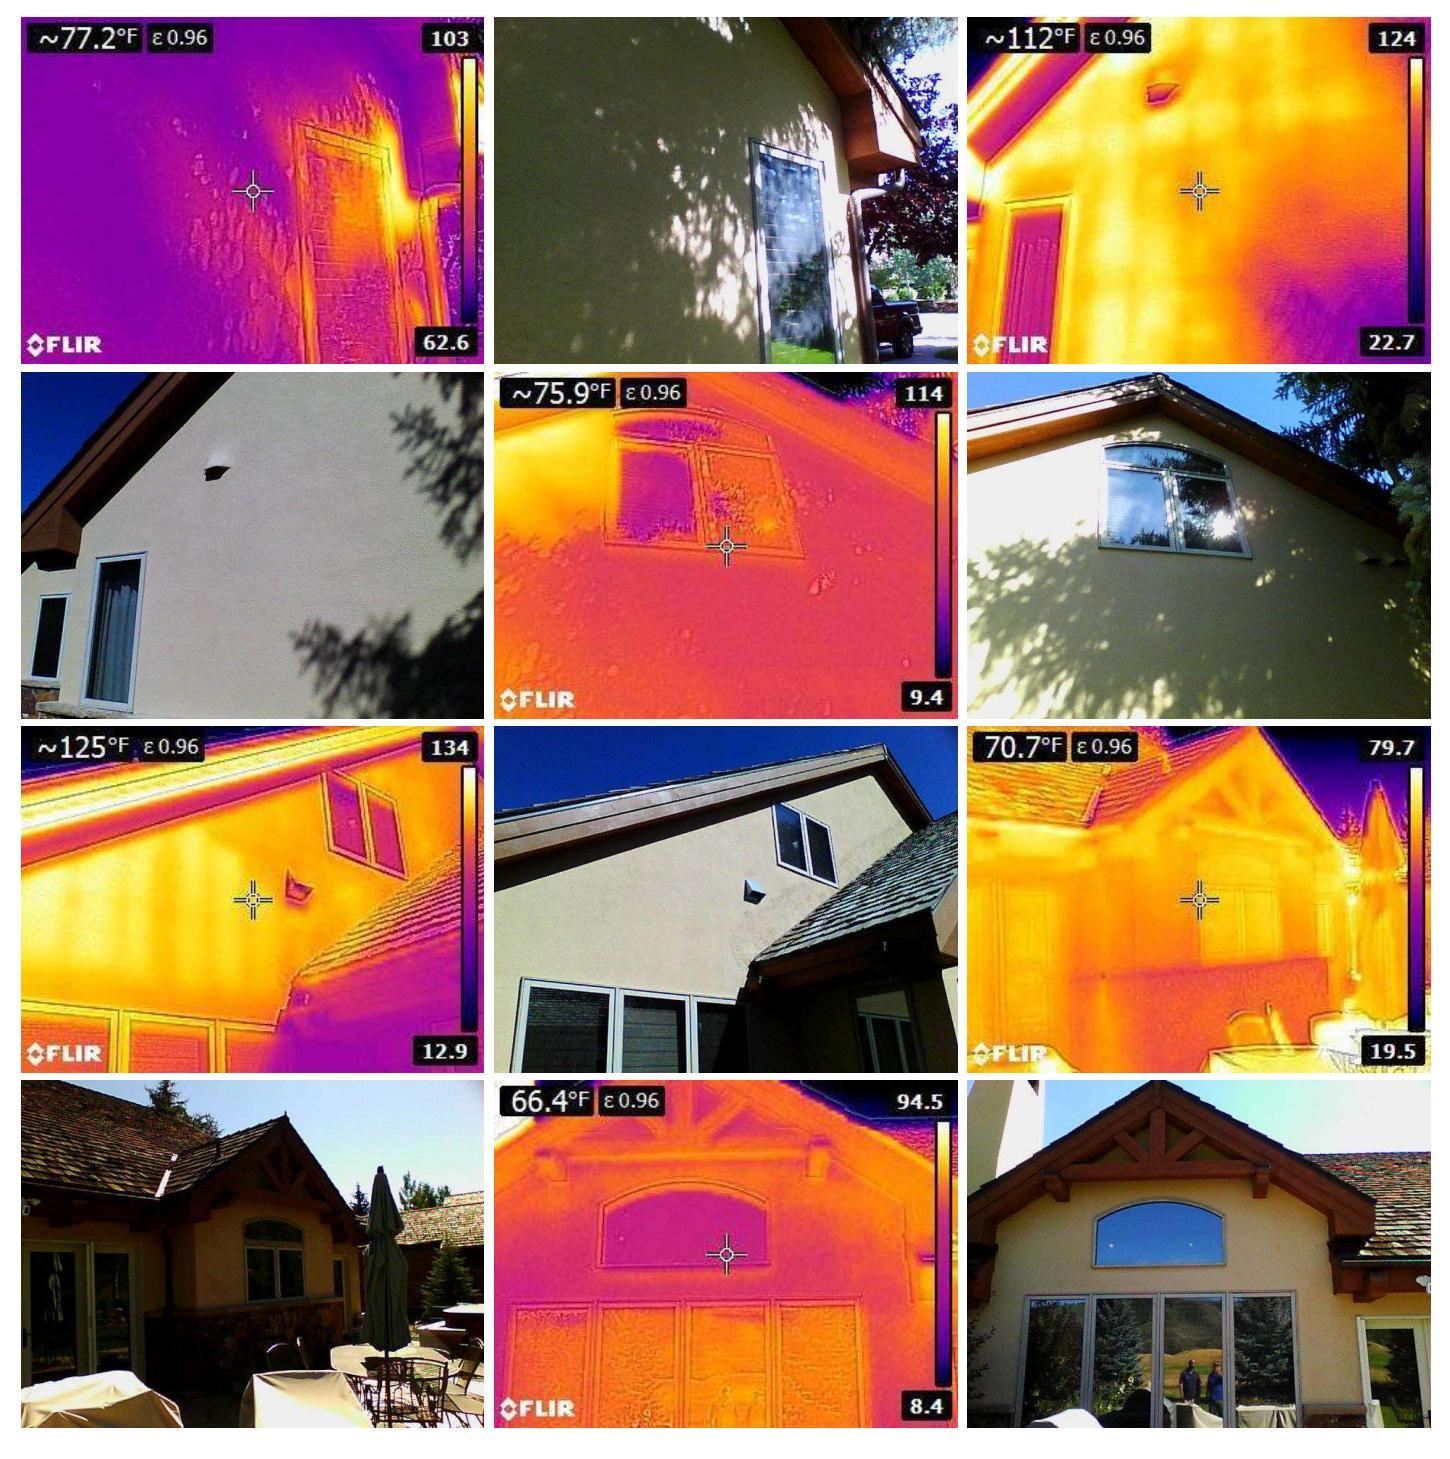
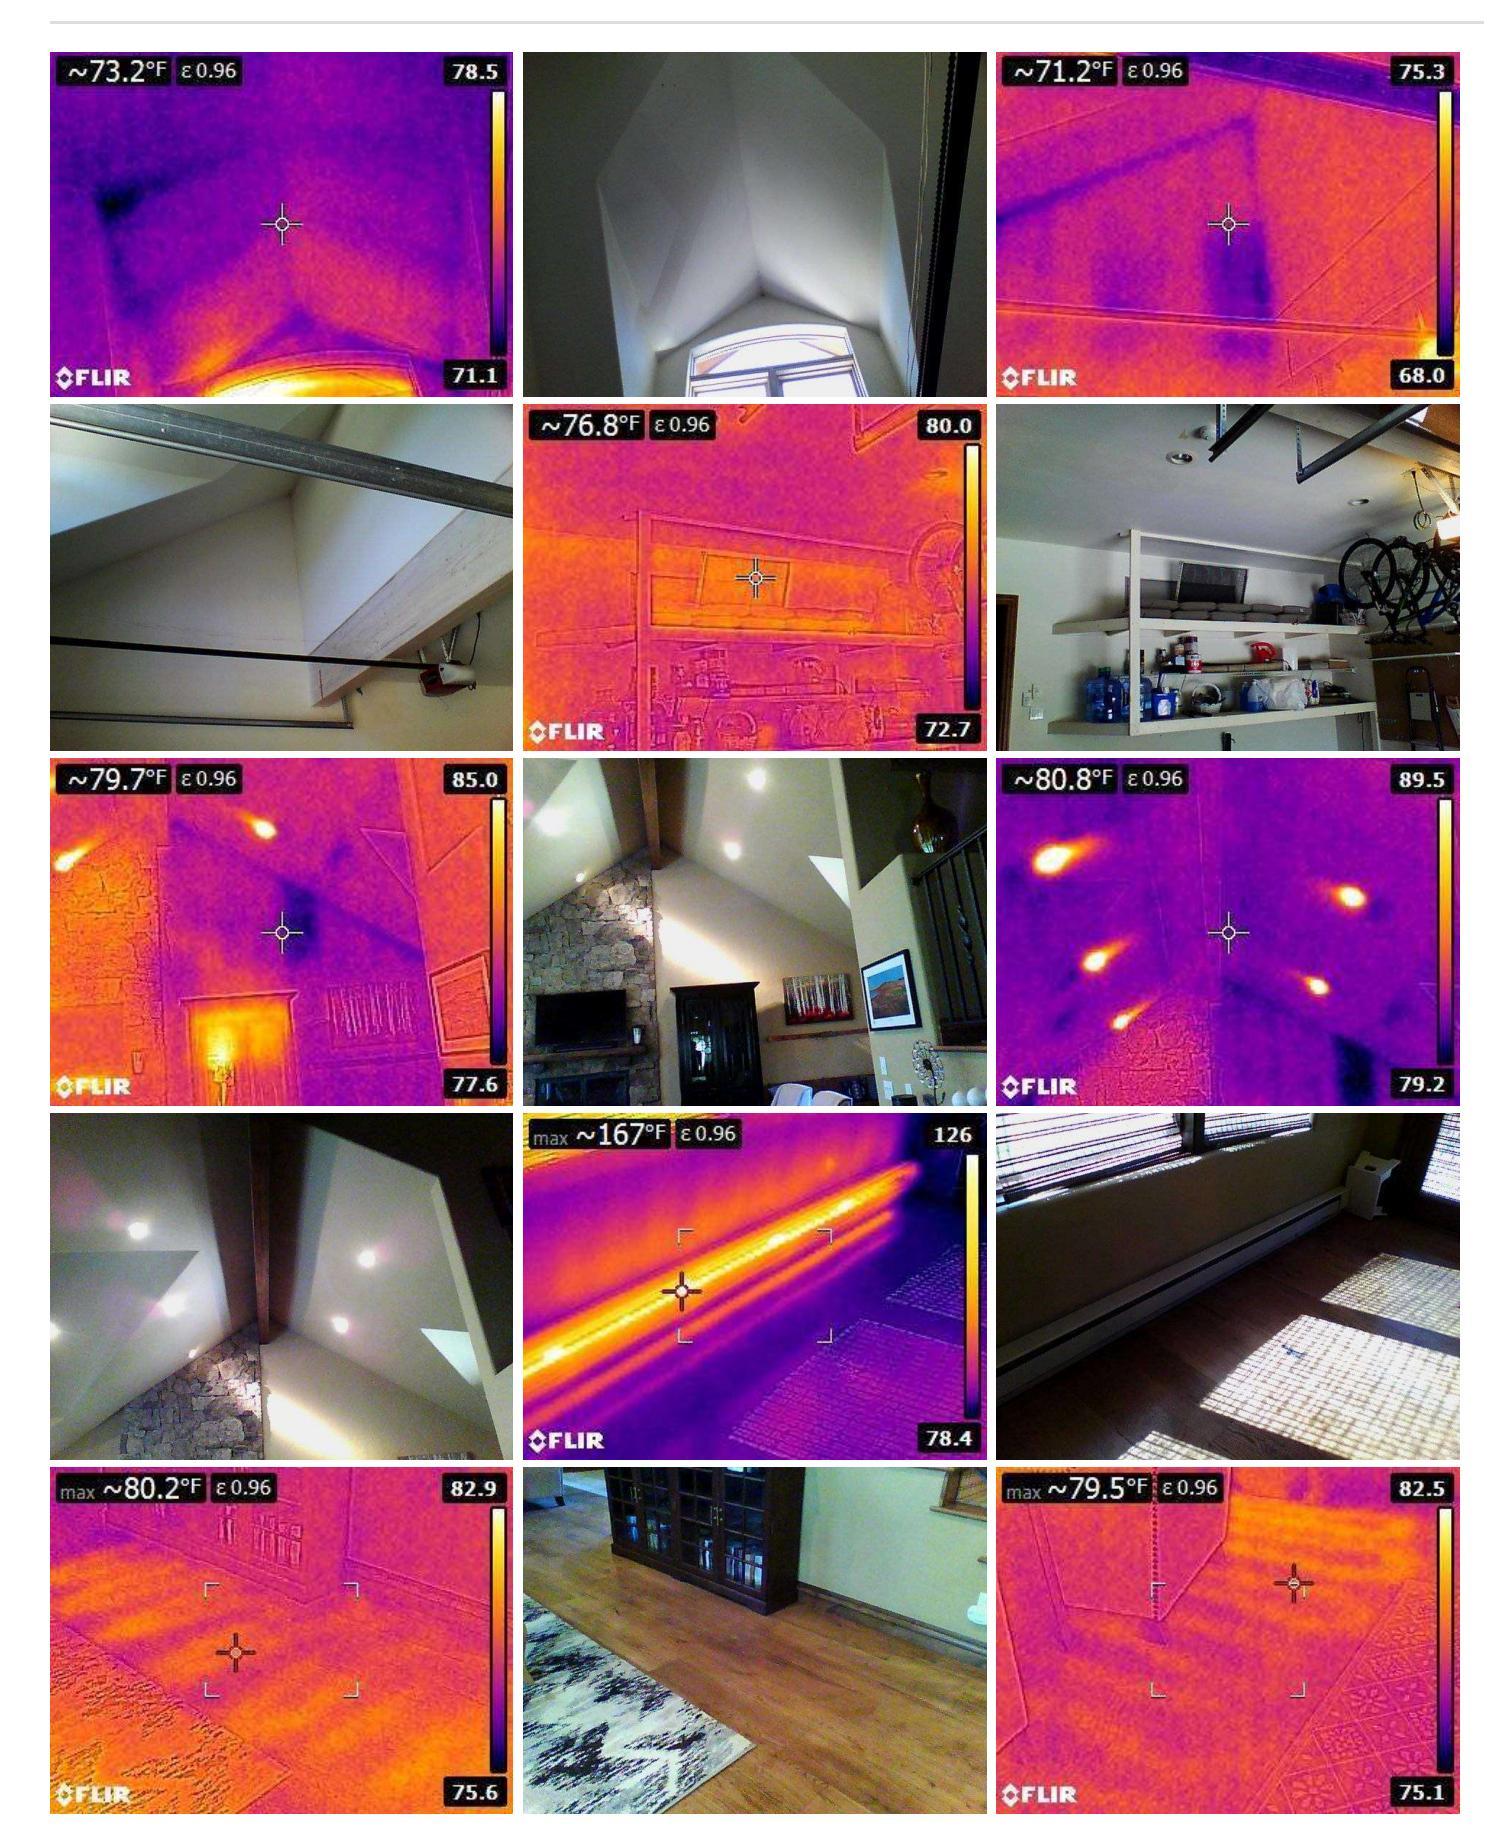
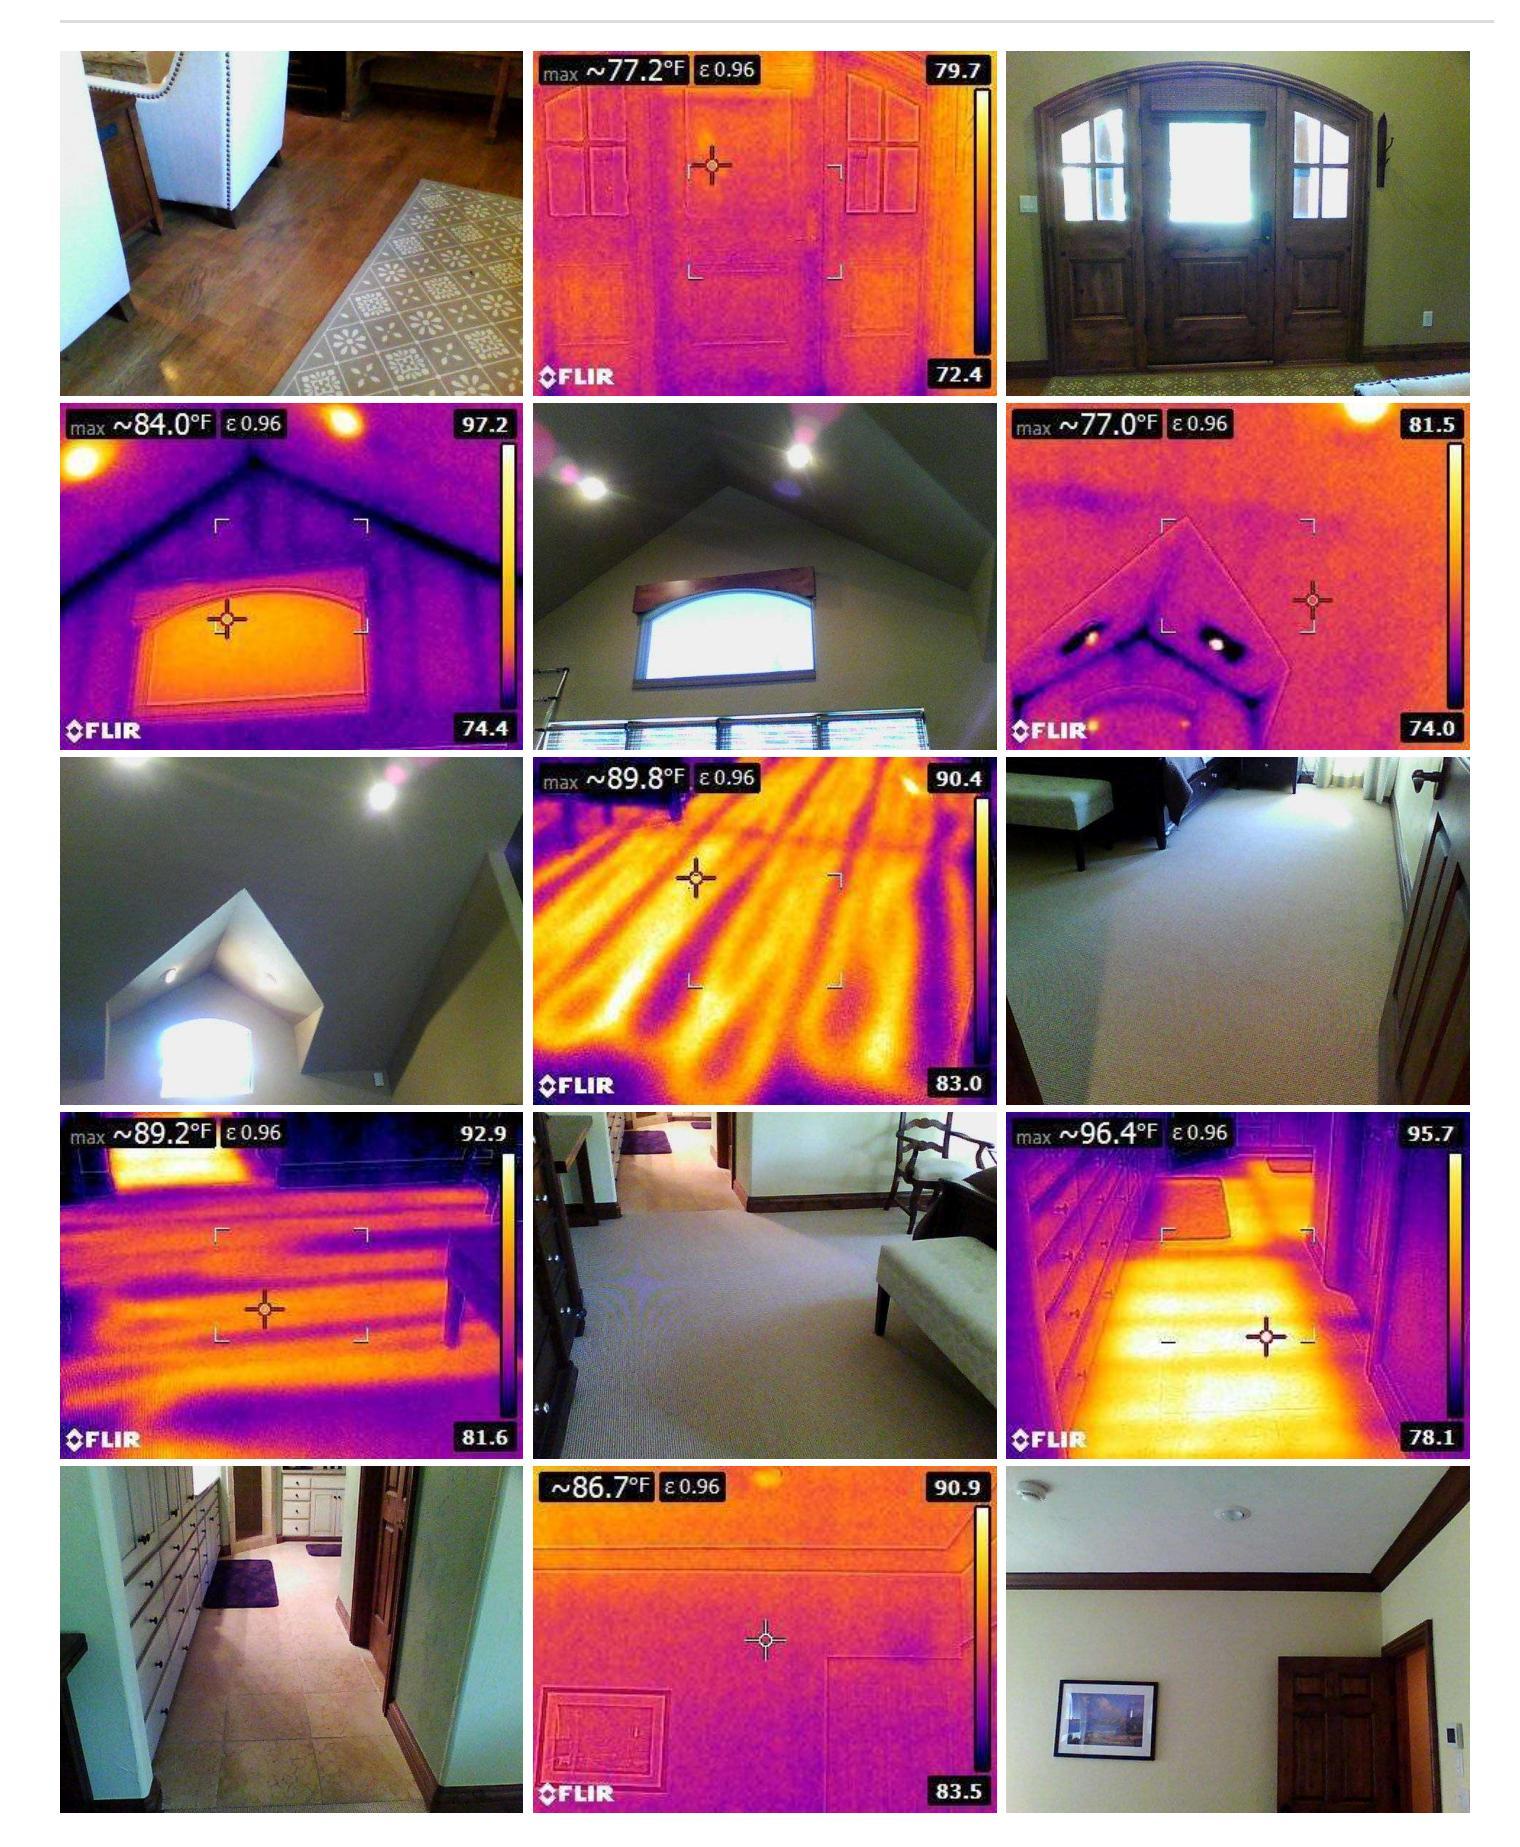
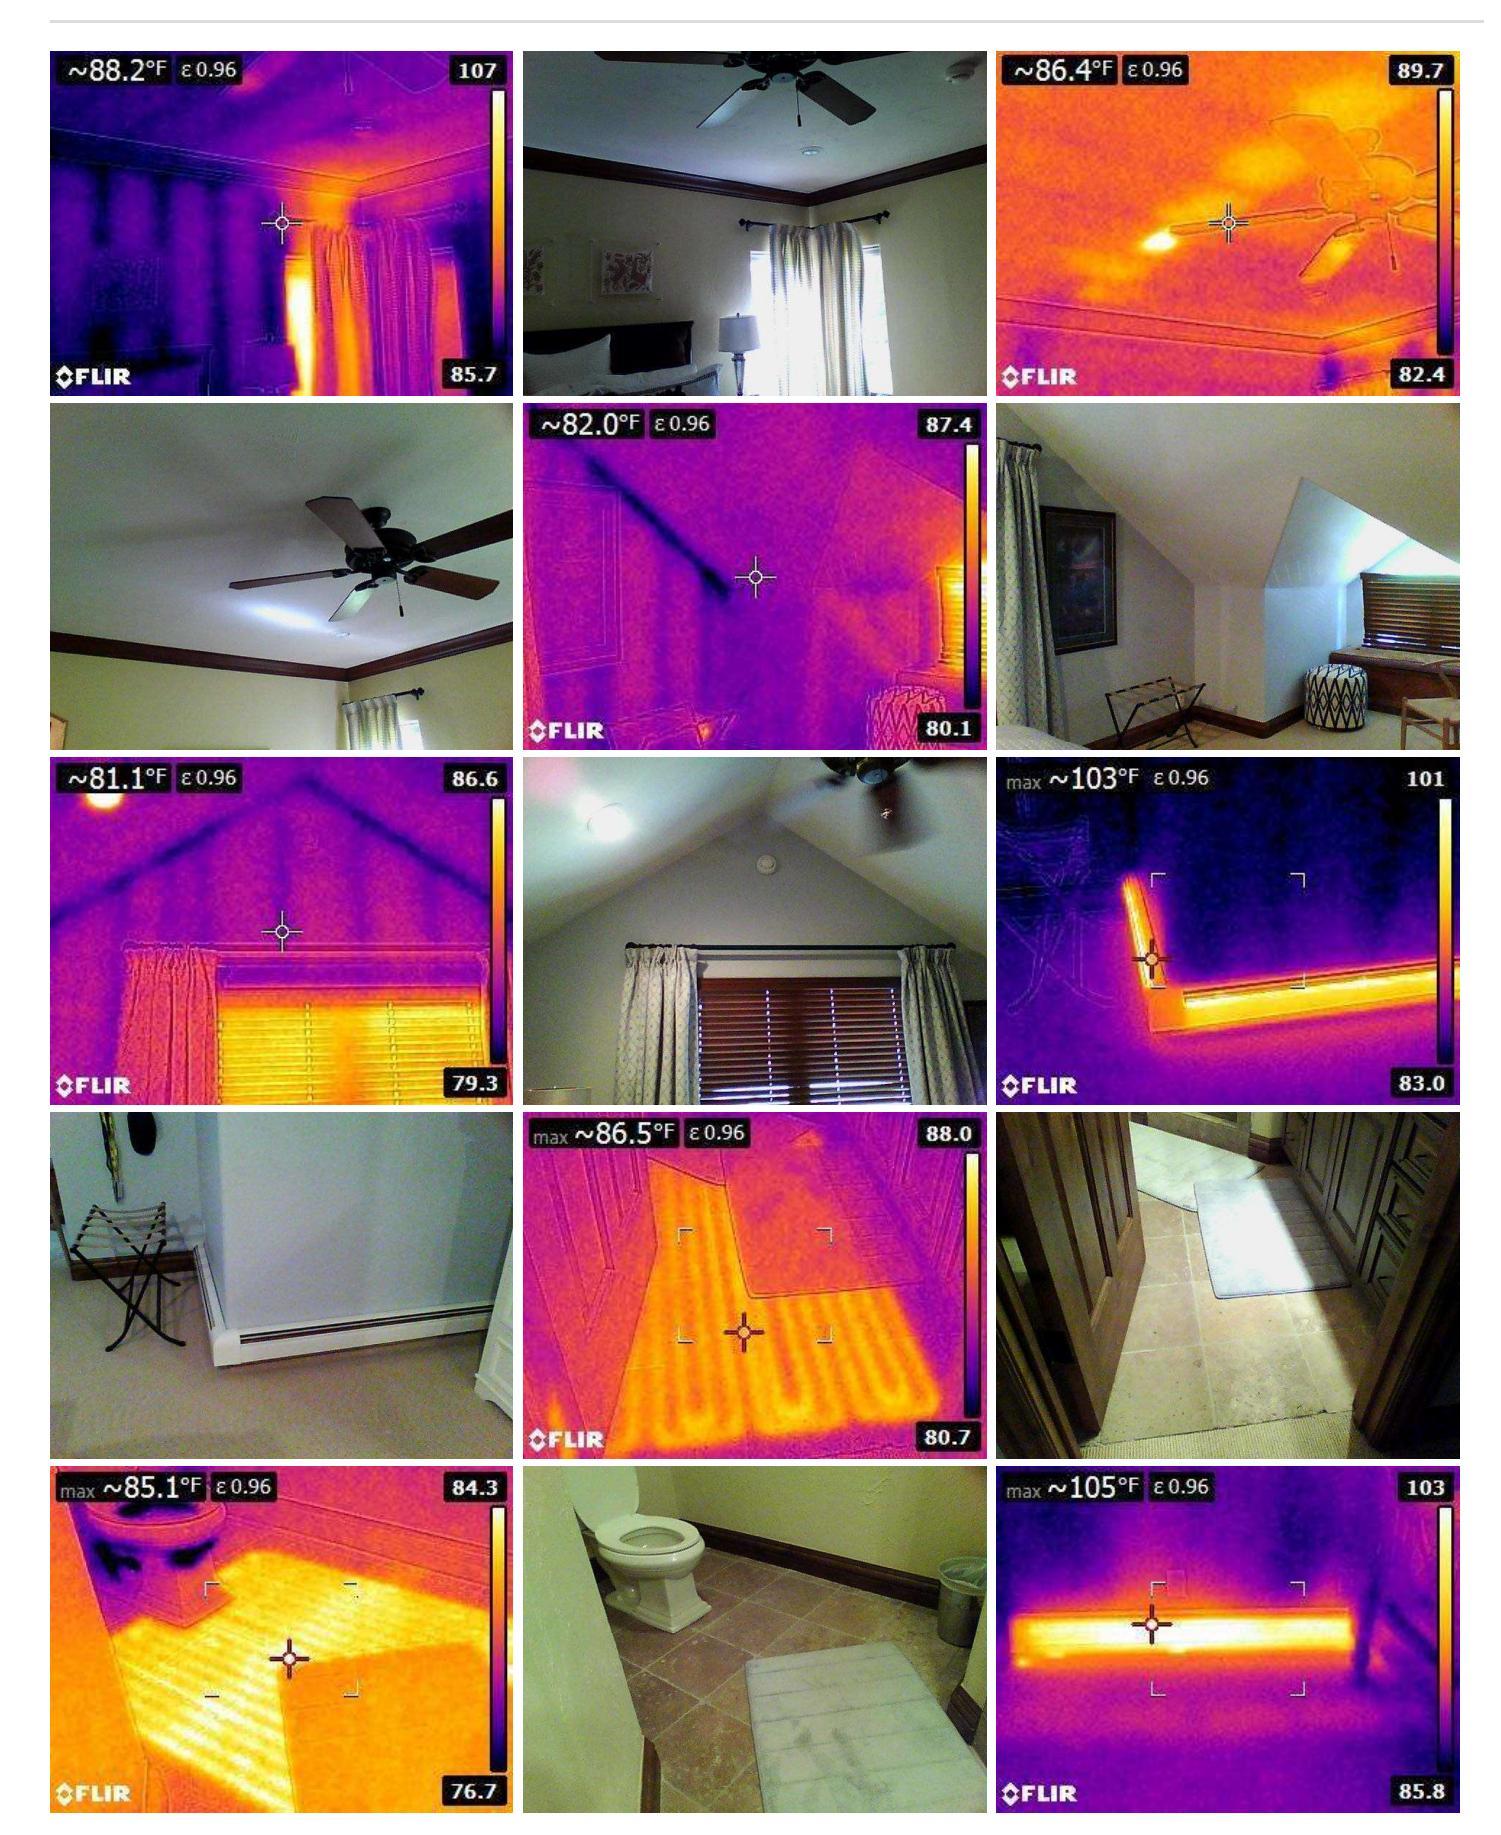
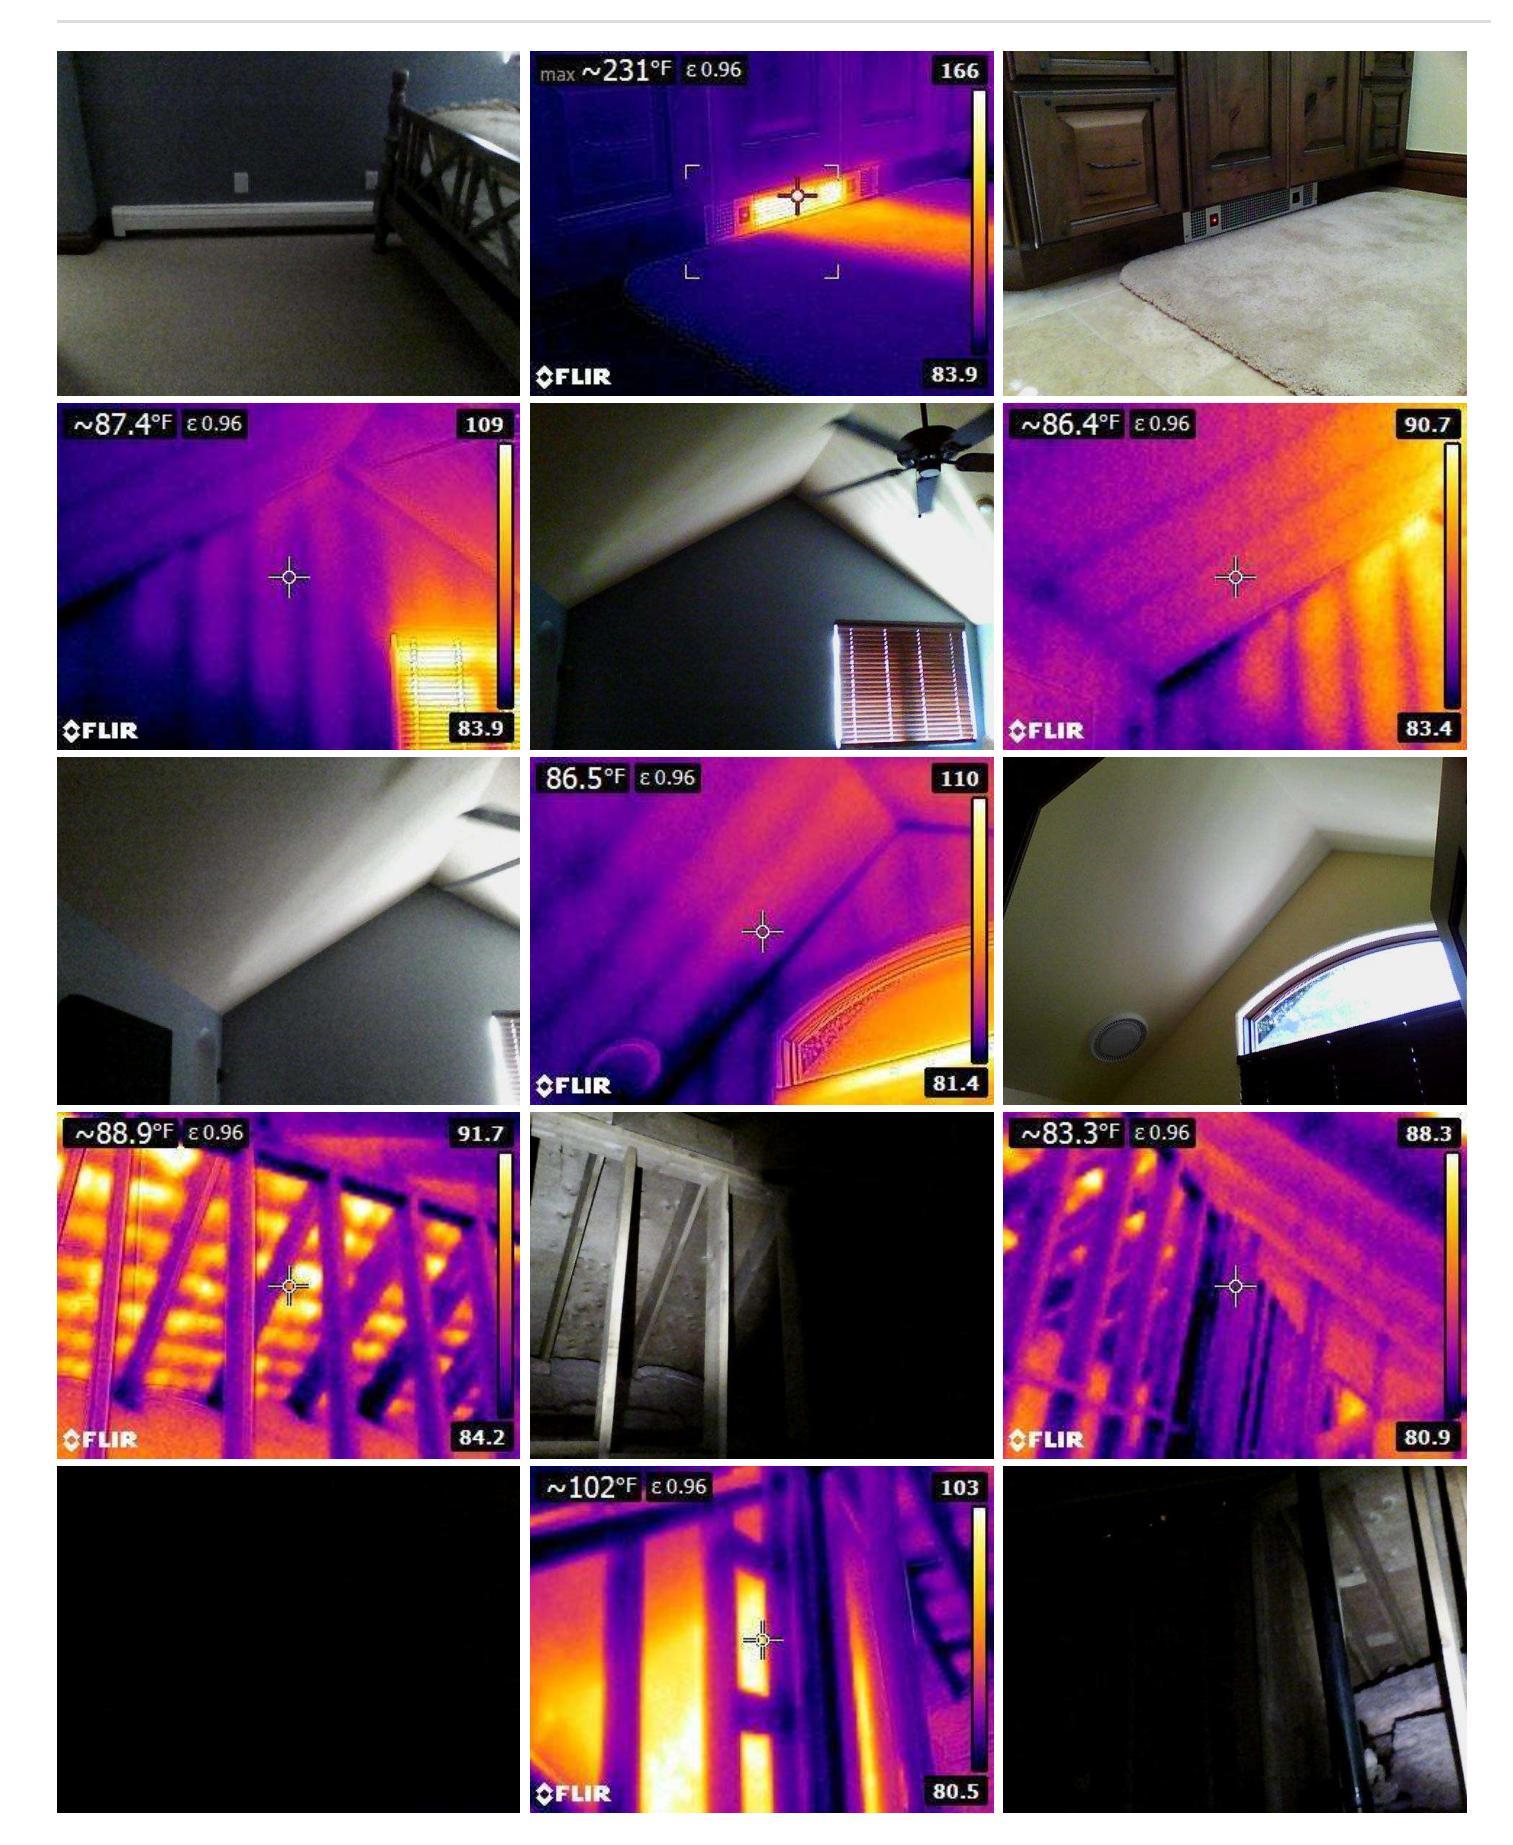
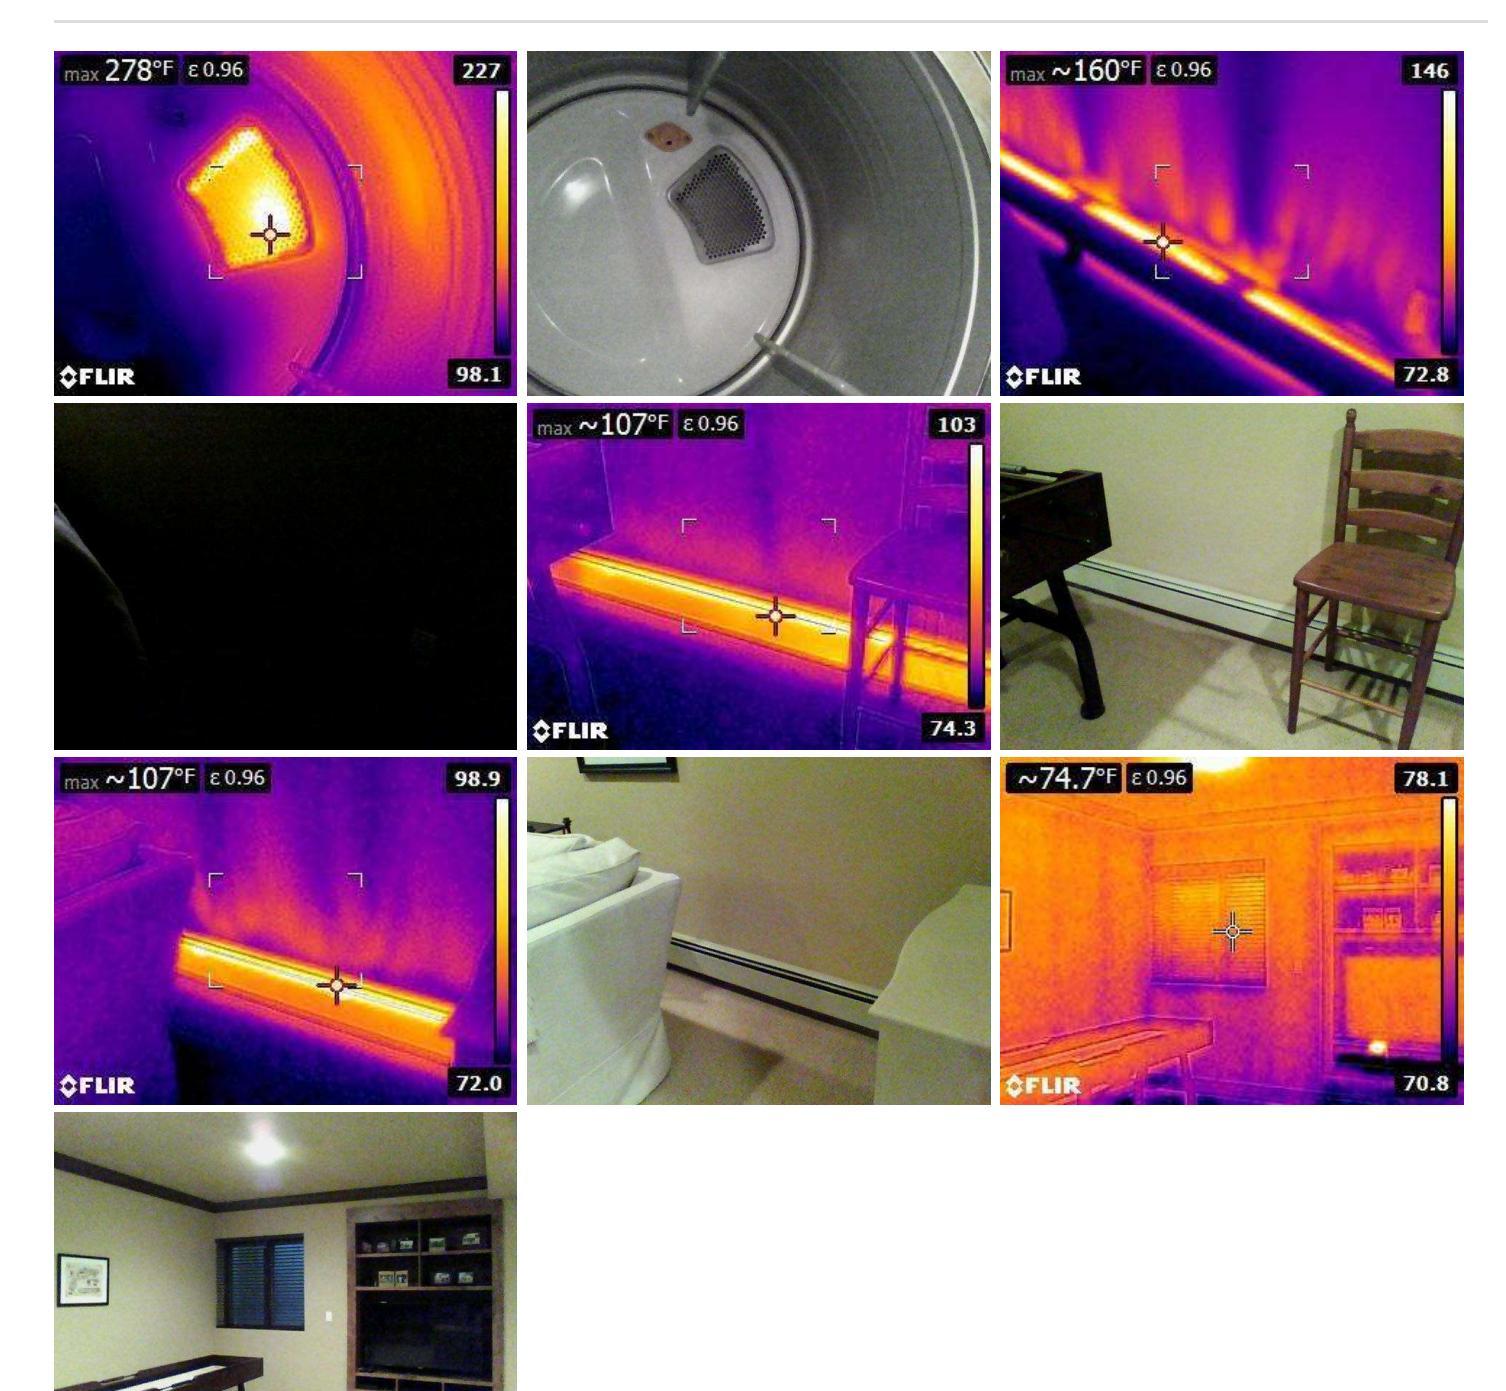
IR Photos: Photos

Miscellaneous Infrared photos. No issues noted, just informational. Infared thermography was employed to evaluate the house systems and appliances and to look for relative differences in surface temperatures of materials that might indicate an area affected (cooled) by moisture intrusion. No indications of any material defects or moisture intrusion were observed. This represents the conditions on the day of the inspection. Some areas that have been wet may not be on the day of the inspection. No material defects or anomalies representing potential water intrusion were detected. Darker or cooler areas might demonstrate thermal bridging, in which cooler framing members of the structure stand out against warmer areas of the wall. Also areas with missing or poorly installed insulation might be apparent. Attached here is a representative sample of the photos taken during the course of today's inspection.
