SINGULAR HOME INSPECTIONS RESIDENTIAL INSPECTION

1234 Main St.
Katy Tx 77449

04/02/2019 9:00AM

PROPERTY INSPECTION REPORT

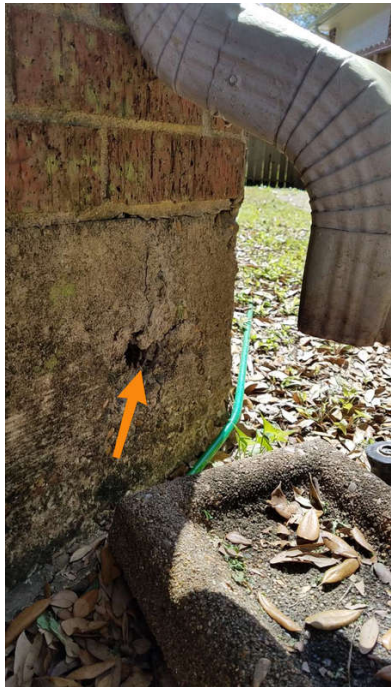
Rear Left

One or more of the post tension cable ends are exposed and need to be properly sealed.

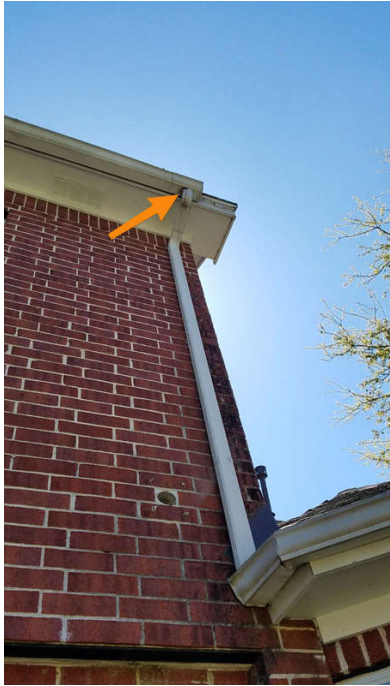
Rear

The downspout is separated.

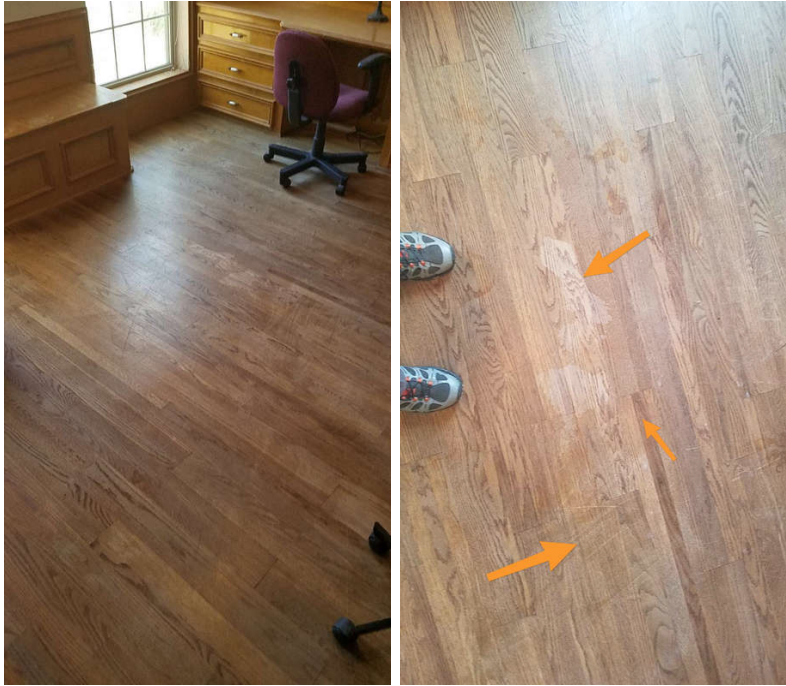
Study/office

The floor covering is noticeably worn and/or damaged in one or more locations of the home.

5: Minor carpet wear - general

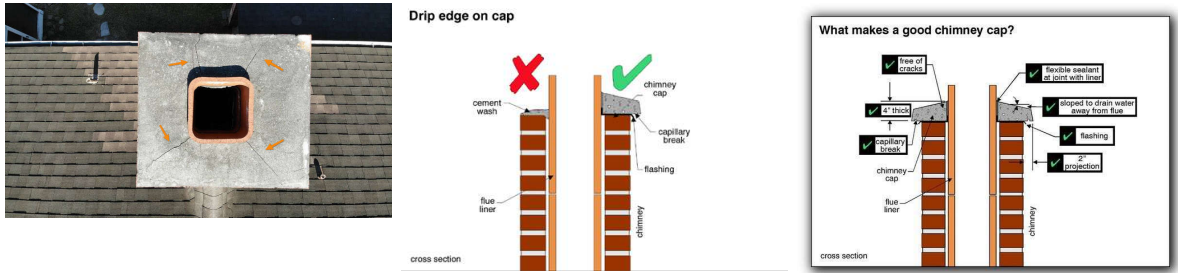
The roof level chimney mortar cap/crown is in need of improvement.

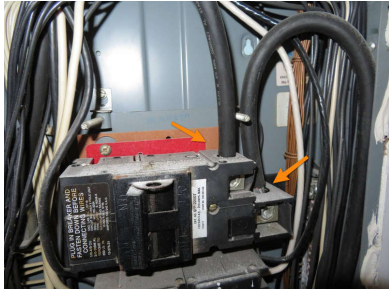
There was no anti-oxidant gel observed on the exposed aluminum conductor terminations.

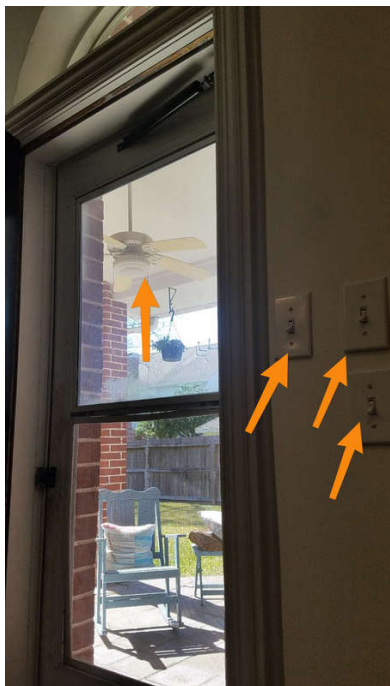
Rear

6: Exterior light inop

Some light fixtures mounted on the exterior walls of the residence were inoperable at the time of the inspection. This condition can be caused by burned out bulbs, the light may be connected to a timer or light-sensitive switch or a problem may exist with the light fixture, wiring or the switch. You should re-test any inoperable light fixtures after replacing the bulbs.

If after bulb replacement the lights still fail to respond to the switch, consider evaluation by a qualified electrical contractor. This condition may be a potential fire hazard.

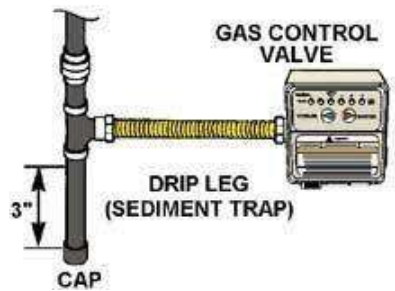
The heater gas supply line is not equipped with a sediment trap just before the gas appliance connector. This condition does not meet current installation requirements and should be corrected.

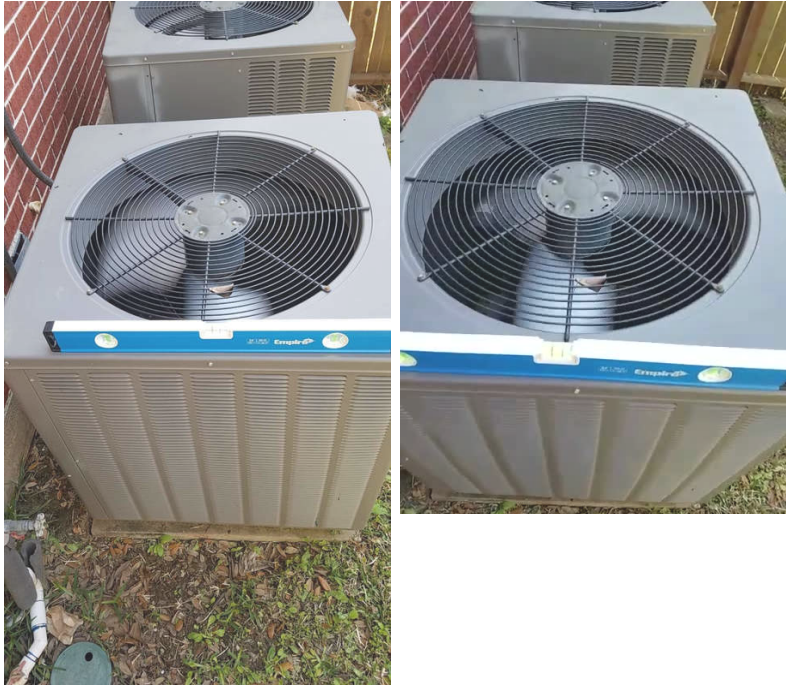
The outside condenser/coil fan motor is out of balance and causes the unit to vibrate more the normal.

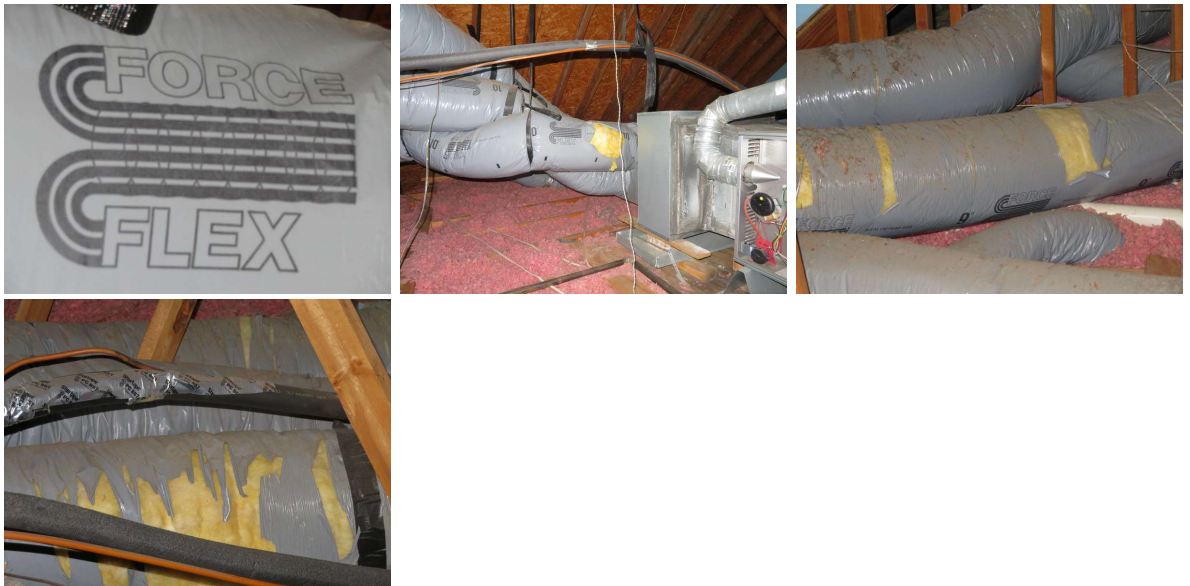
Attic, Various Locations

The covering on the ductwork that is in place has been known to deteriorate with direct and/or indirect UV light. This item should be closely monitored and corrected as necessary.

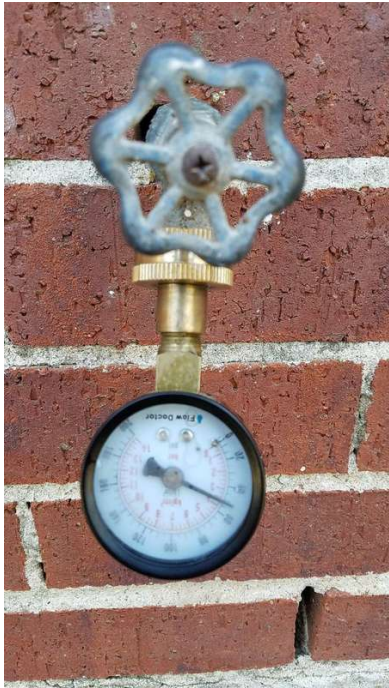
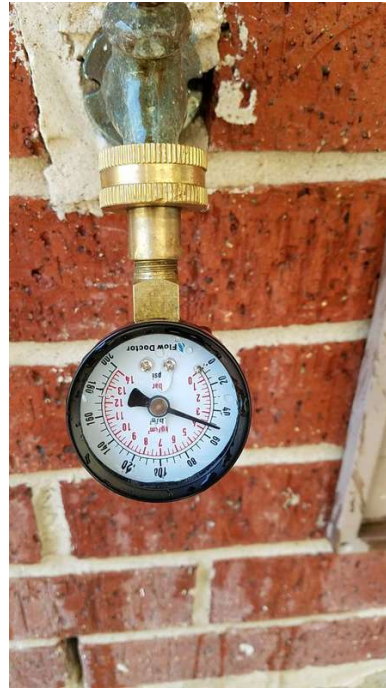
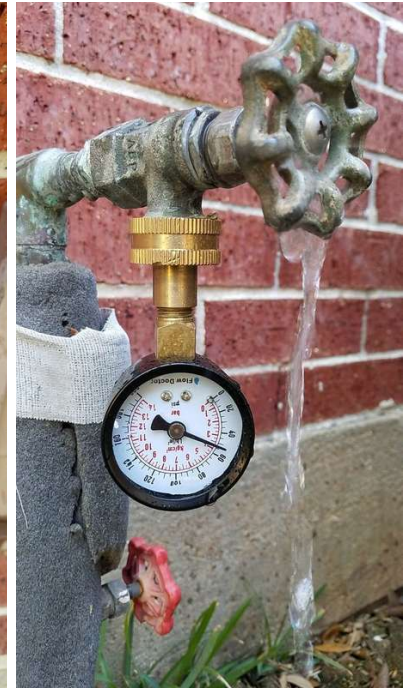
1: "Water Hammering"

Water hammering is a term used to describe noise produced by a destructive force known as hydraulic shock. Water hammering develops in a piping system when an instantaneous change in the velocity of flowing water occurs, or when water flowing at a given velocity is stopped abruptly. A quick closure of a valve, for example, creates some form of shock. The shock wave is accompanied by a pressure surge that can expand the wall of the pipe. Recommend further evaluation by a licensed plumber and repair or replace as necessary.

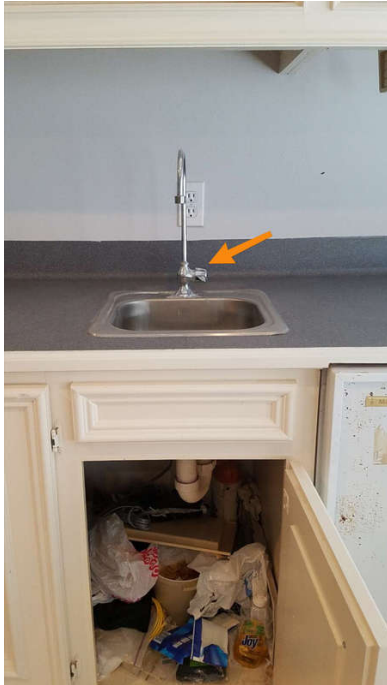
Upstairs Gameroom

3: inoperable

The faucet cold water supply is inoperative. The cause and remedy should be further evaluated.

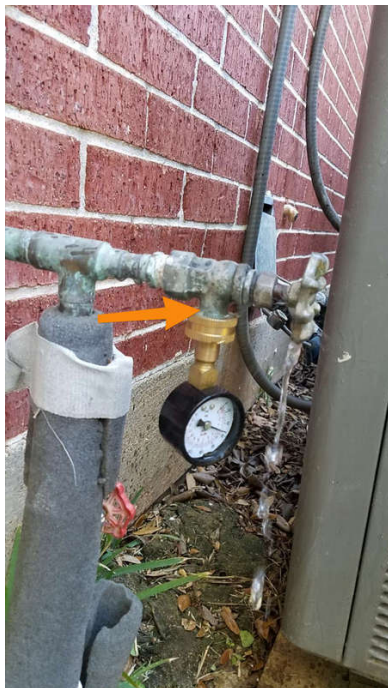
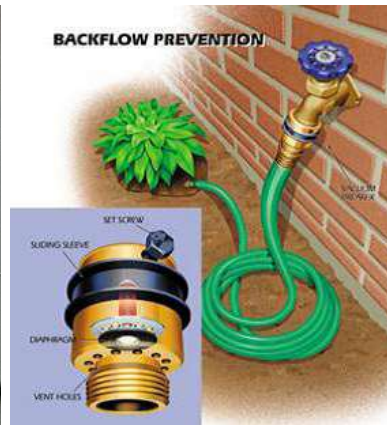
8: Leaks at handle

The exterior water hose bib (faucet) is leaking at the handle when operated.

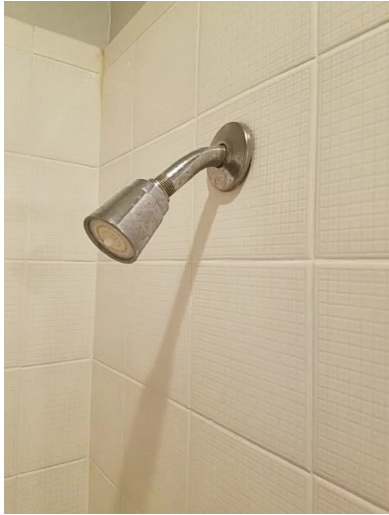
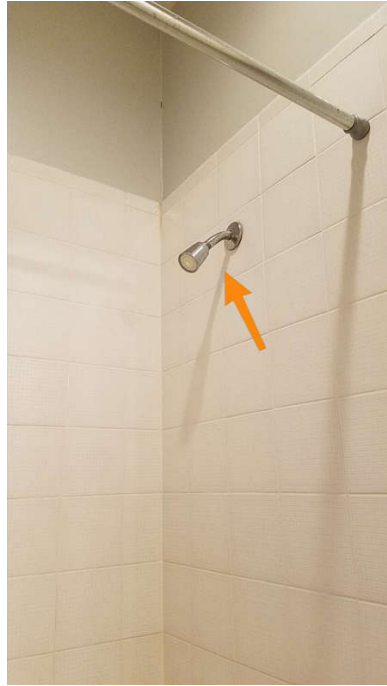
10: Shower spout loose

Shower spout is loose. Recommend a licensed plumber repair or replace as recommended.

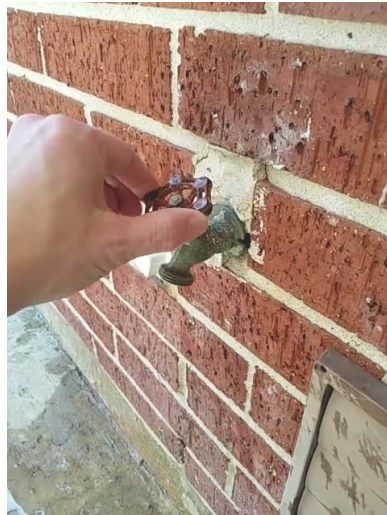
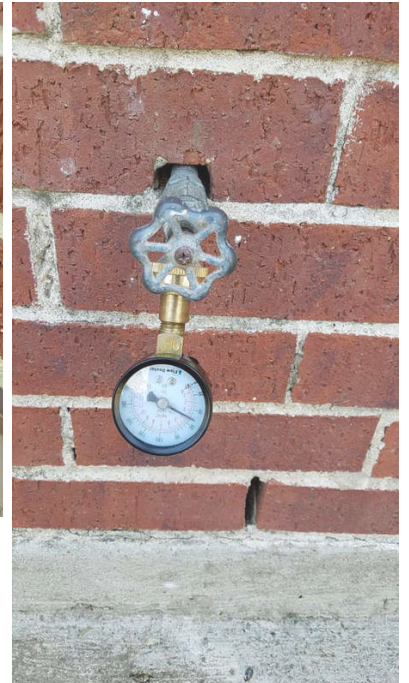
Rear

11: Hose bib pipeing loose

The hose bib is loose at the connection and does not have support for the piping inside the wall. Recommend repair by licensed plumber.

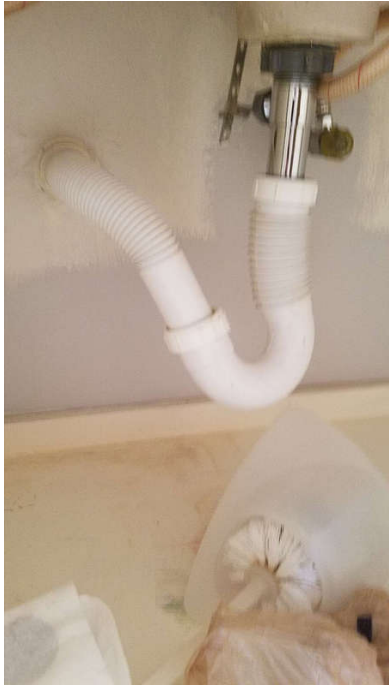
Upstairs Garage apt

3: Improper drain/waste/vent pipes

The home contained drain, waste or vent pipes of improper material which should be replaced with pipes of an approved material by a qualified plumbing contractor.

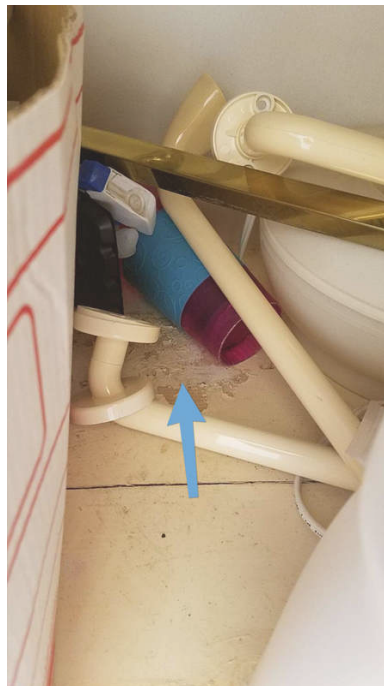
Upstairs Bathroom Left

5: Prior leak

Previous water leaks were observed at and/or around the drain connections under the sink. This would indicate previous problems and should be closely monitored and corrected when necessary.

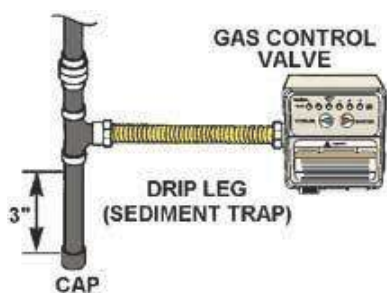
Drip Leg

3: Sediment Trap missing

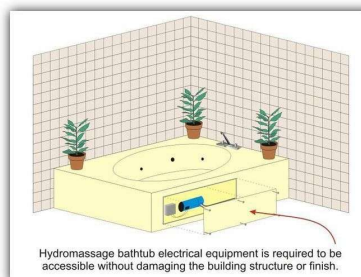
The access to the hydro-massage therapy equipment motor is not readily accessible and inspection of the equipment lines and motor could not be performed. This does not meet current installation standards.

This may be an as-built condition but Per TREC standards of practice we are required to report this condition as a deficiency.

Hydromassage bathtub electrical equipment is required to be accessible without damaging the building structure or finish.

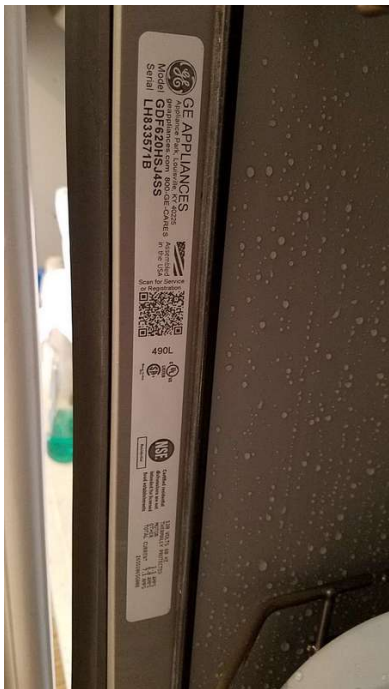
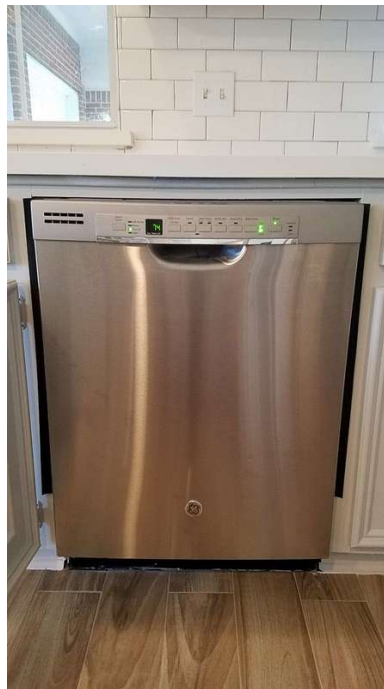
1: rust

Some rusting of the dishwasher interior components was observed.
