# PROSITE PROPERTY INSPECTIONS

## GENERAL HOME INSPECTION REPORT

1234 Main St.  
Gulf Breeze FL 32563

Buyer Name  
02/05/2019 9:00AM

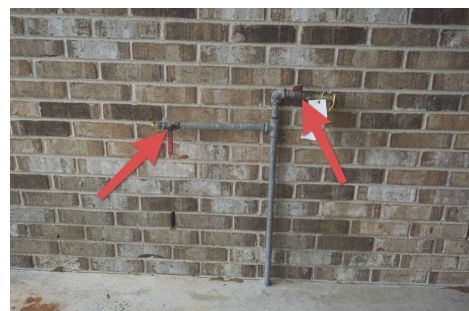
#### GAS UTILITY LEAK

Based on gas odors, gas appeared to be leaking at the one or more local shut-off valves or supply piping located at the back exterior. This is an explosion and fire hazard. A qualified contractor and/or the gas utility company should evaluate and repair immediately.

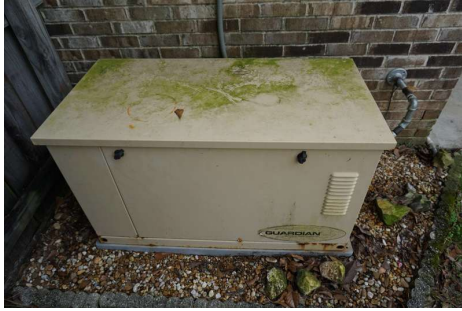
North Exterior

Equipment for a generator system was found. Generators, transfer switches and any associated wiring are excluded from this inspection. Recommend that the client consult with the property owner or review documentation to familiarize themselves with the operation of this system.

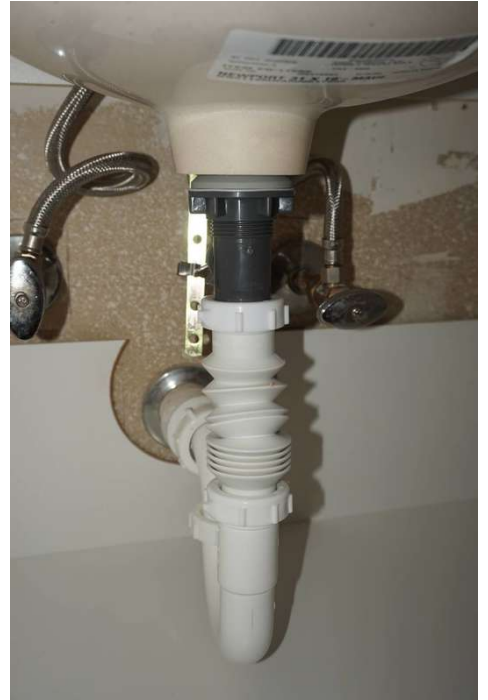
Sink drain for the master bathroom used flexible drain pipe. This type of drain pipe is more likely to clog than smooth wall pipe. Recommend having a licensed plumbing contractor replace this pipe with standard plumbing components (smooth wall pipe) to prevent clogged drains.

Contact a qualified plumbing contractor.

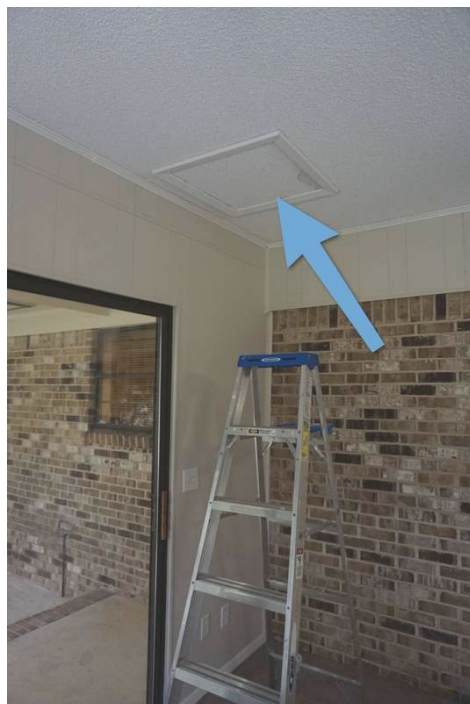
No insulation was installed over the attic access hatch. Recommend installing insulation above hatch for better energy efficiency by a qualified professional.

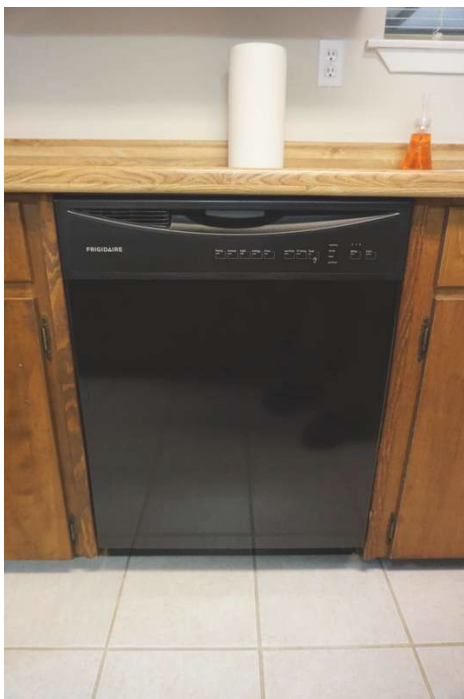
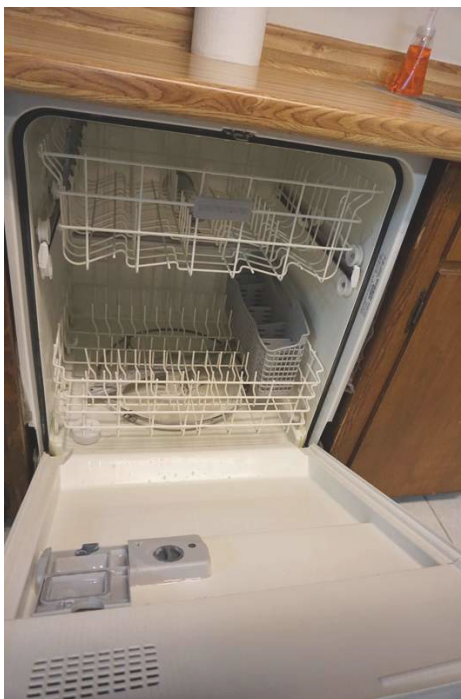
**Dishwasher: Dishwasher Operation**

The dishwasher was functional and operated as expected during the inspection. The unit was operated through a complete cycle. No operational discrepancies were noted.

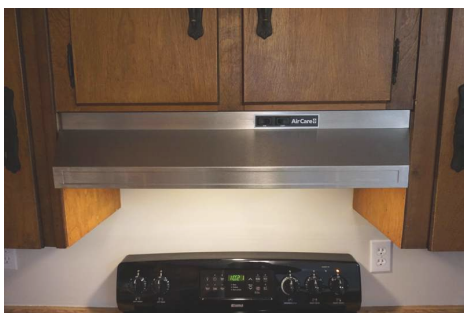
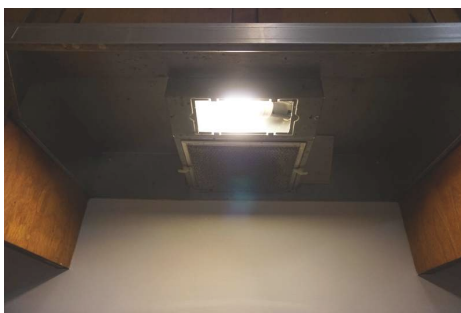
**Hood/Vent: Normal operation**

Hood vent and light functioned as expected during the inspection.

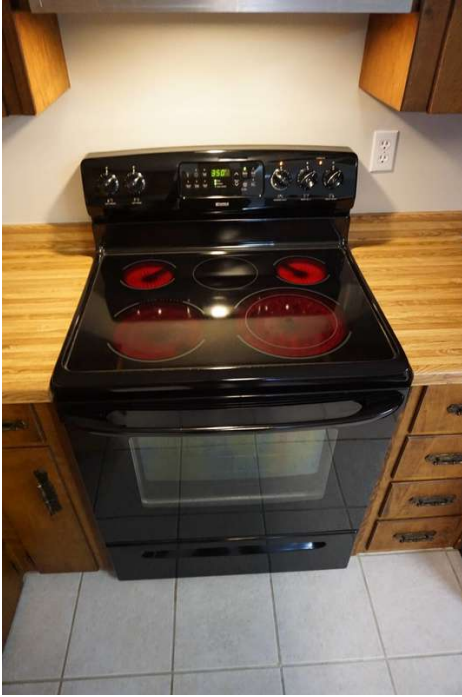
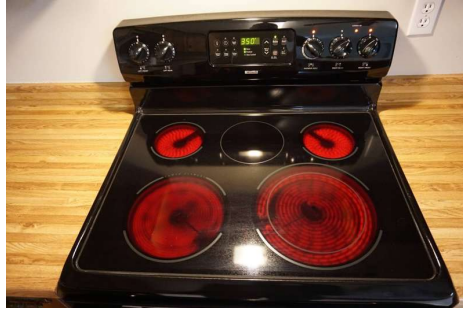
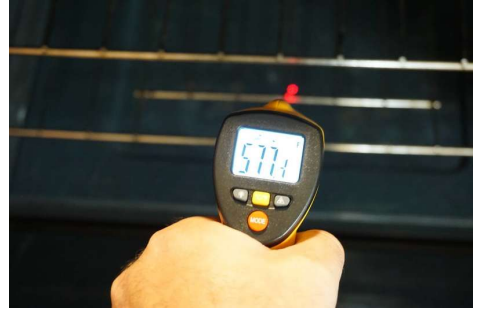
**Range-Cooktop-Oven: Normal operation**

The heating elements for the oven and stove top functioned as expected during the inspection.

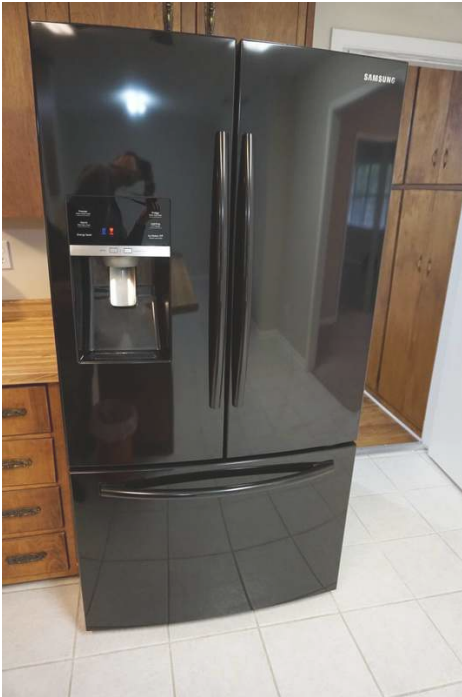
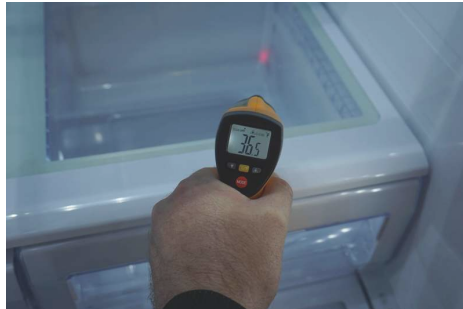
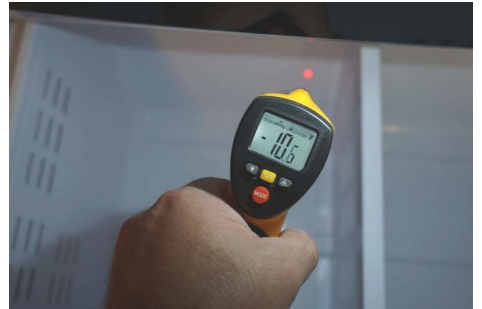
**Refrigerator: Chiller and freezer temp**

36 - -10 Fahrenheit

The refrigerator appeared functional during the inspection. The unit ran cold as expected.
