HOME INSPECTION REPORT

1234 Main St.
Naches WA 98937

01/24/2018 9:00AM

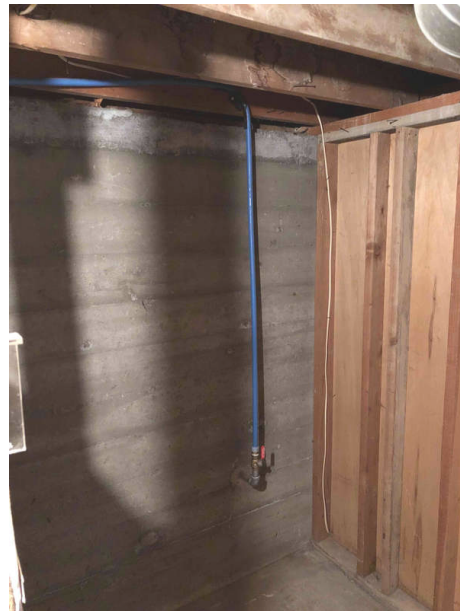
Main Water Shut-Off Location

Basement, Utility Room

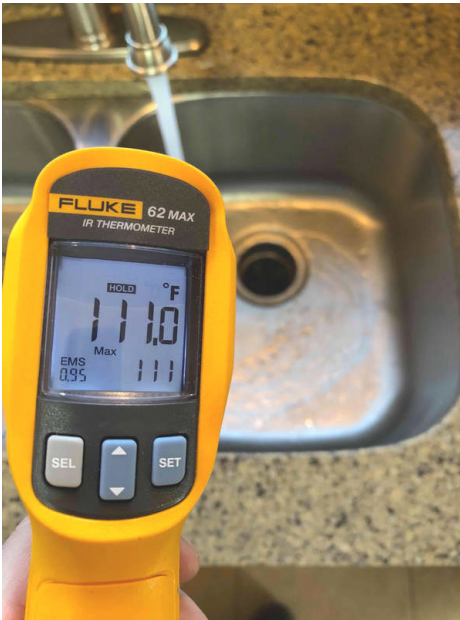
Less than 120°F

The generally accepted maximum safe water temperature to avoid potential scalding is 120F

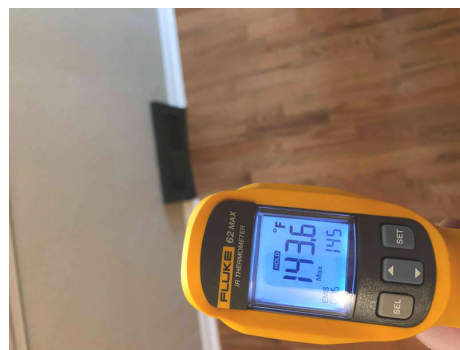
Type Forced air	Location Utility Room	Energy Source/Type Gas
Manufacturer Goodman	Approximate Age 2002	Filter Type Disposable
Filter Size 20x25x1"	Distrabution Central	Recorded Temperature Satisfactory

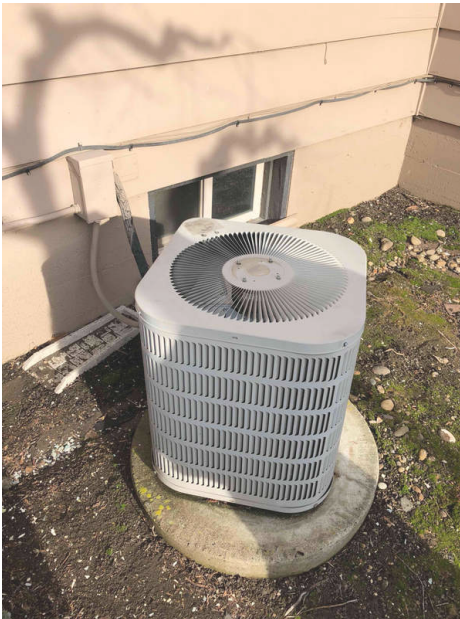
Prolonged operation of a Cooling System below 60°F (outdoor air temperature) may result in damage to equipment. In mild temperature (between 50-60°F) inspector attempts to confirm basic operation of Cooling System by briefly operating but will not operate for a prolonged period of time or attempt to determine Temperature Split. Below 50°F Inspector does not attempt to operate Cooling System but recommends further evaluation by a qualified professional prior to next cooling season.
