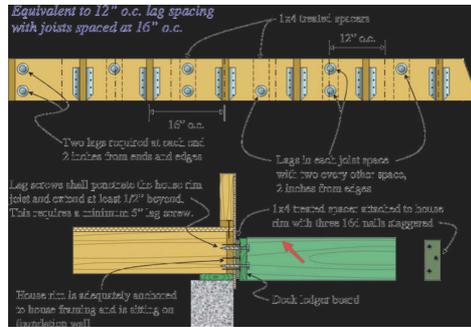
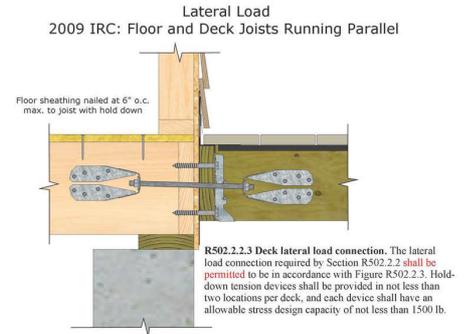
At the time of inspection the deck ledge did not appear to be attached properly to the house. Deck ledger should be designed to resist 3,000 lb. lateral load (force pulling away from ledger) in order to prevent collapse. I recommend a qualified professional evaluate and repair as necessary.

only nails are visible

Recommendation
Contact a qualified deck contractor.

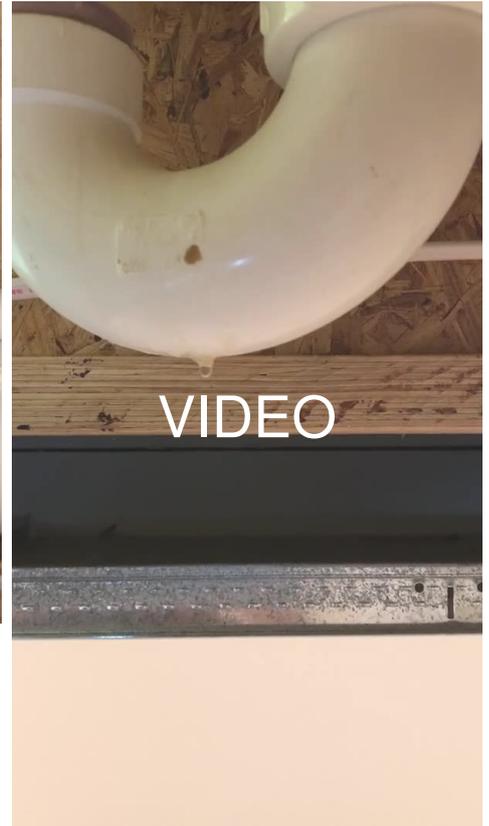
1st Floor shower stall

At the time of inspection I observed an active water leak beneath the 1st floor shower stall. Moisture damage can progress quickly and cause significant damage. I recommend a qualified professional evaluate and repair the leak(s).

Recommendation
Contact a qualified plumbing contractor.
