**SUMMARY**  
1234 Main St. Merrimack NH 03054  
Buyer Name  
03/13/2019 9:00AM

Chris Caisse  
InterNACHI Certified...  
Platinum Home Inspections  
603.897.5495

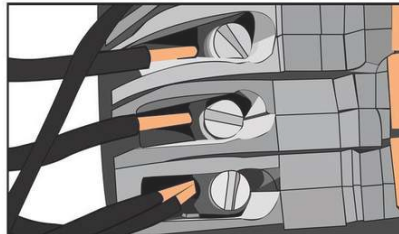
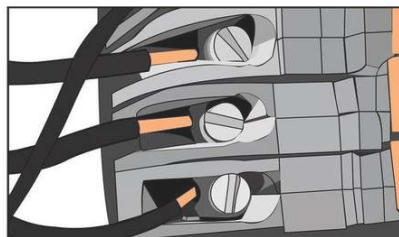
**Double-Tapped Breakers**

Don't

Do

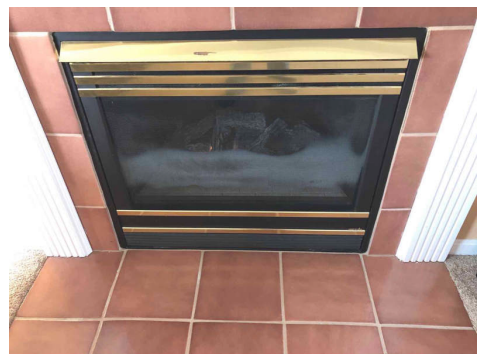
At the time of the inspection, the Inspector observed no deficiencies in the condition of the gas-fueled fireplace in the family room. Full inspection of gas-burning fireplaces lies beyond the scope of the General Home Inspection. For a full inspection to more accurately determine the condition of the fireplace and to ensure that safe conditions exist, the Inspector recommends that you have the fireplace inspected by an inspector certified by the Chimney Safety Institute of America (CSIA). Find a CSIA-certified inspector near you at <http://www.csia.org/search>

Recommendation  
Contact a qualified fireplace contractor.
