**SUMMARY**  
1234 Main St. Jenison Michigan 49428  
Buyer Name  
11/08/2018 9:00AM

Michael Moores  
InterNACHI Certified Home Inspector  
Veteran Inspections & Services  
(616) 379-9388  
michael@veteraninspection.com

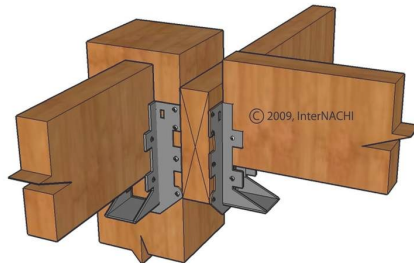
Joist hanger example

**MISSING JOIST HANGER(S)**

The floor joists should be secured to the band joist with appropriately sized joist hangers for proper support. Correction is recommended.

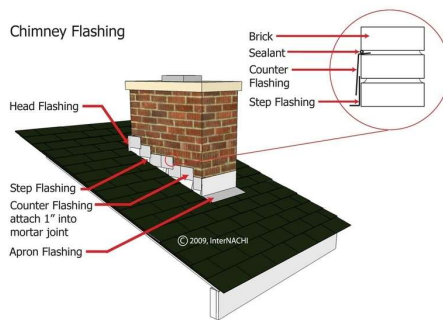
Proper Chimney Flashing Example

Shingles have been installed on top of the chimney flashing which can channel water under the shingles. Correction by a licensed roofing contractor is recommended.

Recommendation  
Contact a qualified roofing professional.
