SUMMARY

1234 Main St. Wheeling WV 26003

Mark Bonar
Certified Master Inspector®
Mountain State Inspections LLC
304-830-3354
wheelinghomeinspector@gmail.com

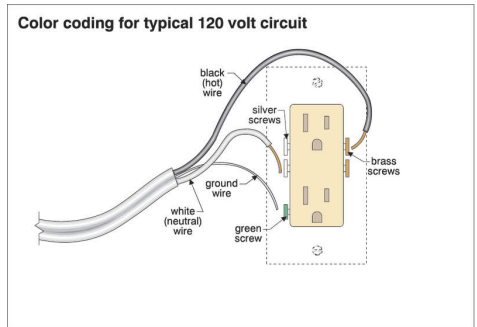
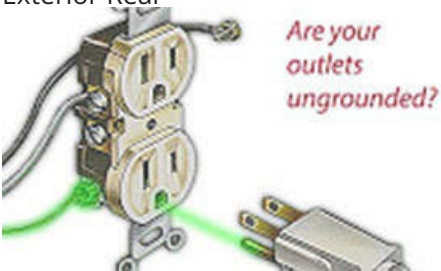
OUTLET REVERSE POLARITY

One or more receptacles have been wired with reverse polarity. This condition should be corrected by a qualified electrical contractor.

Contact a qualified electrical contractor.
