SUMMARY

1234 Main St. Yreka CA 96097

Michael Colombo
CMI, CPI, CCI

Shacks & Shanties Inspection Services
530-598-7856
mike@shacksandshanties.com

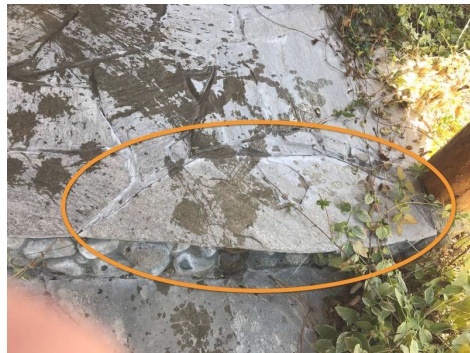
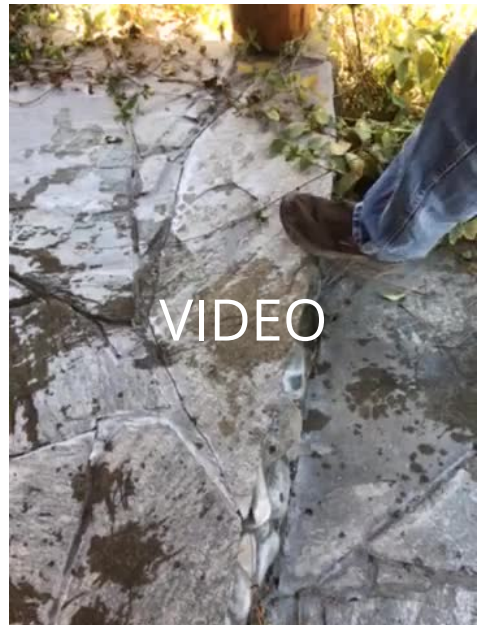
North

DAMAGED

Damaged areas of the walkway were observed. These areas may be a tripping/injury hazard and should be repaired.

Recommendation
Contact a qualified professional.

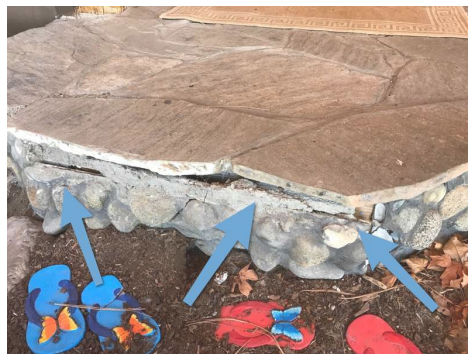
North

DETERIORATION OR DAMAGE

One or more areas of damage or deterioration was observed in the veneer treatment. Recommend repair.

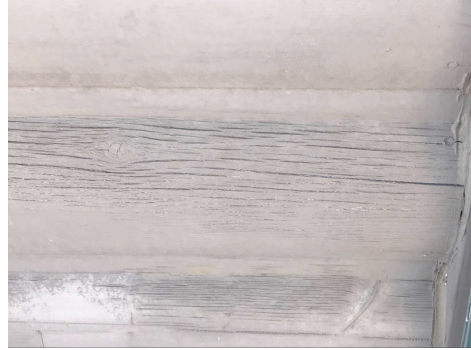
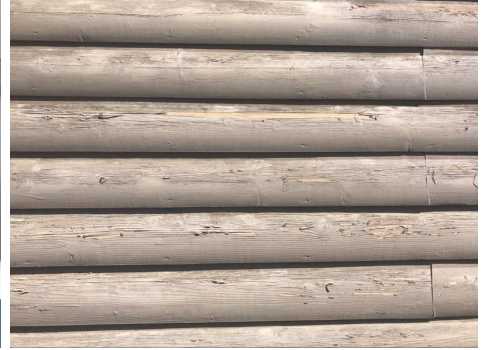
Inadequate clearance between siding and/or trim and ground was observed, with deterioration and/or damage present. Recommend a minimum ground clearance between bottom of siding and ground of 6" to 8". Siding was observed to be in contact with ground, with evidence of wood rot (dry rot). Wood that touches the ground/soil will wick moisture and and start to deteriorate. This also sets up ideal conditions for dry rot to damage wood, and invites wood destroying pests. Recommend soil be pulled away from all trim for a minimum ground clearance between bottom of trim and ground of 6" to 8" and replace and treat areas of dry rot, as necessary.

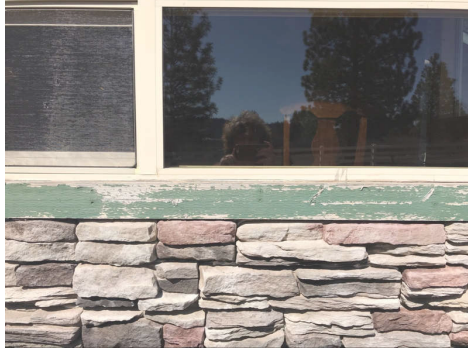
South

Trim was observed to have deteriorated, peeling, missing paint, or seal. Trim that is unsealed and open to weathering will deteriorate and be vulnerable to wood rot (dry rot) conditions. Trim functions as more than an aesthetic accoutrement to the house structure. Trim is an important part of protecting the house structure from water and pest infiltration. Recommend painting or sealing all trim.
