SUMMARY

1234 Main St. Grayslake Illinois 60030

Buyer Name
10/07/2018 9:00AM

John Reim
InterNACHI, CMI
Bee Sure Home Inspection Svcs.
773-425-8275
jrinspect1@comcast.net

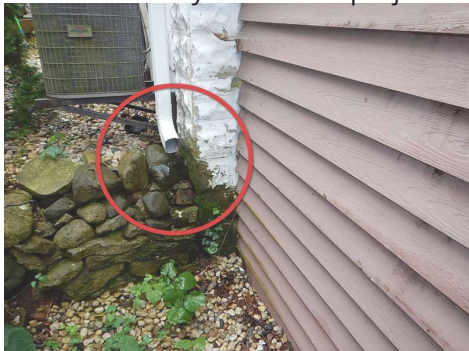
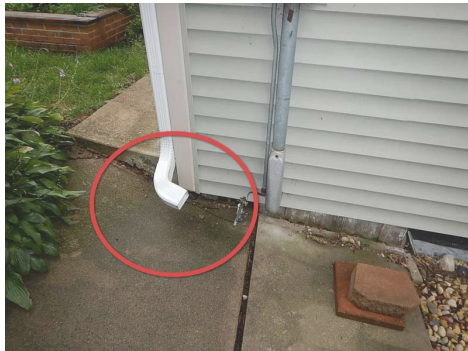
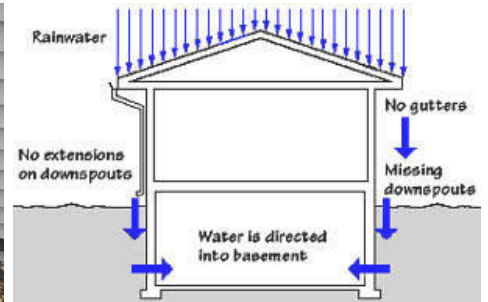
DOWNSPOUTS DRAIN NEAR HOUSE

One or more downspouts drain too close to the home's foundation. This can result in excessive moisture in the soil at the foundation, which can lead to foundation/structural movement. Recommend a qualified contractor adjust downspout extensions to drain at least 4-6 feet from the foundation.

gutters and downspouts

Contact a handyman or DIY project

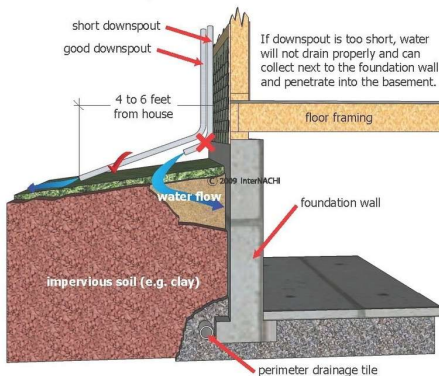
Downspout Extension Too Short

Importance of adequate downspout extensions

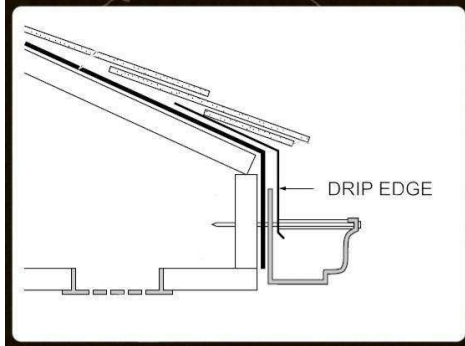
ROOF EDGE FLASHING- IMPROPER OVERLAP

Roof edge flashing was improperly installed in places. When asphalt-saturated felt paper underlayment is used, it should overlap roof edge flashing at the eaves, and be overlapped by the flashing at the rakes. This condition may cause moisture damage to roof sheathing in the affected areas from wood decay and/or delamination. Any corrections should be made by a qualified contractor.

Contact a qualified roofing professional.

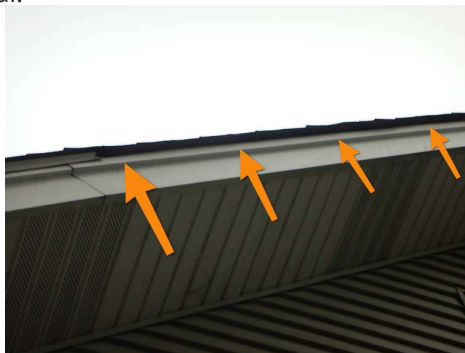
ROOF EDGE FLASHING MISSING

Areas of the roof were missing roof edge flashing. Lack of roof edge flashing leaves the edges of roof sheathing and underlayment exposed to potential moisture damage from wood decay and/or delamination. Water is capable of running behind the gutter systems if no drip edge flashings are installed, which can lead to water damage / rot / decay of the soffit and fascia boards. The inspector recommends replacement of roof edge flashing in areas where it is missing. All work should be performed by a qualified contractor.

missing section of rake edge flashing

Contact a qualified roofing professional.

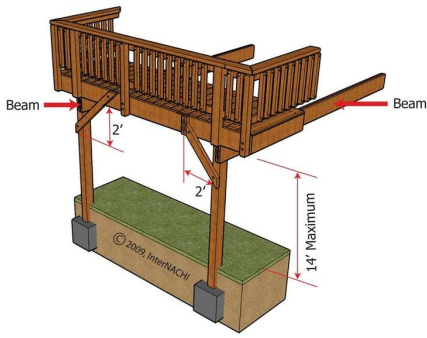
Bracing Perpendicular to Beam

BRACING RECOMMENDED

For elevated deck and porch structures it is strongly recommended that diagonal bracing be installed perpendicular or parallel to the support beams. The bracing will help the deck to resist lateral loads and shifting.

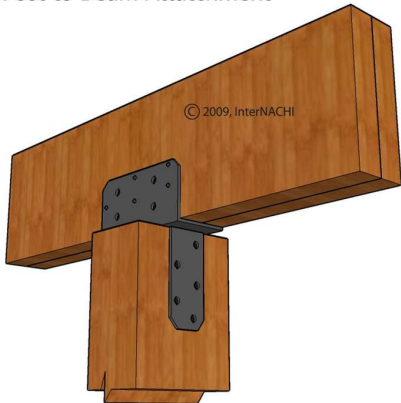
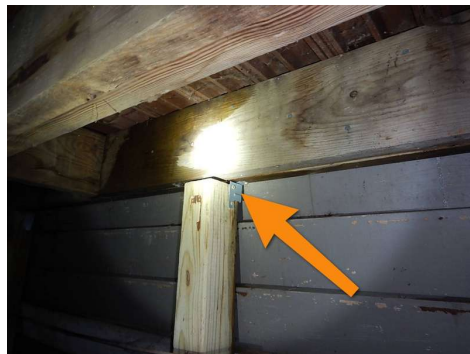
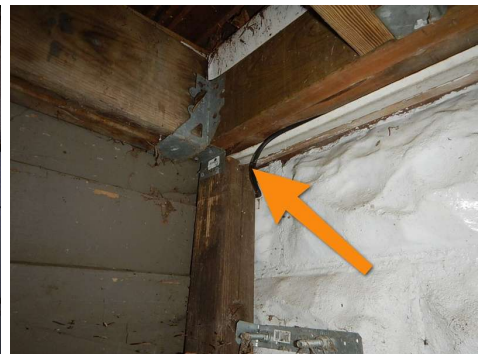
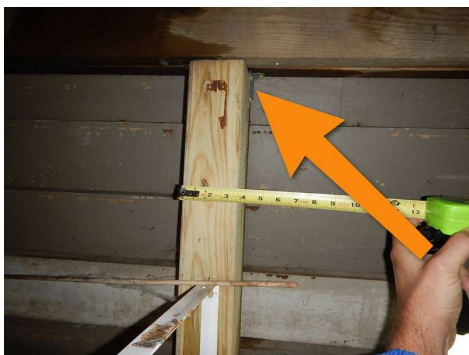
Post to Beam Attachment

DECK - POST TO BEAM / GIRDER CONNECTIONS

The connections between the supporting beams and supporting posts for the deck system do not conform with modern standards for safe deck construction. It is recommended that the connections be evaluated and upgraded by a qualified deck repair specialist to comply with modern and current deck building standards. To prevent beam rotation and resist lateral forces it is recommended that the beam or girder be connected to the supporting deck posts with approved metal connectors and hardware. Though this deck may have been built according to accepted standards at the time of its construction, any recommendations for upgrades or compliance with current standards are ultimately made with your safety in mind, and are recommended for repair.

Contact a qualified deck contractor.

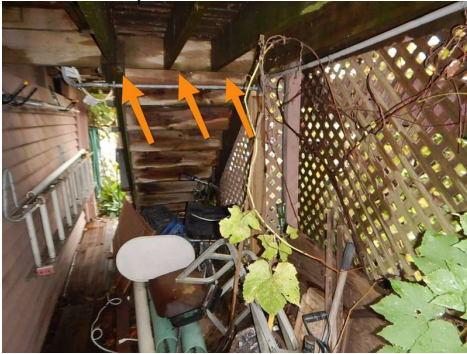
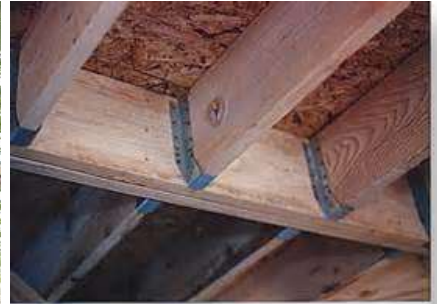
Joist Hangers

Joist hanger(s) are missing or improperly installed. This could cause the deck structure to fail. Recommend that joist hangers be properly installed by qualified contractor. End nailing or toe nailing may not provide adequate attachment.

Contact a qualified deck contractor.

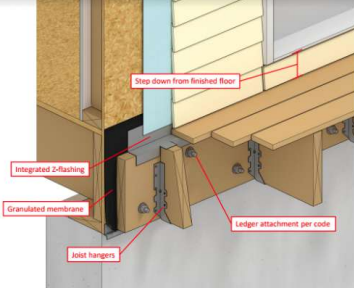
LEDGER BOARD IMPROPERLY INSTALLED

The ledger board is not properly attached to the building. This can cause the deck to pull away from the building and possibly collapse. Recommend that the deck and/or ledger board be properly attached by qualified contractor. Fasteners should be properly spaced and staggered across the length of the ledger board. Flashing is required per current building standards at the ledger to protect from rot / decay and should be strongly considered for older deck systems. Further information on deck construction can be found at: [DCA 6 Prescriptive Residential Wood Deck Construction Guide](#)

Contact a qualified deck contractor.

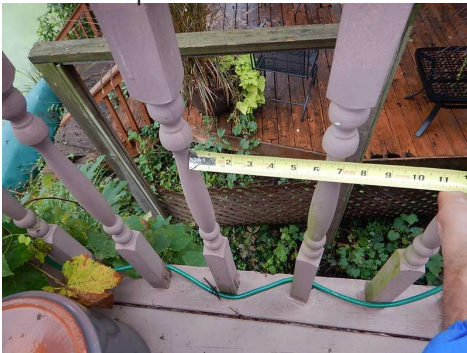
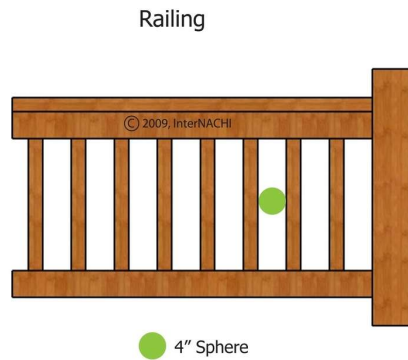
RAILING UNSAFE

There is an unsafe opening in the railing. The spacing on the rail should not exceed 4". An opening greater than 4" is a serious safety hazard especially for children as their head or other body part can become trapped.

Recommendation
 Contact a qualified deck contractor.

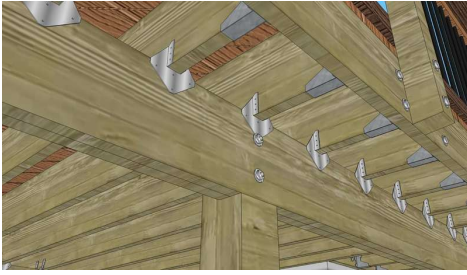
DECK - JOIST TO BEAM CONNECTIONS

The method of attachment observed between the deck joists and the supporting cross beam appears to be inadequate and / or possibly insufficient. Each joist is recommended to be attached to the supporting beam by either toe nailing the joists to the beam AND providing blocking between each joist above the beam to prevent rotation - or - by using approved mechanical fasteners between the joist and beam. Joists may also be installed to the side of the beam with approved hangers, with the tops of the joist being flush with the top of the beam.

Recommendation
 Contact a qualified deck contractor.

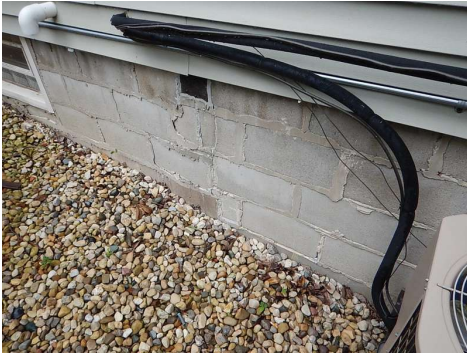
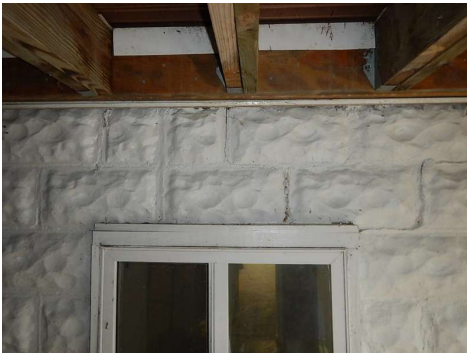
CMU'S - MODERATE CRACKING

Concrete Masonry Unit (CMU) foundation walls had moderate cracking and stepped cracking visible in mortar joints. Cracking should be patched properly to avoid freeze damage and the cause of the cracking should be determined and corrected. It is recommended that you consult with a qualified foundation repair professional or structural engineer before the expiration of your Inspection Objection Deadline to discuss options and costs for stabilization, correction, or needed repairs.

Contact a foundation contractor.

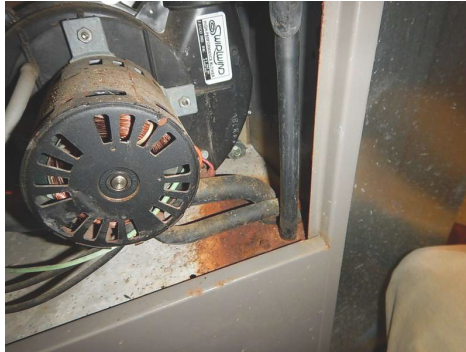
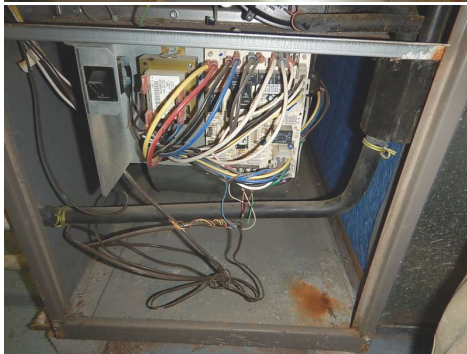
RUST - SIGNS OF LEAKING

There was rusting and corrosion visible inside the furnace cabinet which suggests leakage may be occurring or has occurred in the past from condensate drainage systems.

Recommendation
Contact a qualified HVAC professional.

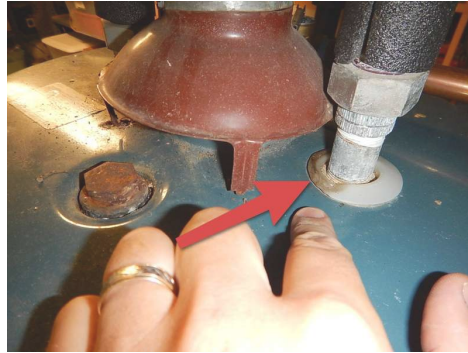
Obtaining combustion air from indoors may be causing some negligible negative pressure inside the home, and may be a contributing factor to the water heater showing signs of back drafting. It is recommended that you consider installing proper piping to obtain combustion air from the exterior of the home to aid in proper venting of flue gases from the water heater.

melted and scorched plastic bushing near water heater draft hood, indicative of back drafting condition

Recommendation
Contact a qualified HVAC professional.

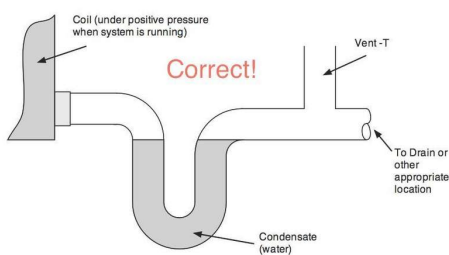
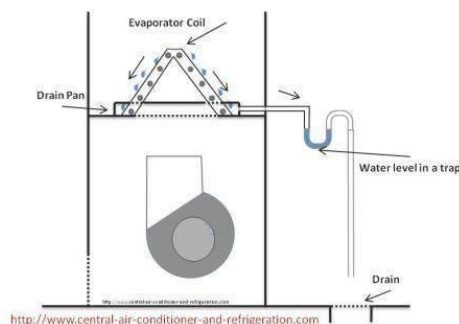
IMPROPER CONDENSATE DRAIN LINE

The installed condensate drain line on the HVAC unit is improperly installed. The line must be provided with a trap and a clean out. Recommend correction to the drain line from qualified HVAC professional.

Recommendation
Contact a qualified HVAC professional.

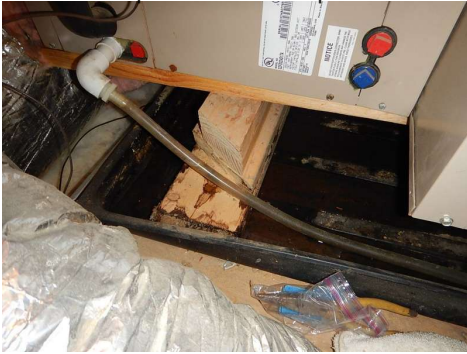
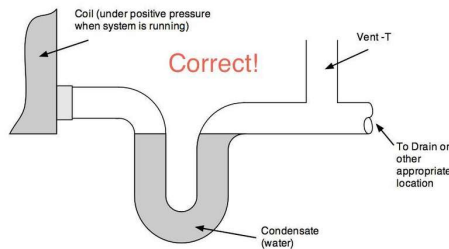
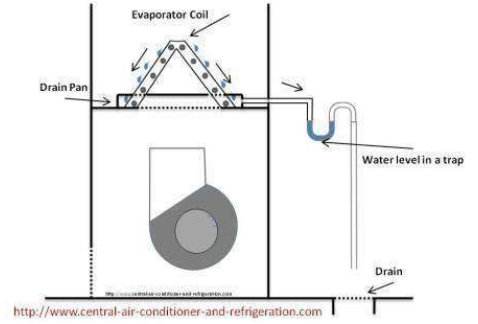
IMPROPER CONDENSATE DRAIN LINE

Contact a qualified HVAC professional.

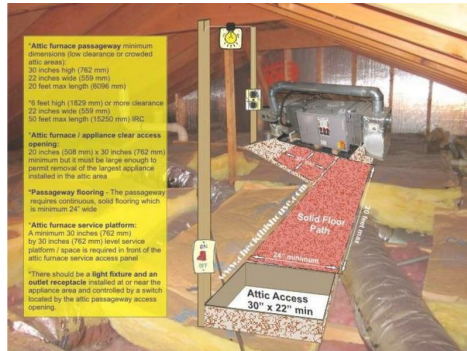
The furnace unit installed in the attic space does not meet modern building and safety standards in regards to a provided pathway and or working platform for servicing or maintaining the unit. It is recommended that a continuous solid pathway be constructed a minimum of 24" wide, and a platform to be installed in front of the furnace for servicing which should be a minimum of 30"x30". The pathway should begin at the entrance to the attic space and be no longer than 20 feet. Lack of adequate pathway and or service platform may create a safety hazard for those who need to access the furnace for service or maintenance, and could result in injury or ceiling damage.

installed pathway and service platform are inadequate and pose a hazard

Recommendation
Contact a qualified professional.

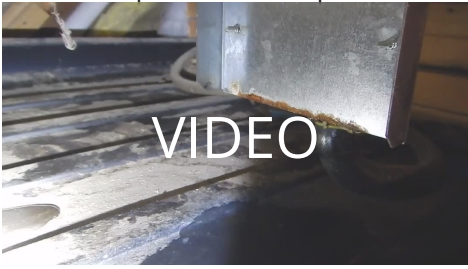
The furnace unit was observed to have an active leak from the condensate drainage systems and is in need of repair from a qualified HVAC professional.

Recommendation
Contact a qualified HVAC professional.

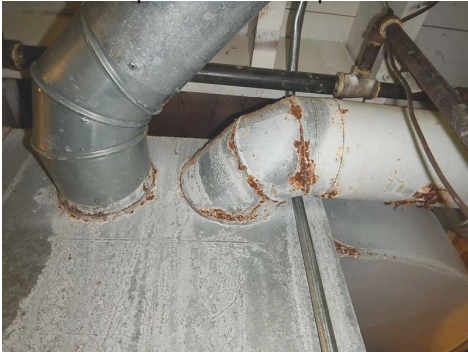
DUCT WORK - CORROSION / RUST

Some of the duct work for the HVAC system was observed to have moderate corrosion and rust present. This may indicate that the duct work is at or nearing the end of its useful lifespan. It is recommended that you have the duct work evaluated by a qualified HVAC professional to determine the extent of any damage or needed repairs / replacements at this time.

Recommendation
Contact a qualified HVAC professional.

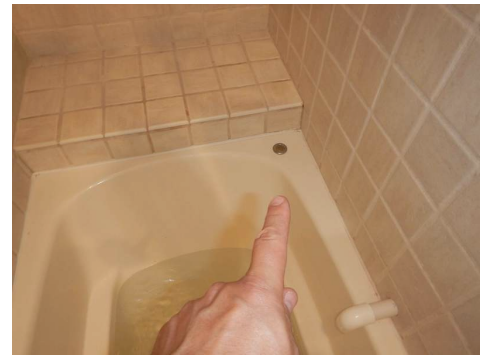
WHIRLPOOL TUB - INOPERABLE

Contact a qualified plumbing contractor.

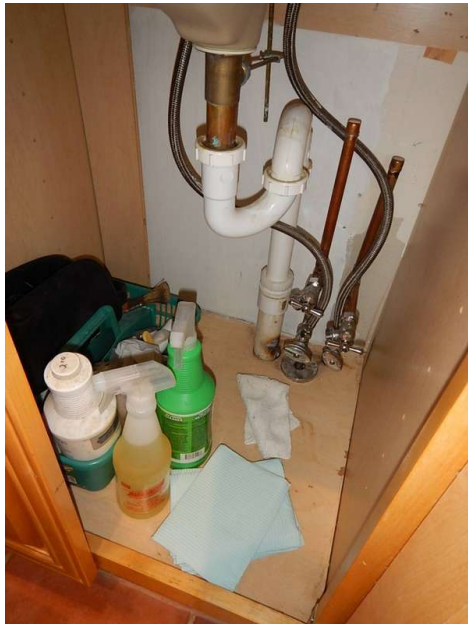
Master Bathroom

S-TRAP

Contact a qualified plumbing contractor.

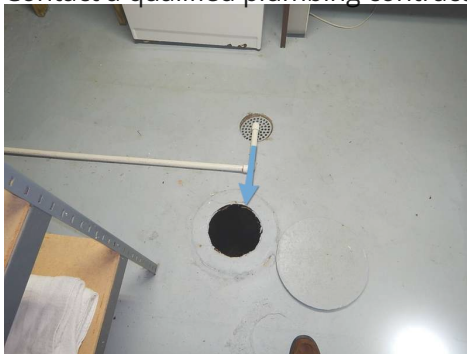
catch basin in use, floor drain is actively discharging to basin

Contact a qualified plumbing contractor.

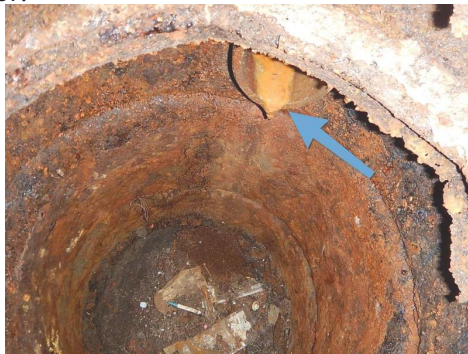
floor drain is actively discharging into a catch basin

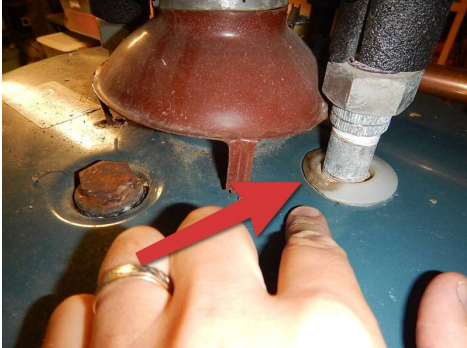
This gas-fired water heater showed evidence of prior backdrafting at the time of the inspection. "Backdrafting" is a condition in which the invisible, odorless, tasteless, toxic products of combustion from the water heater flue leak into the living space. Excessive exposure to these products of combustion can result in injury or death (carbon monoxide hazard). The Inspector recommends that an evaluation and corrections be performed by a qualified plumbing contractor.

scorching / melting of plastic bushing adjacent to draft collar

Contact a qualified plumbing contractor.

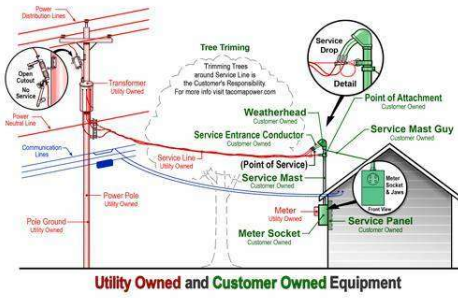
The overhead service-drop conductors were attached directly to the home exterior at the roof. Components anchoring the conductors to the roof appear that they may be inadequate or loose (bulging observed in roofing shingles near anchor point) at the time of the inspection. This could be due to a failing connection, or it could also simply be the way the shingles were installed around the attachment. The Inspector recommends that before the expiration of your Inspection Objection Deadline, you consult with an electrical professional to evaluate the connection and discuss options and costs for any needed correction. Any work on the service conductors should be performed by a qualified personnel only.

Ideally the drip loops should have a minimum 18" of clearance above the roof surface, and your utility provider or electrical contractor may recommend raising the electrical mast to achieve greater roof clearance. Conductors which are too close to the roof may become damaged, or become covered by heavy snowfall.

It appears the shingles may be lifting around the electrical attachment. Further evaluation is recommended. This may just be how the shingles were installed, or could be an underlying problem with the connection coming loose.

Recommendation
Contact a qualified professional.

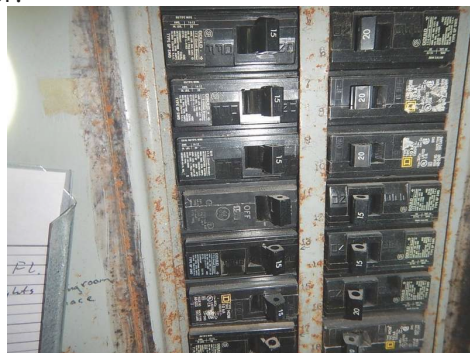
Electrical panel manufacturers stipulate that only their brand of service equipment should be utilized in the electrical panel. For example, General Electric service panels call for use of General Electric brand circuit breakers. The use of other manufacturers equipment in the electrical panel is poor practice, may result in poor connections and fire risks, and will void most panel manufacturers warranties. There were circuit breakers observed to be in use inside the electrical panel(s) which may not be conforming to the panel manufacturer specifications, and further evaluation / replacement is recommended from a qualified electrical professional.

circuit breakers are present which are not manufactured by Gould such as G.E., Square D, and Siemens - evaluate and correct as necessary to conform with panel manufacturer specifications

Recommendation
Contact a qualified electrical contractor.

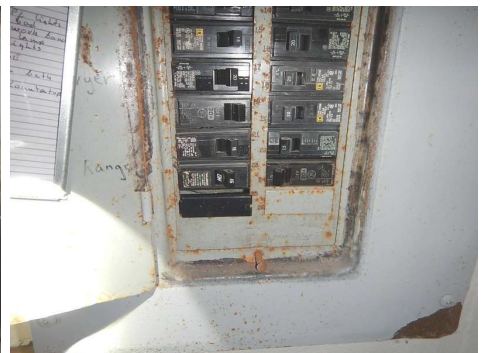
circuit breakers are present which are not manufactured by Gould such as G.E., Square D, and Siemens - evaluate and correct as necessary to conform with panel manufacturer specifications

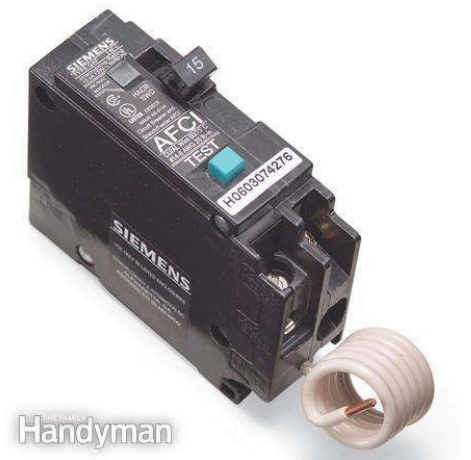
No arc-fault circuit interrupter (AFCI) protection was installed to protect electrical circuits in bedrooms. Safety standards with which new homes must comply require the installation of AFCI protection of all bedroom electrical receptacles. This type of protection is designed to detect electrical arcing, which is a potential fire hazard.

Contact a qualified electrical contractor.

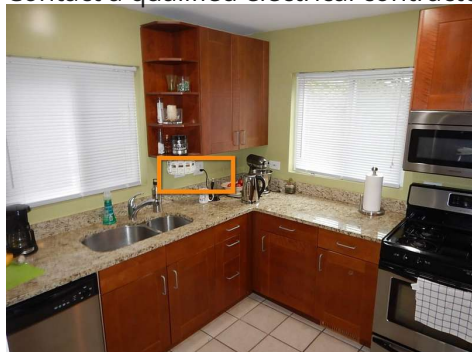
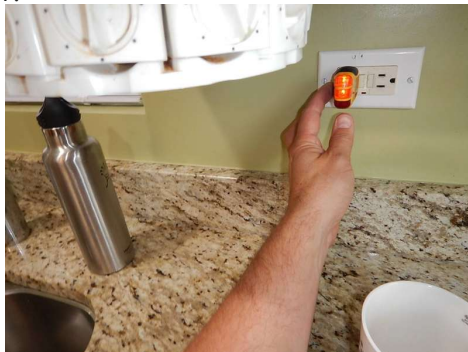
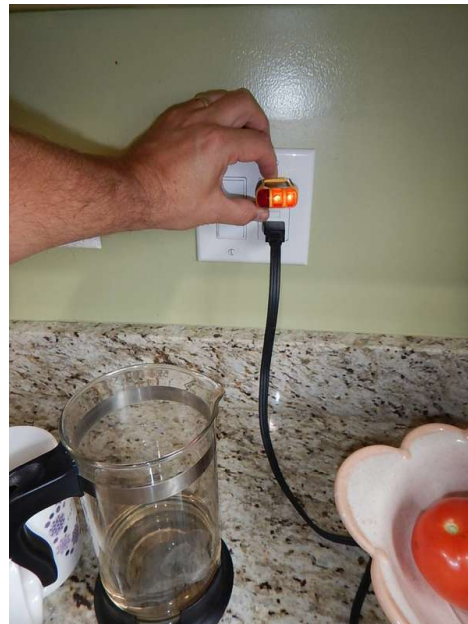
GFCI FAILURE

A ground fault circuit interrupter (GFCI) electrical receptacle did not respond to testing, did not re-set, was slow to re-set or made a buzzing sound when re-set. The Inspector recommends replacement of the receptacle to ensure that it works correctly when required. All work should be performed by a qualified contractor.

Contact a qualified electrical contractor.

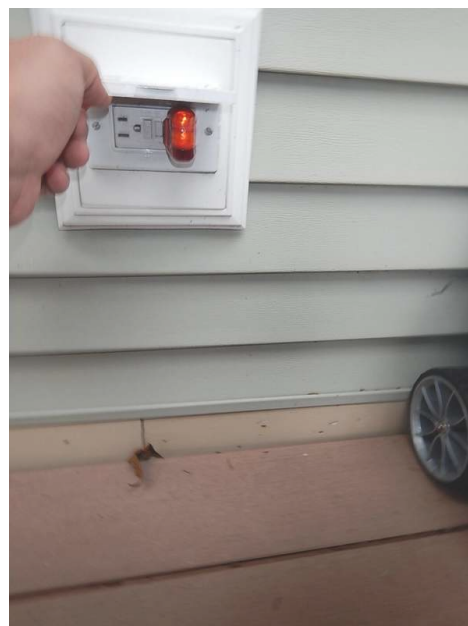
GFCI FAILURE

One or more of the exterior GFCI protected electrical receptacles failed to pass a trip test with our instrument. It is recommended that the receptacle(s) be evaluated for repair or replacement by a qualified electrical professional for your safety. Condition is common on older model GFCI receptacle units as a result of age, or on receptacles which have been improperly installed or miswired.

Contact a qualified electrical contractor.

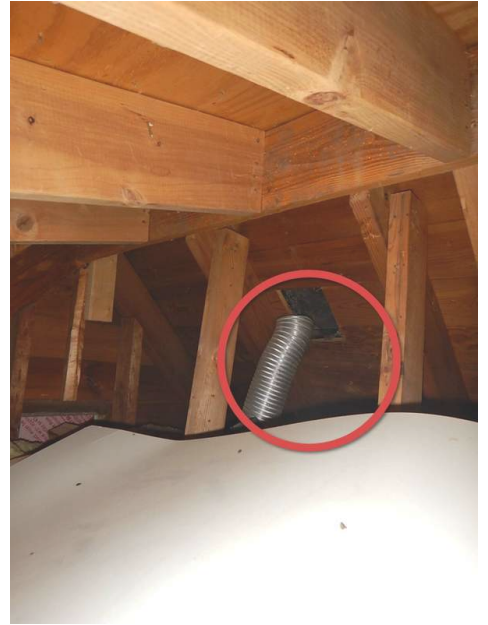
BATH EXHAUST TERMINATES NEAR TOP VENT

Bathroom fan(s) were observed to be terminated near an installed roof top turtle vent. Directional winds can prevent the bath exhaust products from exiting the attic area, which can potentially cause problems with, moisture and mold. Recommend a qualified attic ventilation contractor or roofing professional properly install exhaust fans to terminate to the exterior, via a baffled jack vent.

Contact a qualified roofing professional.

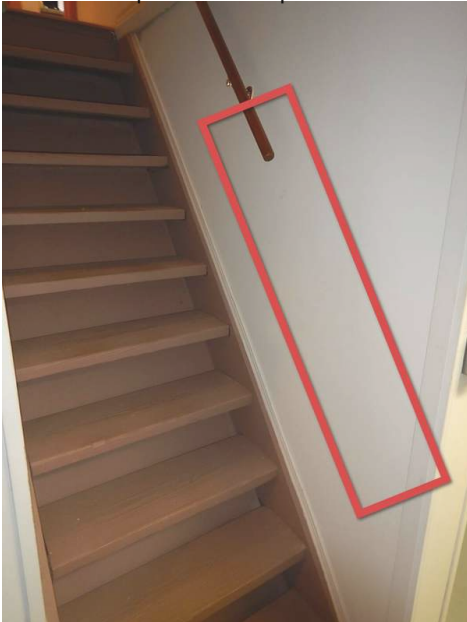
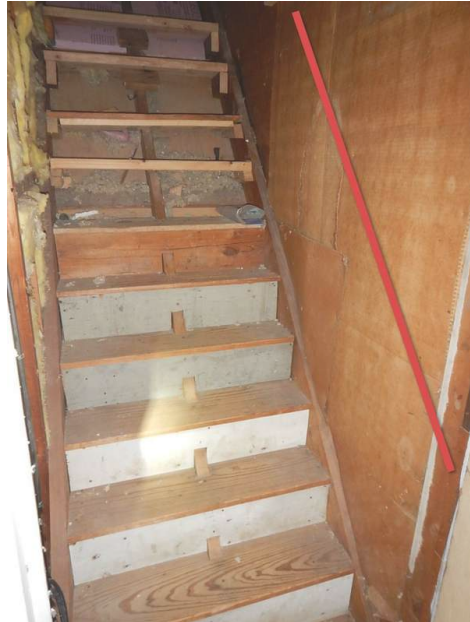
STAIRCASE- NO HANDRAIL

Although it had 4 or more risers, this staircase either had no handrail installed, or existing handrail was observed to be improper. This condition is a potential fall hazard. In order to comply with generally-accepted current standards which require a handrail at staircases with 4 or more risers, this staircase would need a handrail installed. Handrail should be continuous and graspable. The Inspector recommends that a handrail be installed that complies with modern safety standards. All work should be performed by a qualified contractor.

Contact a qualified carpenter.

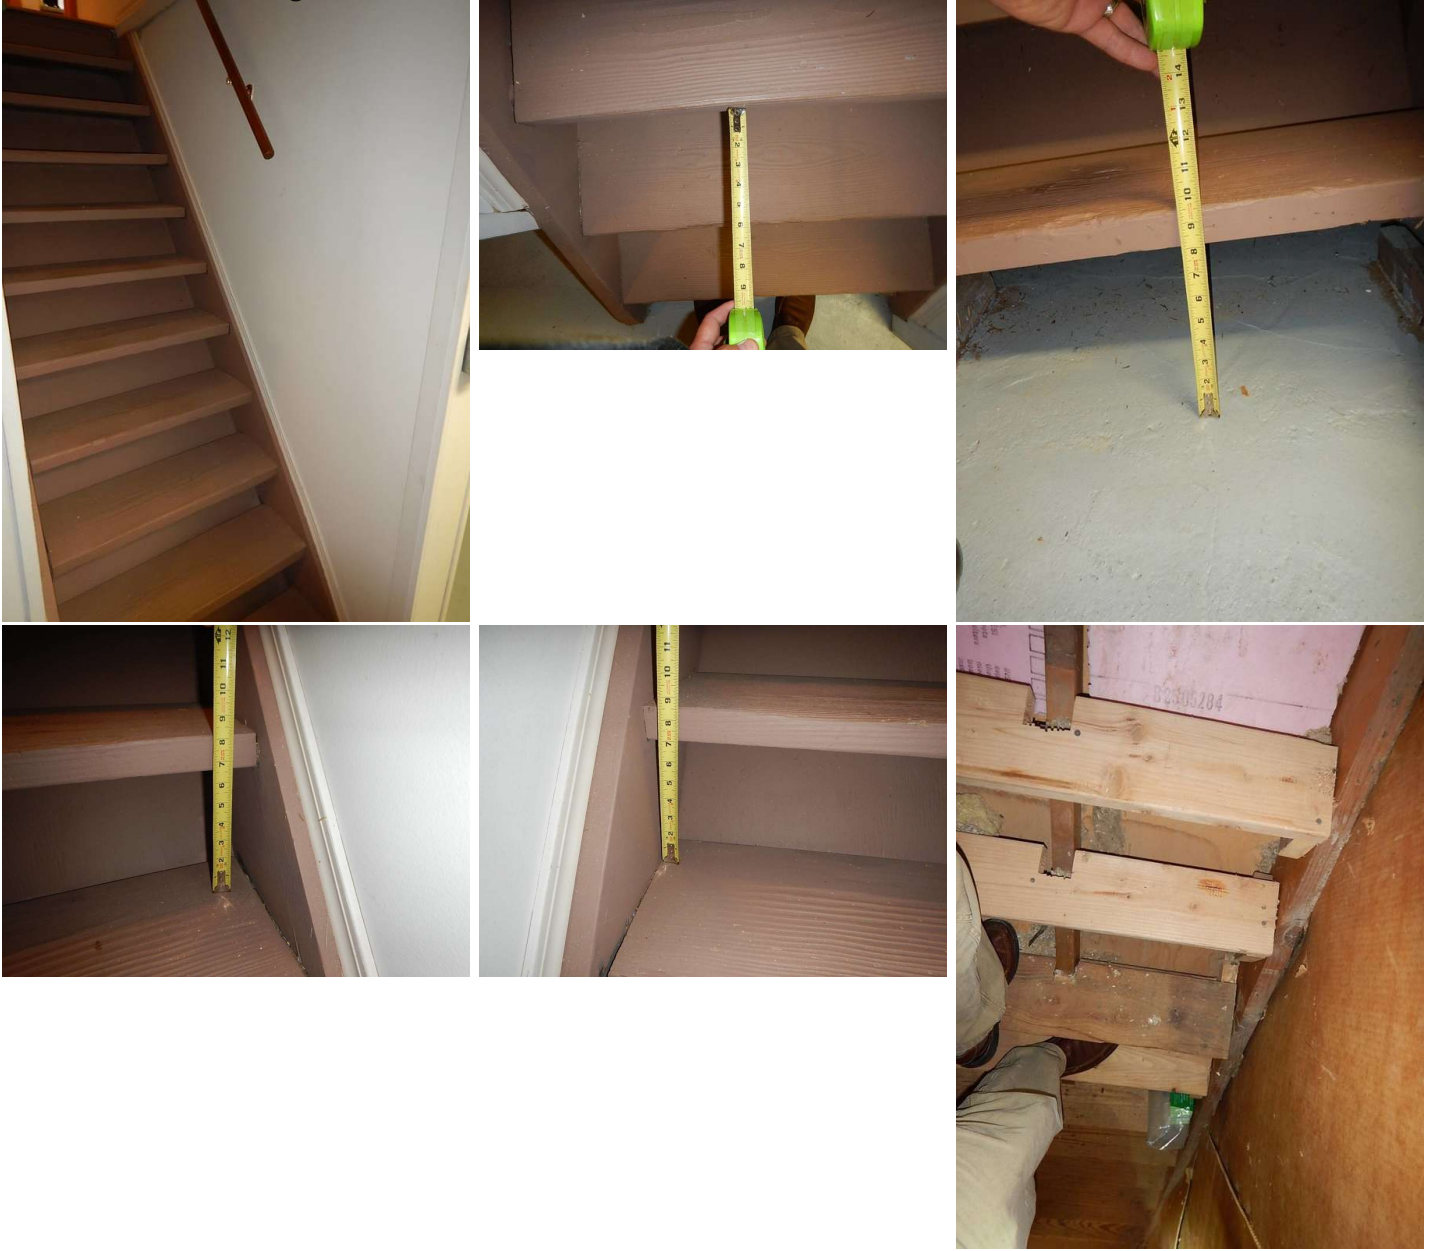
STAIRCASE- NOT COMPLIANT TO MODERN STANDARDS

The staircases were older and will not comply with modern safety standards or modern stair designs. Issues such as tread depth, riser height, steep pitch, and overhead clearances may present possible hazards. You may wish to discuss options and costs for correction from a qualified general contractor.

Recommendation
Recommend monitoring.

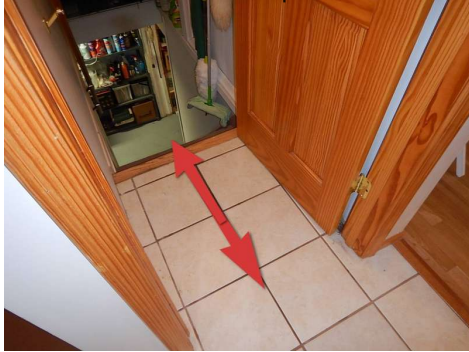
DOOR OPENS INTO STAIRWELL - SAFETY HAZARD

36" minimum landing size, door opening into too small of a landing may pose a hazard

Contact a qualified carpenter.

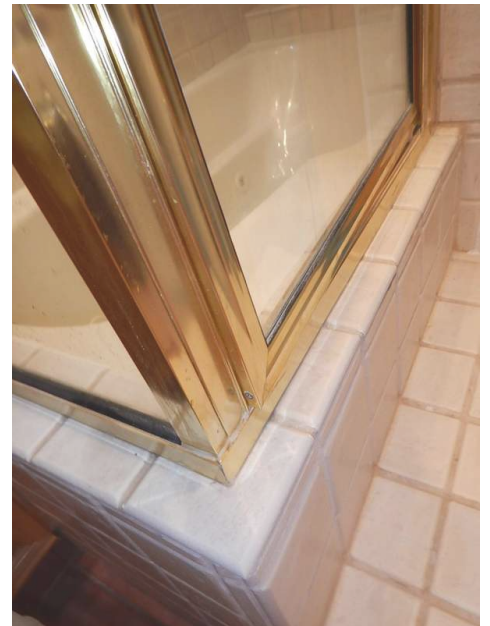
SHOWER DOOR - POOR SEAL

Contact a qualified professional.

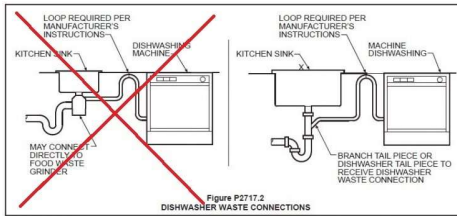
NO HIGH LOOP

High Loop installation - IL prohibits connections to disposers

Contact a qualified plumbing contractor.

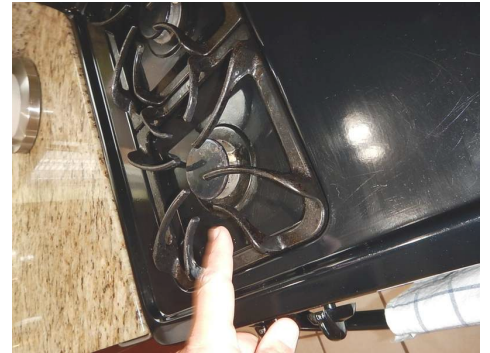
COOKTOP BURNER INOPERABLE

One or more heating elements did not heat up when turned on. Recommend qualified professional evaluate & repair.

Contact a qualified handyman.

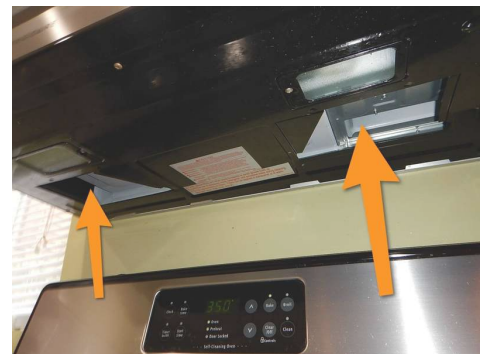
EXHAUST FAN - MISSING FILTERS

Contact a qualified appliance repair professional.

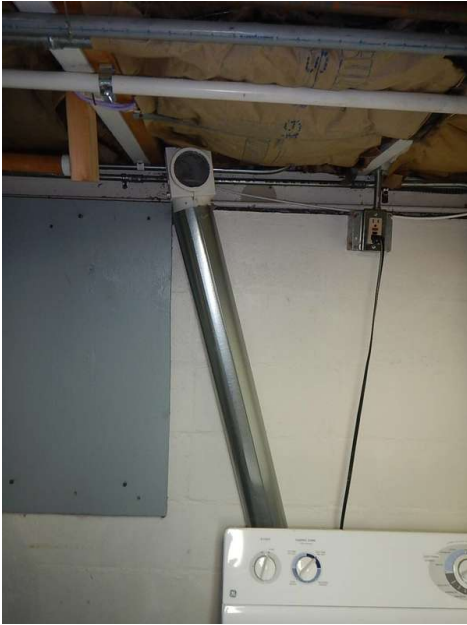
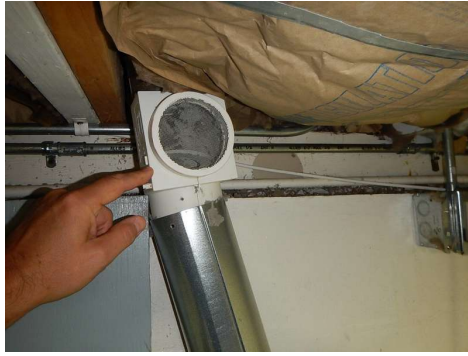
DRYER VENT - OPENING INTO INTERIOR

Contact a qualified appliance repair professional.

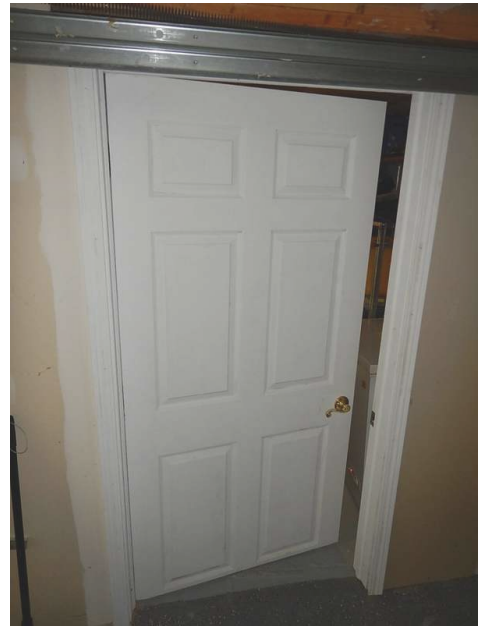
13.6.1 Occupant Door (From garage to inside of home)

Contact a qualified door repair/installation contractor.
