SUMMARY
1234 Main St. Wellington 6022
Buyer Name
10/27/2018 9:00AM

Adam Collins
LBP; NZQA in Carpentry
(advanced), Roofing level 4, Asbestos
Identification
inquest.co.nz
+64 210372132
inquest.kiwi@gmail.com

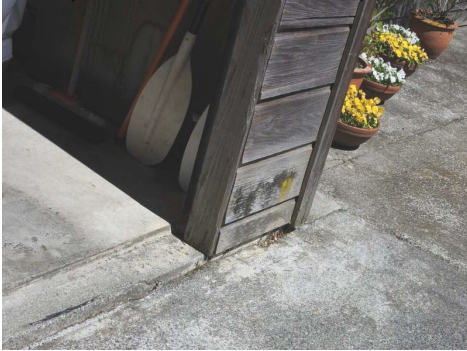
Example of a recommended product.

The driveway has a negative slope and drains towards the structure. Recommend a driveway contractor to install a threshold drain.

Recommendation
Contact a qualified handyman.
Estimated Cost
\$850 - \$1,450
