SUMMARY

1234 Main St. Tempe Arizona 85282

Buyer Name
01/03/2019 9:00AM

Scott Alack
AZ License # 67432
The Dwelling Inspector
480-773-5435
scott@thedwellinginspector.com

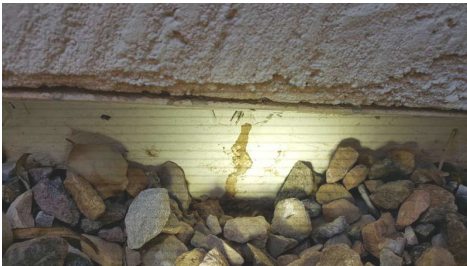
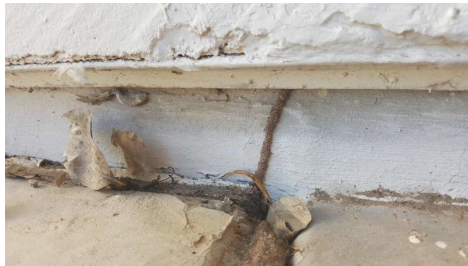
3.1.1 Exterior Wall Cladding

POSSIBLE PRESENCE OF WOOD DESTROYING ORGANISMS

Contact a qualified pest control specialist.

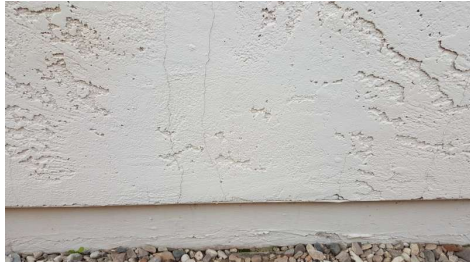
3.1.2 Exterior Wall Cladding

MINOR CRACKS IN STUCCO

Stucco showed cracking in one or more places. This could be a result of temperature changes or building settlement and is typical as homes with stucco age. Recommend a stucco repair contractor to seal and repaint to prevent water penetration.

Contact a stucco repair contractor

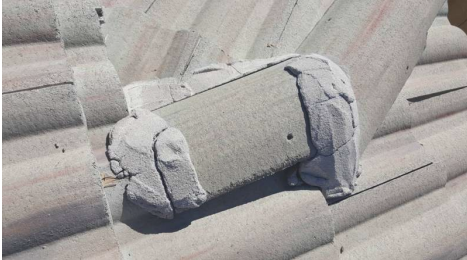
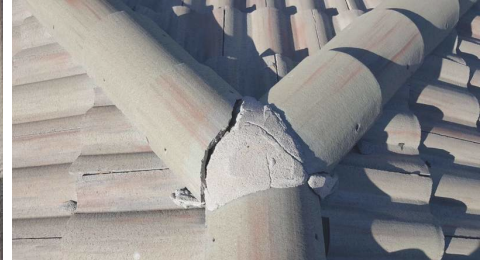
BROKEN CONCRETE MUD BALLS

Several concrete "mud balls" were observed to be broken and in need of repair. Mud balls should be repaired by a qualified roofing contractor to prevent moisture intrusion, leaking, damage and deterioration.

Contact a qualified roofing professional.

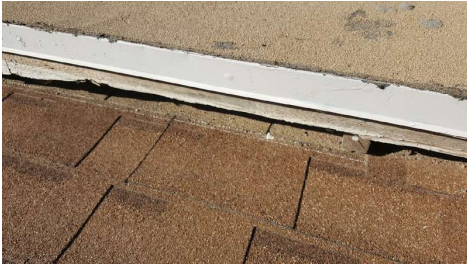
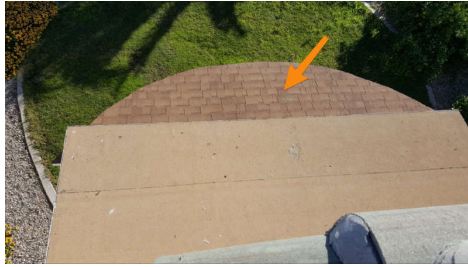
The roof covering material appeared to be inappropriate for the roof slope and may allow water penetration, premature wear, weather damage and other defects. You are encouraged to have a licensed roofing contractor to physically inspect the roof to fully evaluate the condition of the roofing materials.

Contact a qualified roofing professional.

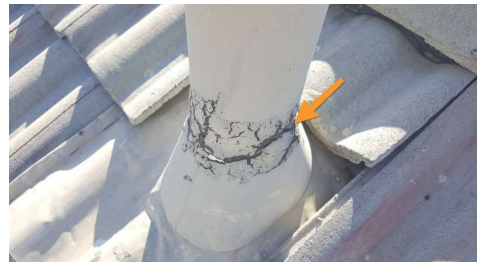
ROOF PENETRATIONS HAD CRACKED SEALANT

Contact a qualified roofing professional.

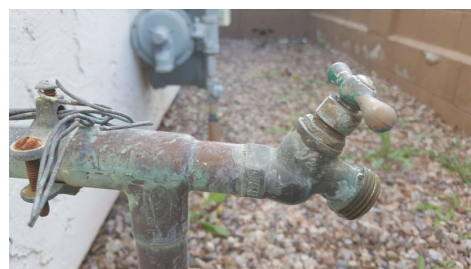
RECOMMEND UPGRADE REPLACING GATE VALVE(S)

Contact a qualified plumbing contractor.

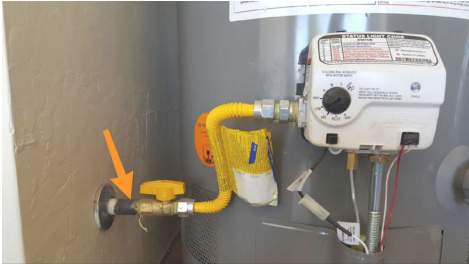
No sediment trap or drip leg was installed. Sediment traps and drip legs are installed to keep particulates and moisture out of the gas valve. Particulates or moisture in the gas valve can interfere with water heater burner operation. The Inspector recommends installation of a sediment trap/drip leg by a qualified plumbing contractor.

Recommendation
Contact a qualified plumbing contractor.

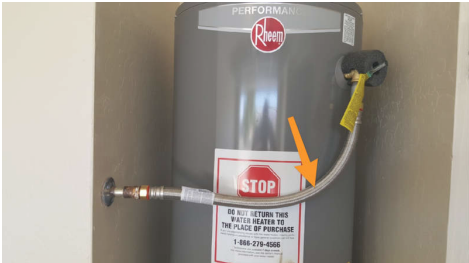
5.6.3 Water Heater

IMPROPER DISCHARGE PIPE MATERIAL

The discharge pipe of the water heater temperature/pressure relief (TPR) valve was of an improper material. TPR discharge pipes should be galvanized steel, copper pipe, or CPVC. The Inspector recommends correction by a qualified contractor.

Recommendation
Contact a qualified plumbing contractor.

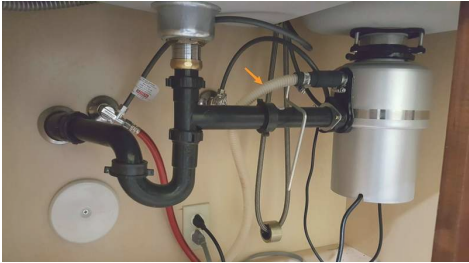
There is no air gap or high loop in the discharge line from the dishwasher to the garbage disposal or drain. Implication: Grey water from the sink can back up into the dishwasher and can subsequently contaminate dishes and/or flood the floor.

Recommendation
Contact a qualified appliance repair professional.

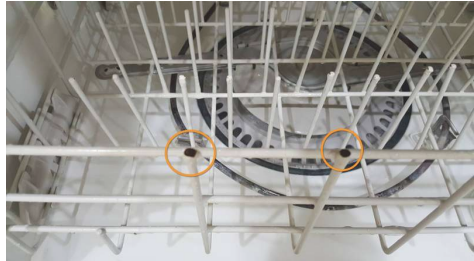
11.4.2 Dishwasher

RUST OR DISCOLORATION

Rust or discoloration was present at the interior of the dishwasher walls and/or racks that are an indication of wear, age or other defects. The dishwasher may be an older component and the future life expectancy cannot be determined. you can continue to use and service this component until replacement is necessary.

Recommendation
Recommend monitoring.

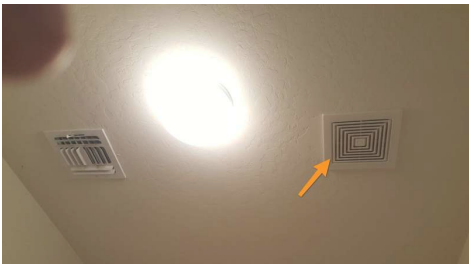
11.14.1 Laundry Exhaust Fan

EXHAUST FAN WAS DIRTY

The exhaust fan in the laundry room was dirty and needs to be cleaned. Recommend cleaning by a qualified professional.

Recommendation
Contact a qualified professional.

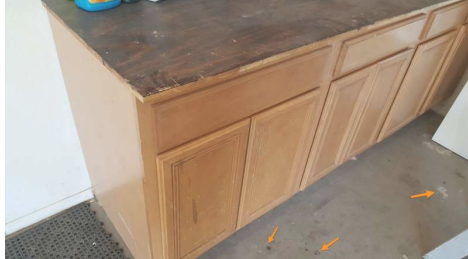
12.1.1 Floor
STAINING

Garage floor shows visible staining from oil/grease and paint. Recommend scrubbing with a degreaser or cleaning solution.

Recommendation
Recommended DIY Project
