SUMMARY

1234 Main St. Tempe AZ 85284

Aaron Westman
AZ #68161, NACHI18091738
22 HOME INSPECT LLC
(480) 506-6610
westman.a@22homeinspect.com

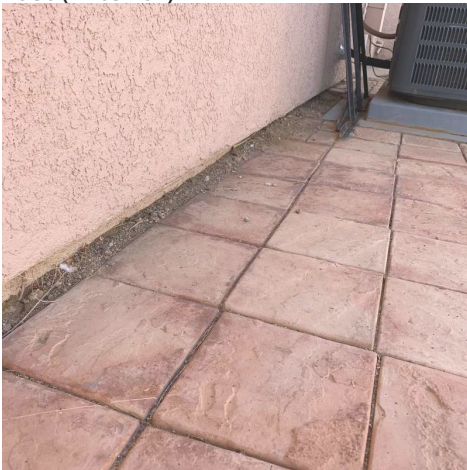
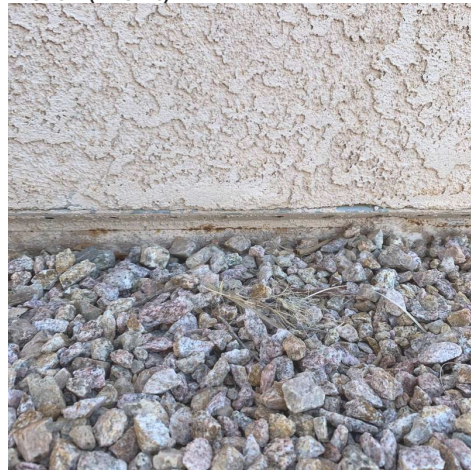
North (Front)

STUCCO SIDING - MINOR THERMAL CRACKING

OBSERVED AROUND ENTIRE HOME

The stucco covering exterior walls showed widespread minor cracking. This type of cracking, called "thermal cracking" is typically due to internal stresses created by temperature changes. It is common as stucco ages and is currently a cosmetic concern, not a structural problem. However, recommend continuing monitoring and cracks exceeding 1/16-inch in width should be filled with an appropriate material to minimize future damages.
