SUMMARY

1234 Main St. Roanoke VA 24018

Brian Cullop
VA LIC#3380001082
Ace Home Services LLC
540.293.6622
brian@theacecrew.com

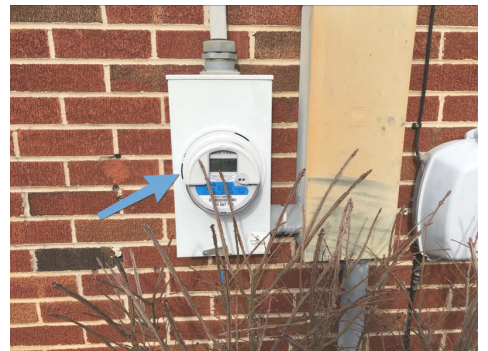
5.3.1 Electric Meter

METER OK

At the time of the inspection, the Inspector observed no deficiencies in the condition of the electric meter. Electric meters are installed by utility companies to measure home electrical consumption.

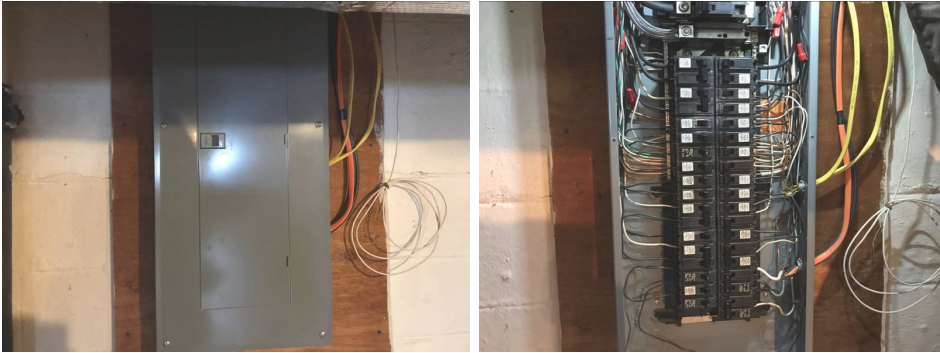
5.4.1 Service Entrance Conductors

INSPECTED AT PANEL

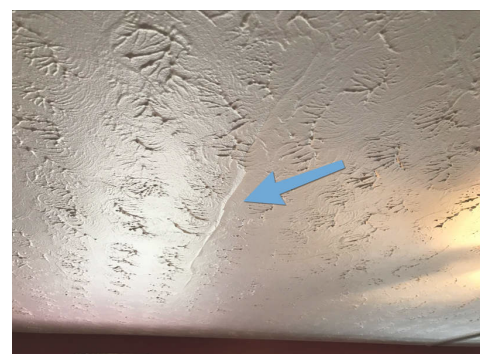
At the time of the inspection, the Inspector observed few deficiencies in the condition of the home ceilings. Any exceptions will be listed in this report.

Contact a qualified professional.

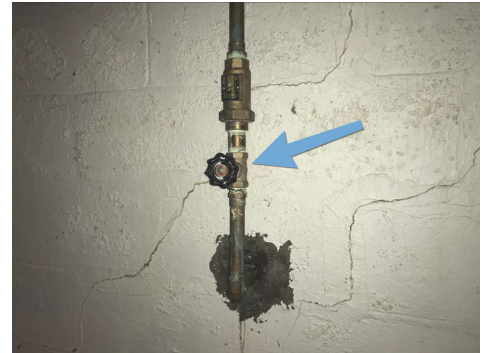
At the time of the inspection, the Inspector observed no deficiencies in the condition of the main water supply shut-off valve. It was not operated but was visually inspected.

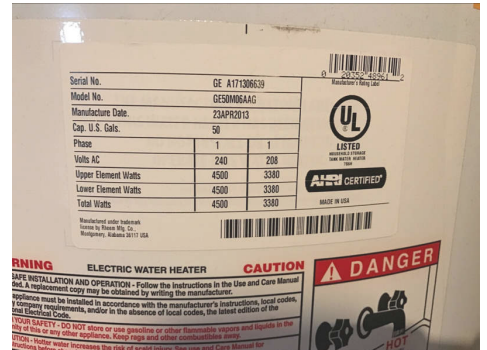
7.6.1 Electric Water Heater

PHOTO

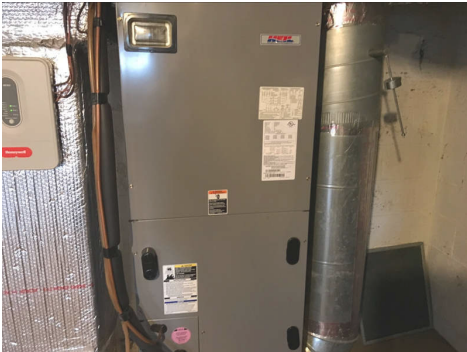
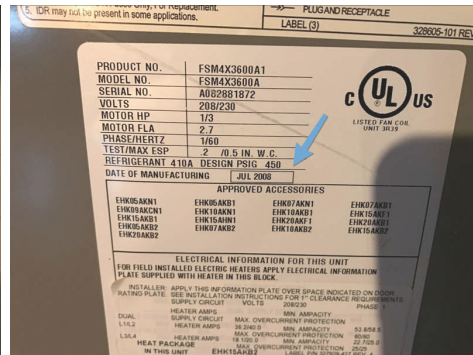
8.2.1 Furnace

FURNACE OK

At the time of the inspection, the Inspector observed no deficiencies in the condition of this furnace. Inspection of the furnace typically includes examination/operation of the following:

11 years old

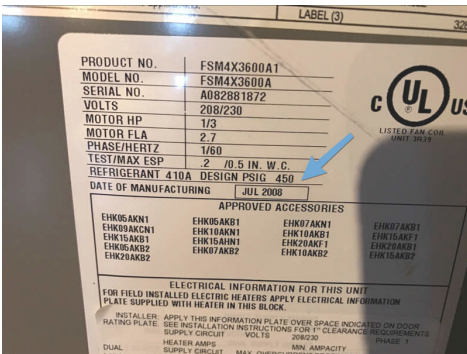
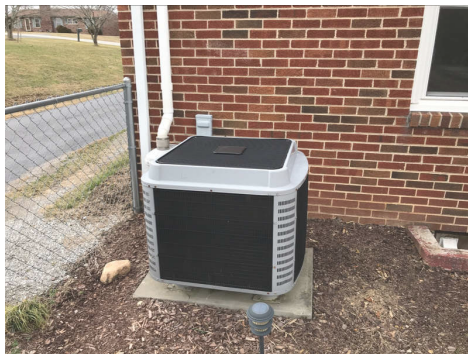
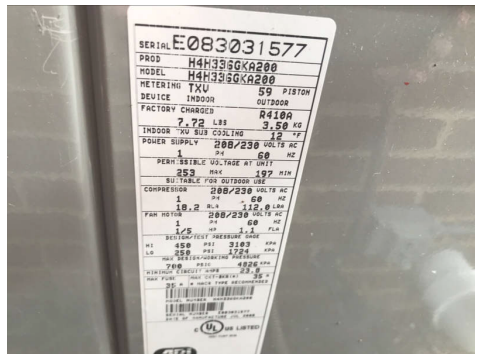
14.1.1 Central Air Conditioner

Information from the air-conditioner label/data plate is shown in the photo.

Did not operate due to temp

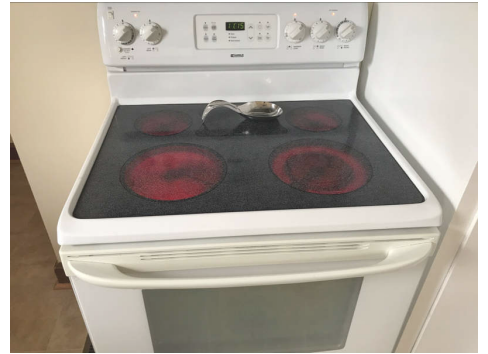
The range was electric. Inspection of electric ranges is limited to basic functions, such as testing of the range-top burners, and bake/broil features of the oven.

Contact a qualified professional.

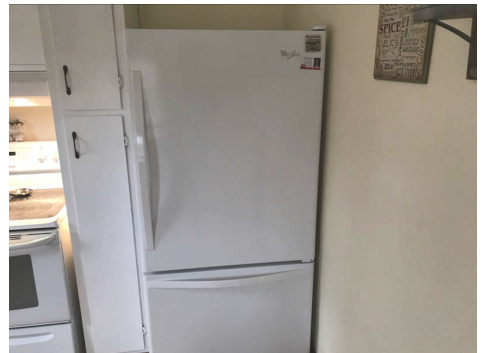
At the time of the inspection, the Inspector observed no deficiencies in the condition of the refrigerator.
