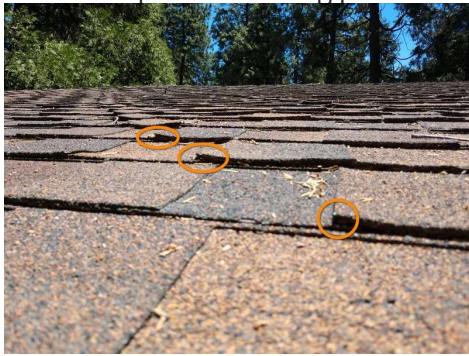
2.1.1 Coverings

**CURLING**

GARAGE, CARPORT, HOUSE

Observed the roof covering to be curling at the corners and edges. This is a sign of age and also the effects of moisture beneath.

Recommend further evaluation by a licensed roofing contractor.

Contact a qualified roofing professional.

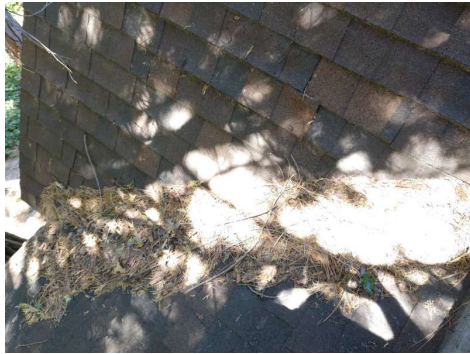
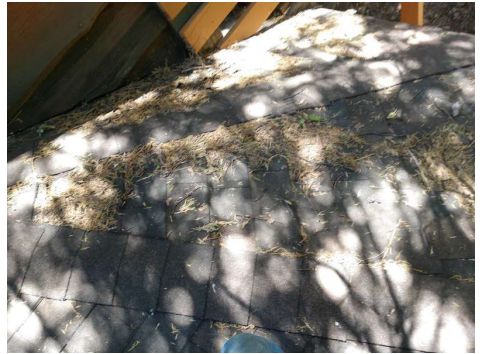
2.1.2 Coverings

**DEBRIS**

AREAS UNDER AND NEAR TREES.

Debris observed on roof surface. Recommend removal.

Contact a qualified roofing professional.

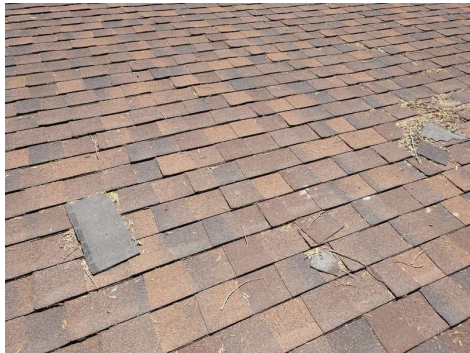
2.1.3 Coverings

**DAMAGED (GENERAL)**

RIDGES, LOWER PITCHED ROOFS.

Roof coverings showed moderate damage. Recommend a qualified roofing professional evaluate and repair.

Contact a qualified roofing professional.

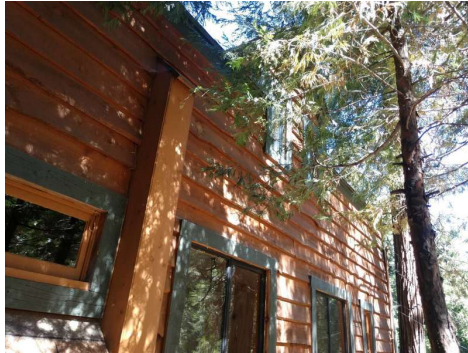
Tree branches are in contact with roof covering and structure. Tree limbs and branches can physically damage the wall coverings and roof coverings and can drop debris that can block valleys and gutters and hasten the deterioration of roof coverings. Tree limbs and entire trees can fall during high wind events.

Recommend evaluation and correction by licensed tree contractor.

Contact a qualified tree service company.

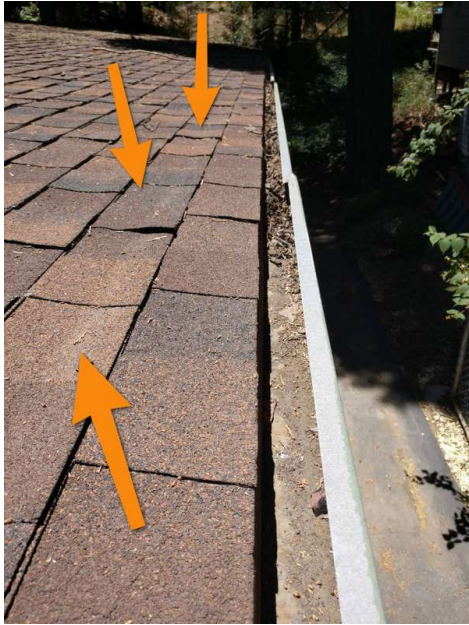
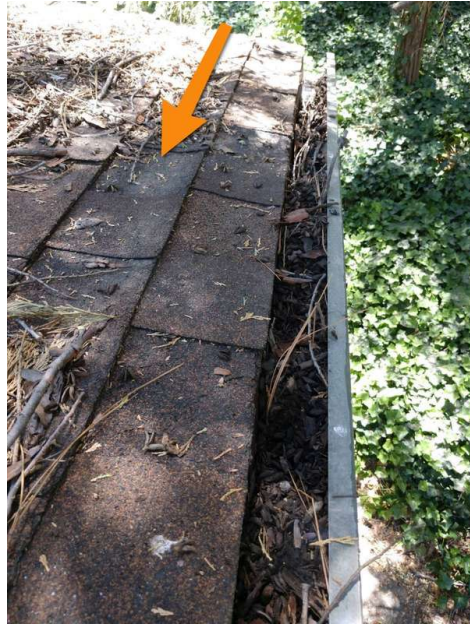
## 2.1.9 Coverings

### **PONDING**

Observed ponding in one or more areas of roof. Ponding can lead to accelerated erosion and deterioration.

Recommend a qualified roofing contractor evaluate and repair as needed.

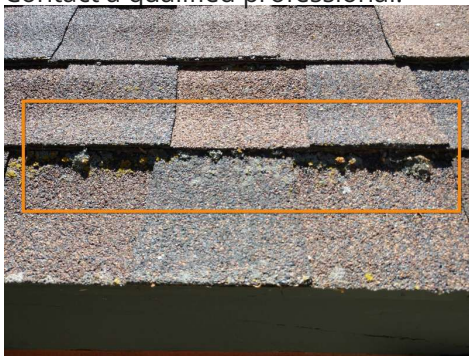
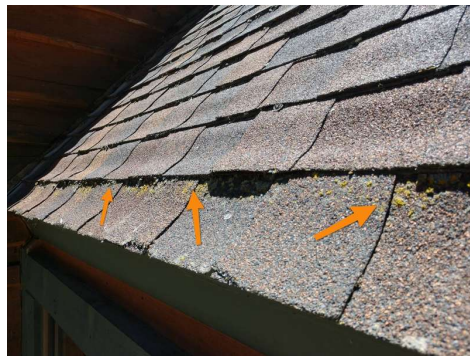
### 2.1.10 Coverings

## BIOLOGICAL GROWTH

Observed biological growth (moss) on the roof covering. It is there because there is enough moisture and shade to support its needs. It is neither a health hazard nor exceedingly damaging to the roof material per several manufacturers, however retained moisture on a roof is a potential issue.

Recommend evaluation by a licensed roofing contractor.

Contact a qualified professional.

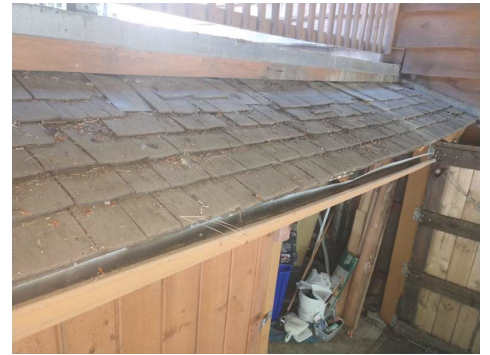
**GUTTER LOOSE**

The gutter is loose and needs to be re-fastened to fascia and pitched properly.

Recommendation  
Contact a qualified gutter contractor

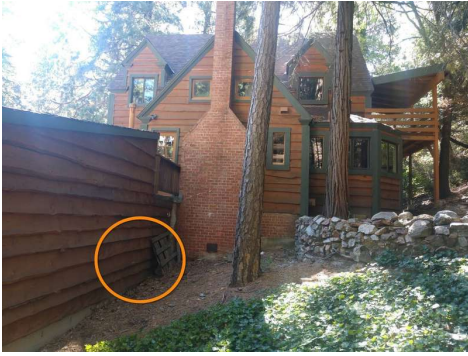
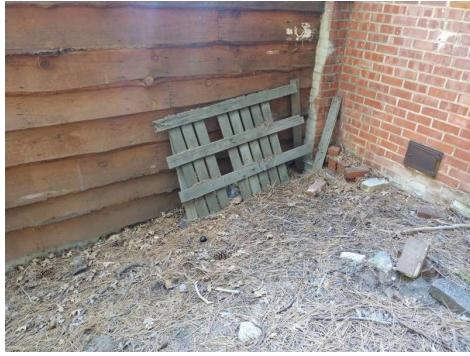
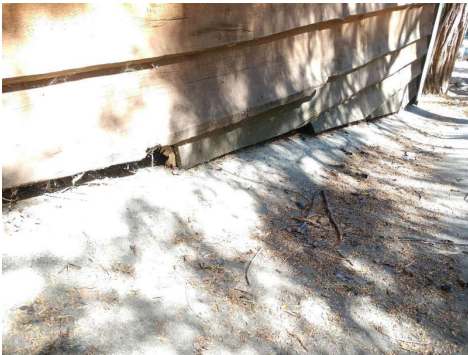
#### **INADEQUATE GROUND CLEARANCE**

Inadequate clearance between siding and ground. Recommend a minimum ground clearance between bottom of siding and ground of 2" to 4". Siding in contact with the ground or soil is a serious concern, the reasoning is that condition can provide direct access for wood destroying insects and excessive moisture absorption.

Recommend clearing soil and ground cover away from the siding where necessary, and trimming the siding as needed at concrete flat work. Consult a licensed siding contractor if this is not a DIY project.

Contact a qualified siding specialist.

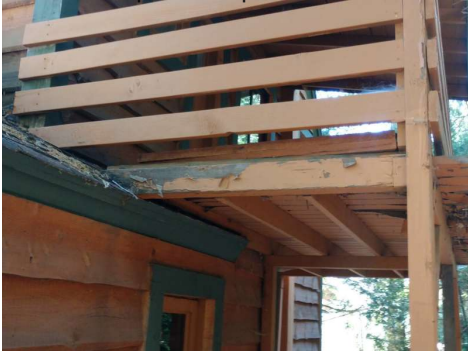
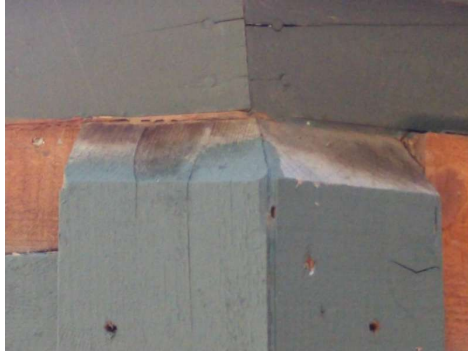
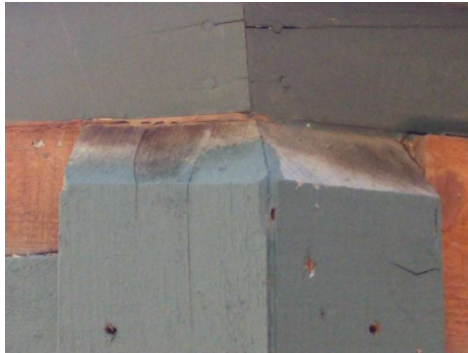
**PAINT DAMAGE**

Recommend evaluation and correction by a licensed painting contractor.

Recommendation  
Contact a qualified painter.

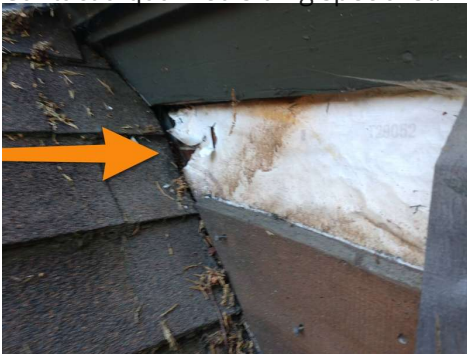
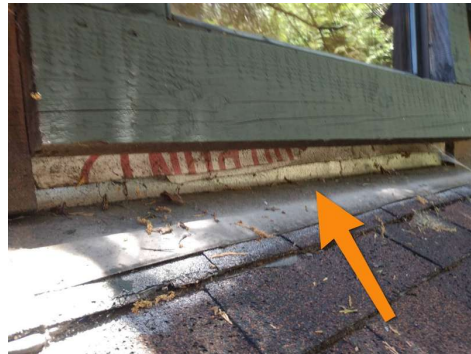
### 3.1.5 Siding, Flashing & Trim

#### **SPLITTING**

Contact a qualified siding specialist.

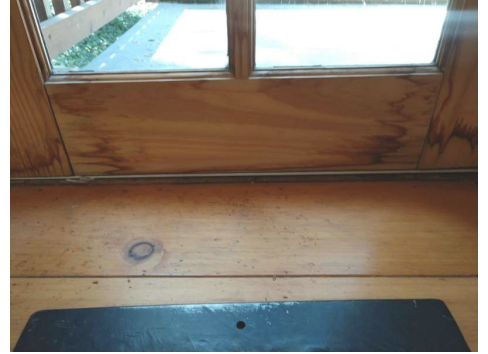
### 3.3.3 Exterior Doors

#### **PAINT/REFINISH NEEDED**

Recommended DIY Project

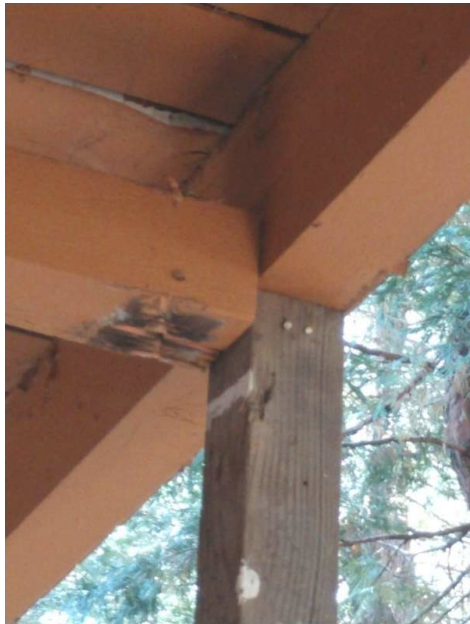
No mechanical fastener securing base to post.

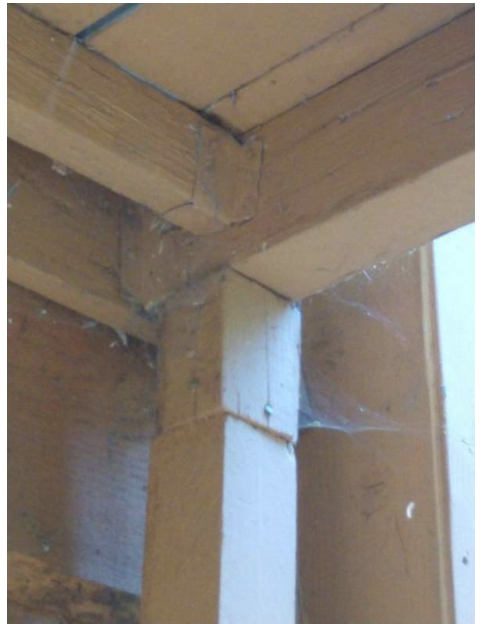
Post is not supporting the load of this framing member.

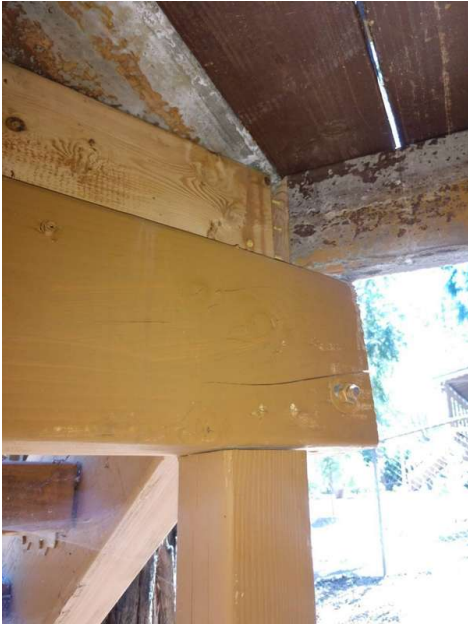
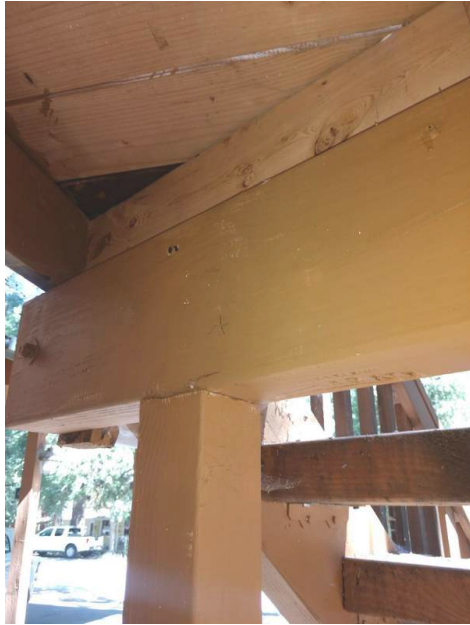
An extension was added to this post supporting the load of a deck.

The post to beam connection should be in a bracket that provides a more secure attachment. The stair stringers should be mechanically fastened by use of a bracket, lag or machine bolts.

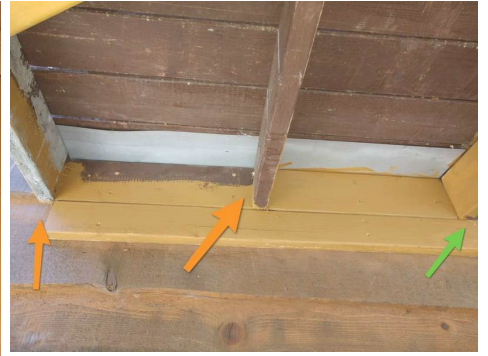
Orange arrows indicate unsupported deck joists. The green arrow indicates a supported deck joist.

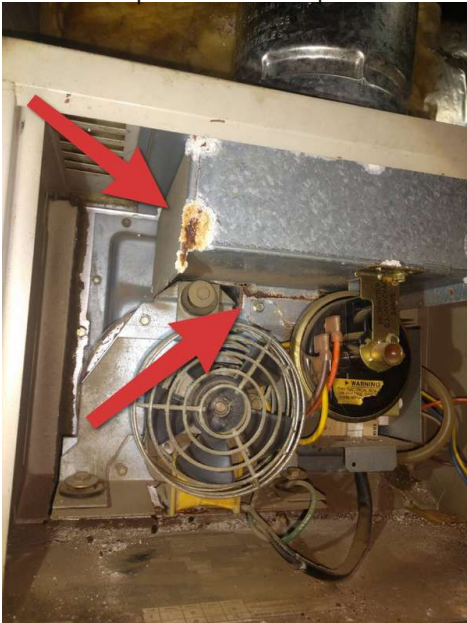
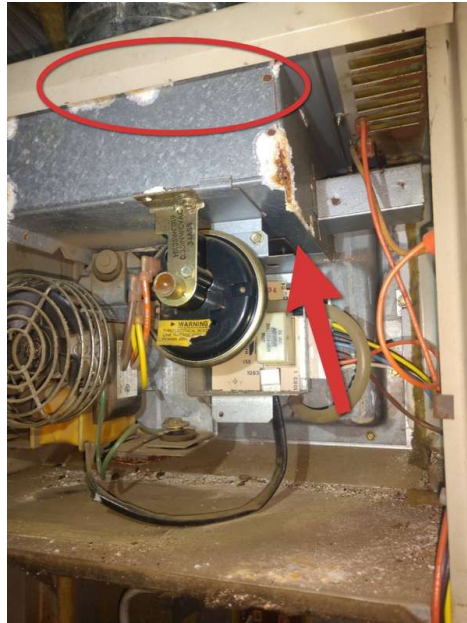
Furnace was corroded in one or more areas. This could be the result of improper venting, which the source would need to be identified. Recommend a HVAC contractor evaluate and repair.

Recommendation  
Contact a qualified HVAC professional.

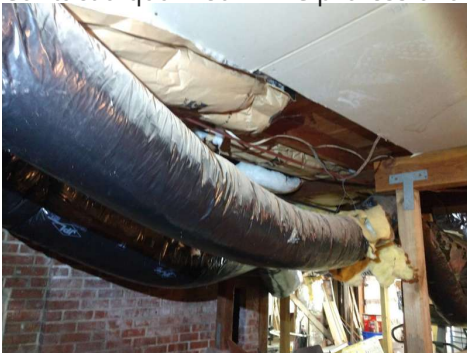
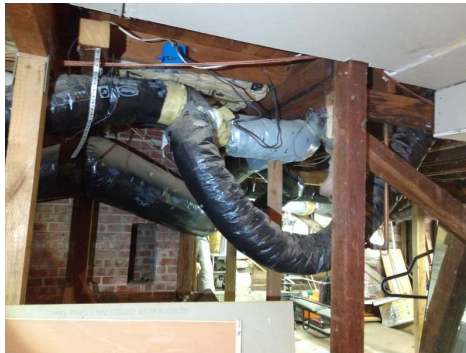
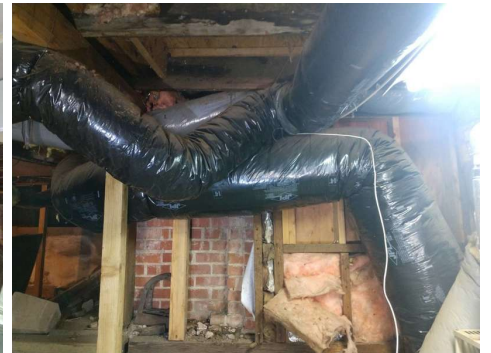
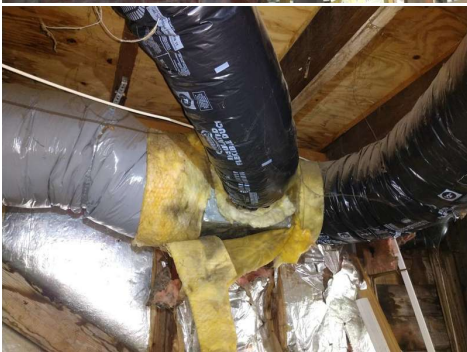
4.3.2 Distribution Systems

**INADEQUATE SUPPORT**

Contact a qualified HVAC professional.

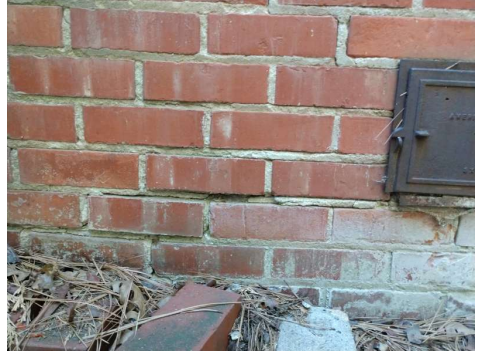
4.4.1 Vents, Flues & Chimneys

**CHIMNEY REPOINT NEEDED**

Contact a qualified masonry professional.

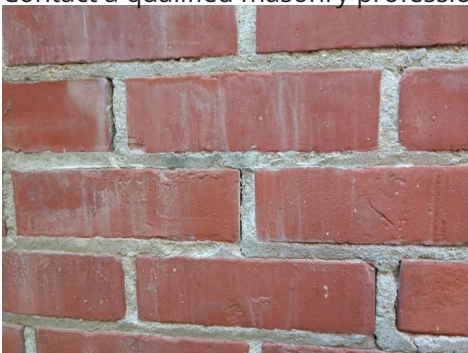
4.4.2 Vents, Flues & Chimneys

**CRACKING - MINOR**

Contact a qualified masonry professional.

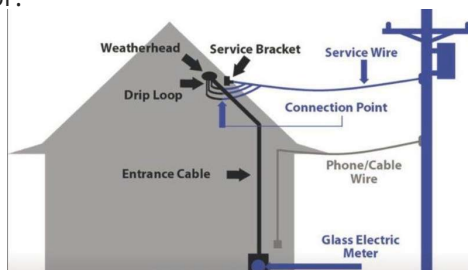
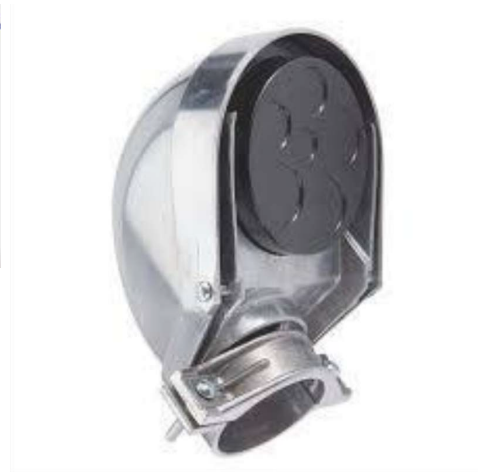
Example of complete weather head.

Plastic protective insert is missing.

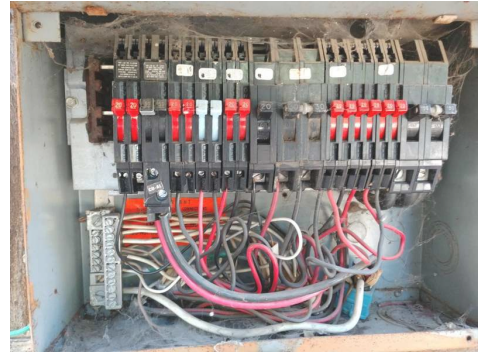
Dirt, dust and debris were observed inside electrical panel. This could increase resistance and cause an electrical fire. Recommend a licensed electrician evaluate and correct.

Contact a qualified electrical contractor.

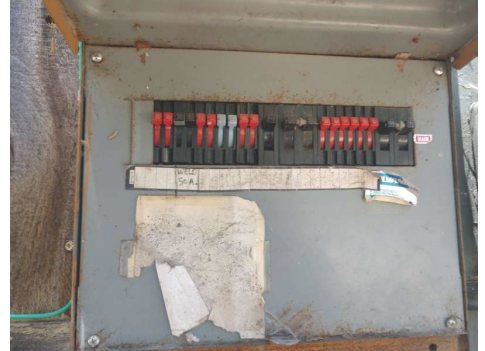
7.2.2 Main & Subpanels, Service & Grounding, Main Overcurrent Device

Labels are faded and almost unreadable. Recommend new labels be placed.

Recommended DIY Project

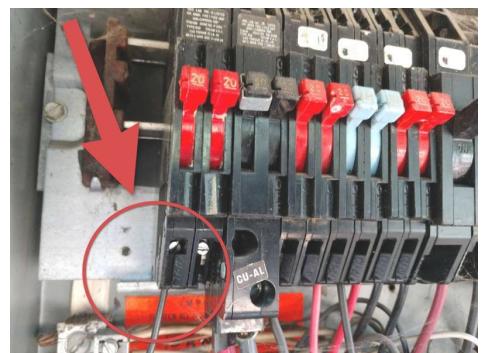
Observed 14 gauge wire attached a 20 amp breaker. The 14 gauge wire is rated for breakers up to 15 amps only. Overheating of the wiring could occur, creating a fire hazard.

Recommend consulting a licensed electrical contractor for evaluation and correction.

Contact a qualified electrical contractor.

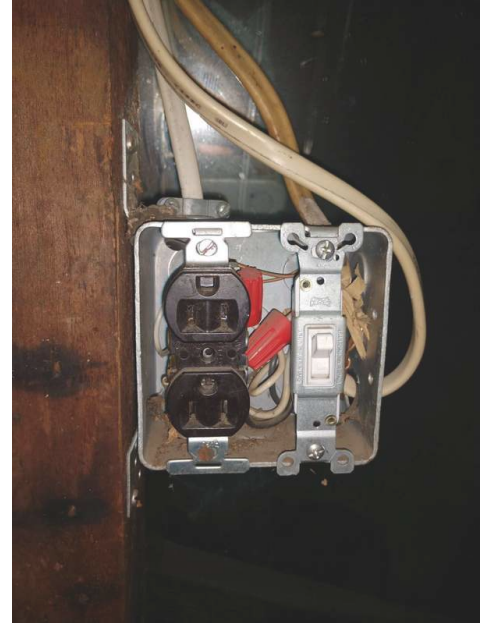
One or more receptacles are missing a cover plate. This causes short and shock risk. Recommend installation of plates.

Recommended DIY Project

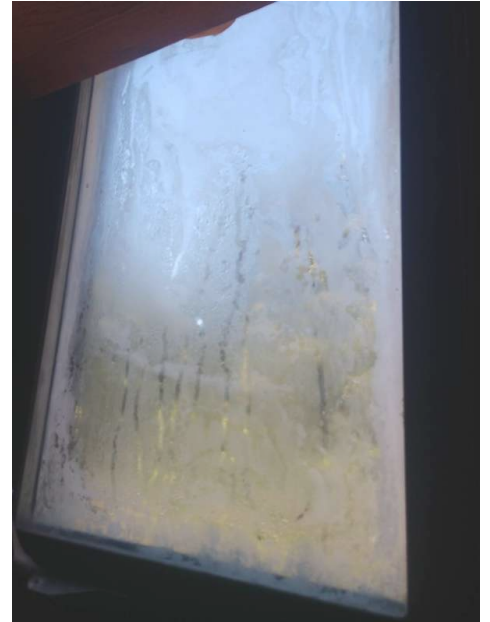
Observed condensation between the window panes, which indicates a failed seal. Recommend consulting a licensed window contractor to evaluate & correct.

Contact a qualified door repair/installation contractor.

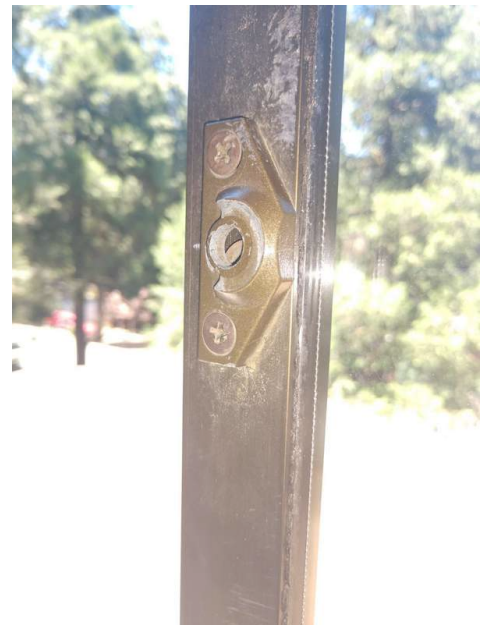
8.2.2 Windows

Observed broken handle on window. This is required to latch the window securely shut. Recommend consulting a licensed window contractor for evaluation and correction.

Contact a qualified window repair/installation contractor.

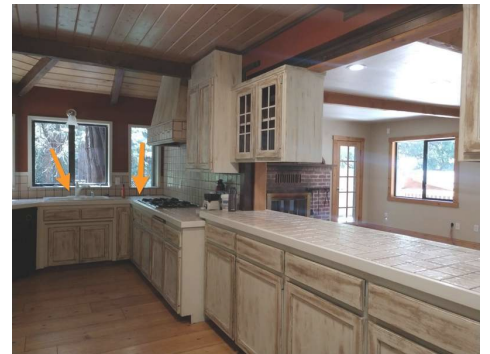
Grout lines were cracked or greatly deteriorated. Recommend consulting a licensed contractor to evaluate and repair or replace grout if this is beyond a DIY project.

Recommendation  
Contact a qualified countertop contractor.

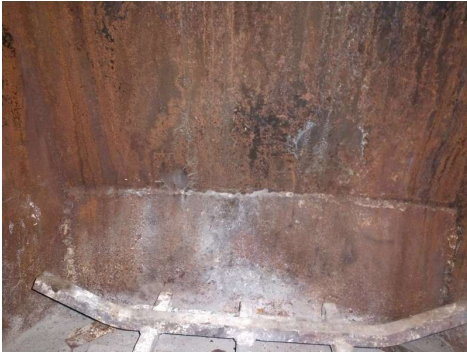
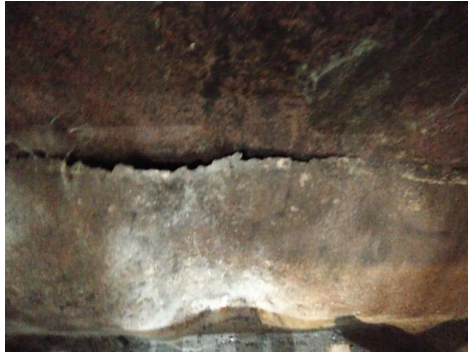
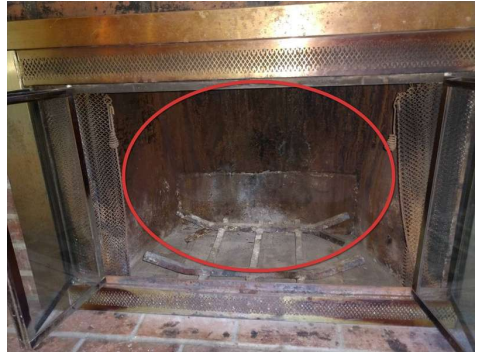
11.1.4 Fireplace

**RUST**

Contact a qualified fireplace contractor.

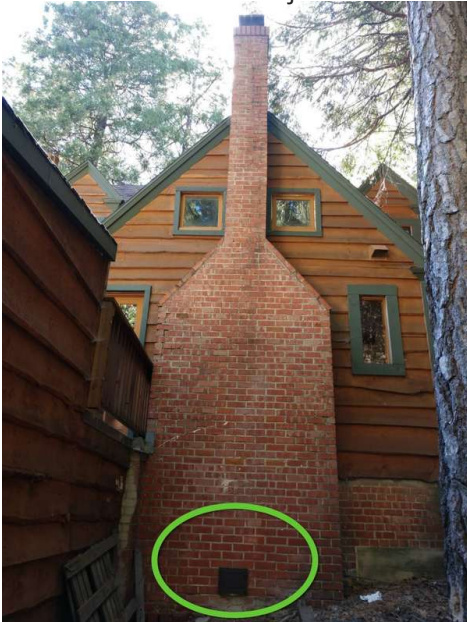
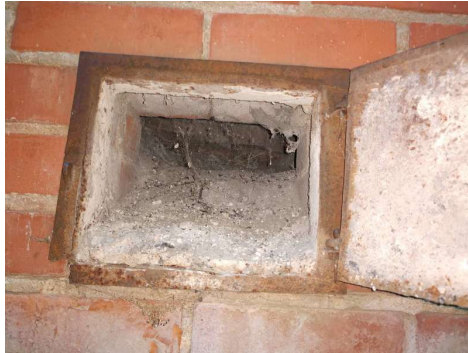
11.1.5 Fireplace

**CLEANOUT FULL**

Recommended DIY Project

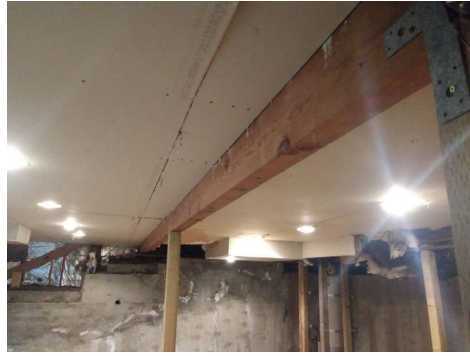
4x8 overspanned.

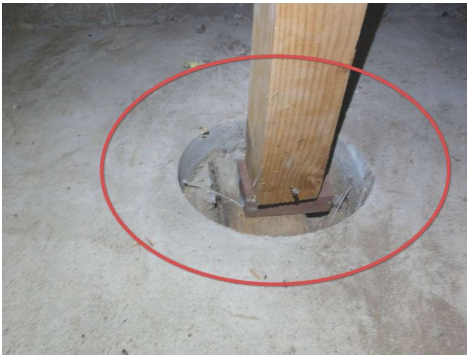
One bolt with no nut or fastener - green circle. No hold down bolts, posts not securely attached - red line

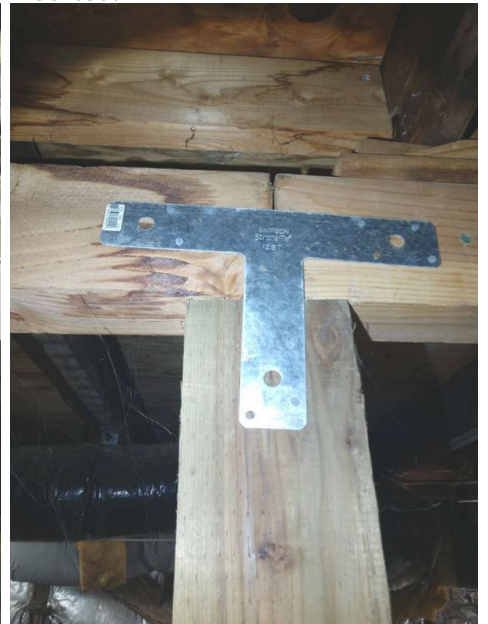
Undersized fasteners for this application.

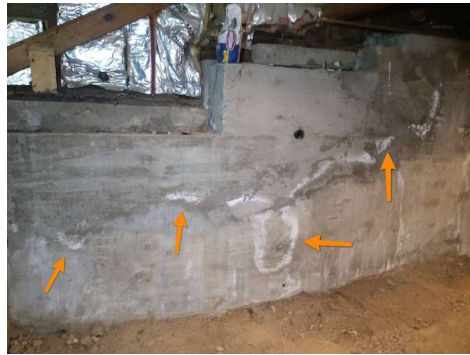
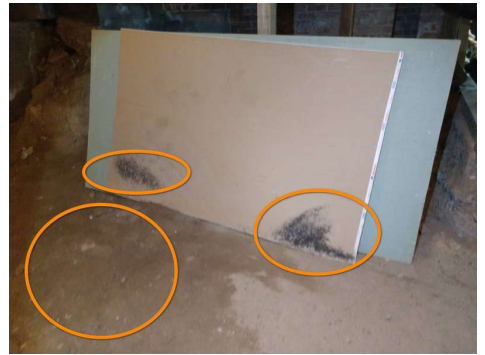
Moisture intrusion was evident on the surface of the floor slab or walls in the basement/crawlspace. This can compromise the soil's ability to stabilize the structure and could cause damage. Recommend a licensed contractor identify the source of moisture and remedy.

Recommendation  
Contact your builder
