SUMMARY

1234 Main St. North Augusta SC 29841

Jeff Young
SC License: RBI 49162 /...
Premier Home Inspections of the CSRA
706 836 4488
jeff@premiercsra.com

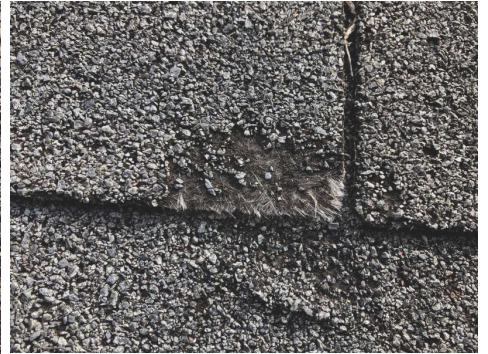
SHINGLE DAMAGE (MINOR)

Minor damages to the shingles were observed in multiple locations. Given the damage was observed in various locations, this may be the result of storm damage.

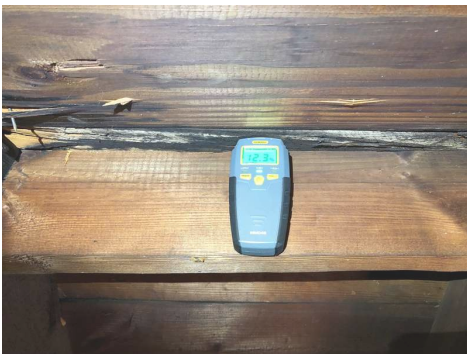
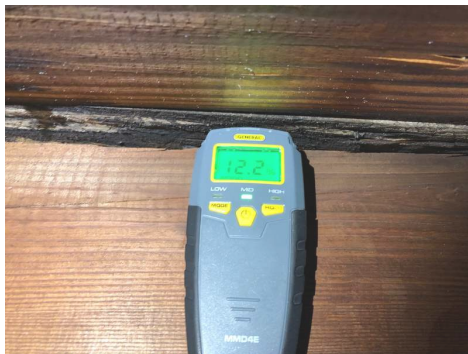
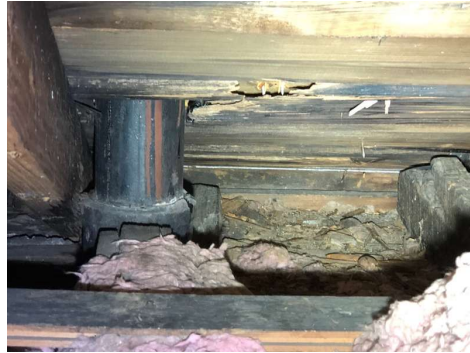
ACTIVE LEAK

There was an active leak on the roof decking. The moisture reading recorded higher than normal moisture levels. Evaluation and repairs are recommended.

* The observed leaks were observed at the roof ridge adjacent to the front gable.

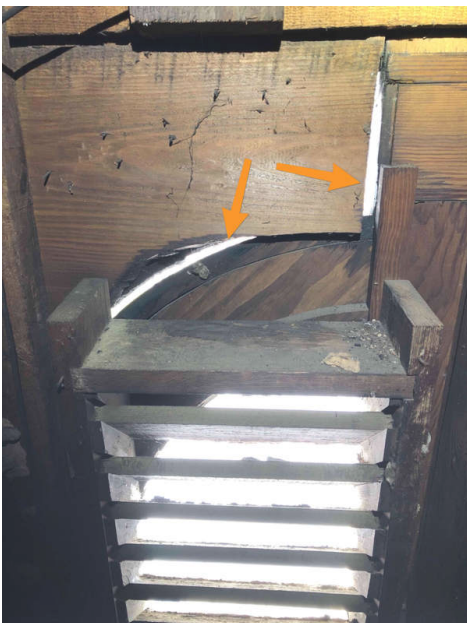
FRONT GABLE VENT, REAR INTERIOR HALLWAY

SEAL PENETRATIONS

Penetrations should be sealed to prevent water/moisture intrusion, potential rodent entry into attic space, and loss of conditioned air from the home.

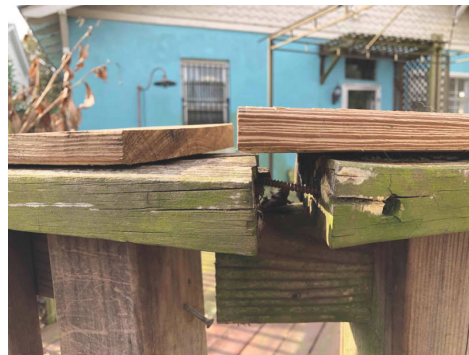
GUARD RAIL DETERIORATION

The guard rail exhibited wood rot damages likely due to prolonged water/moisture exposure over time. The damaged areas should be replaced. As part of general maintenance, exterior decking components and the decking surface should be inspected, repainted, and sealed at least every 5 years to ensure the deck structure and all components are in good condition and to prolong the life of the deck.

*A portion of the railing system was pulling apart. The specific location is the back left side of the railing system.

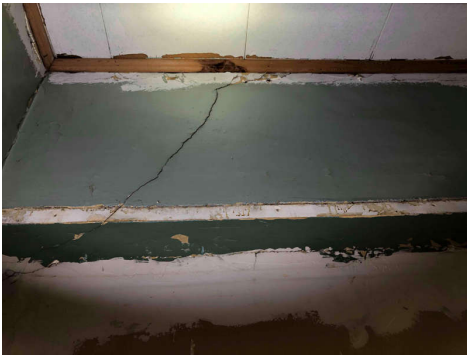
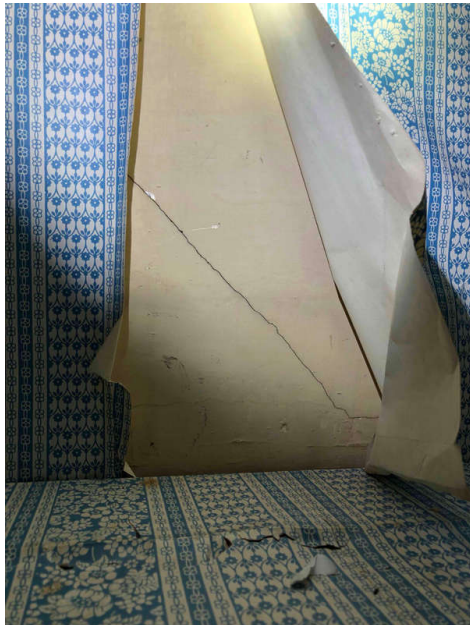
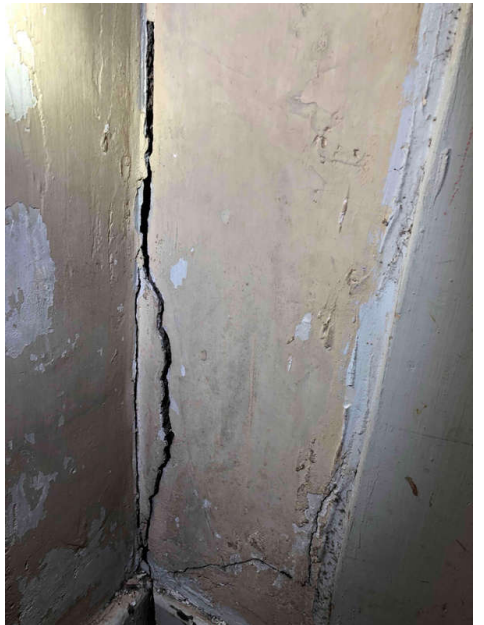
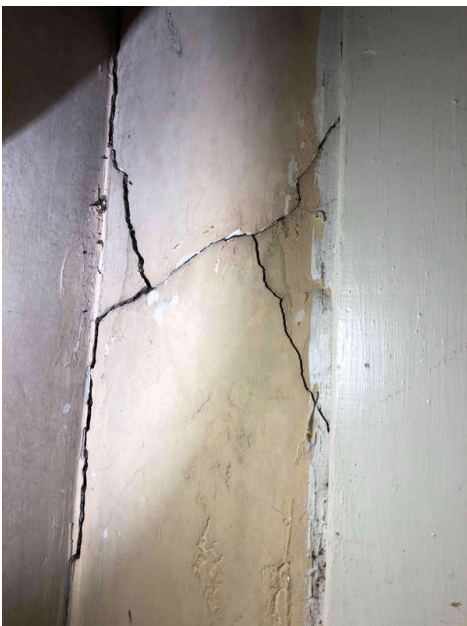
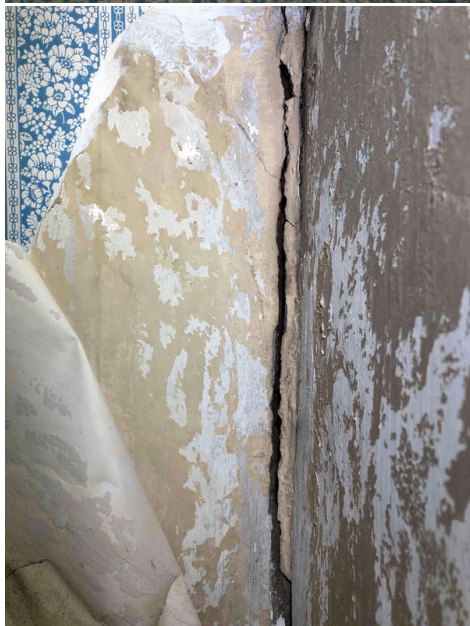
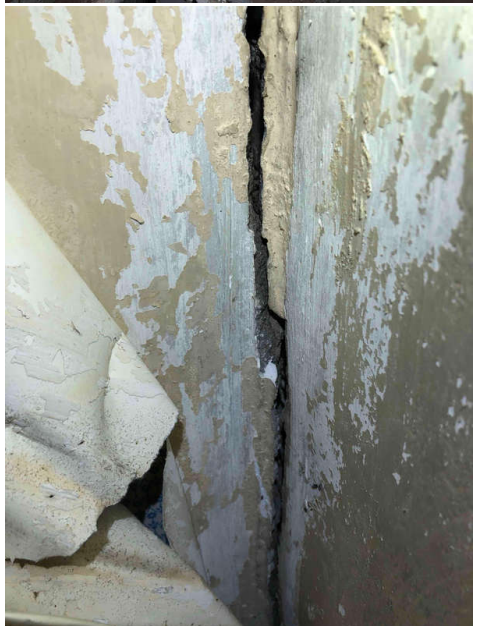
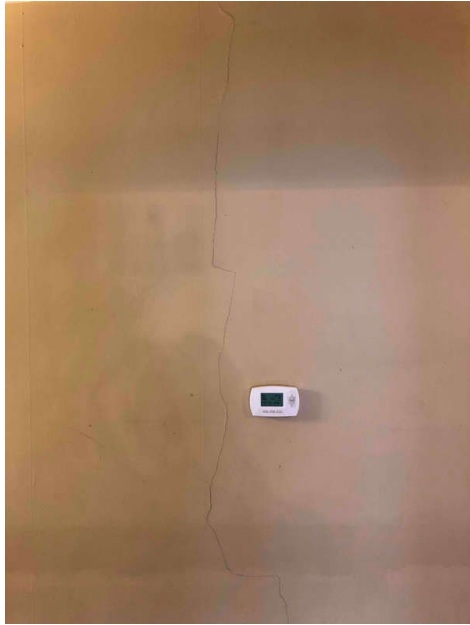
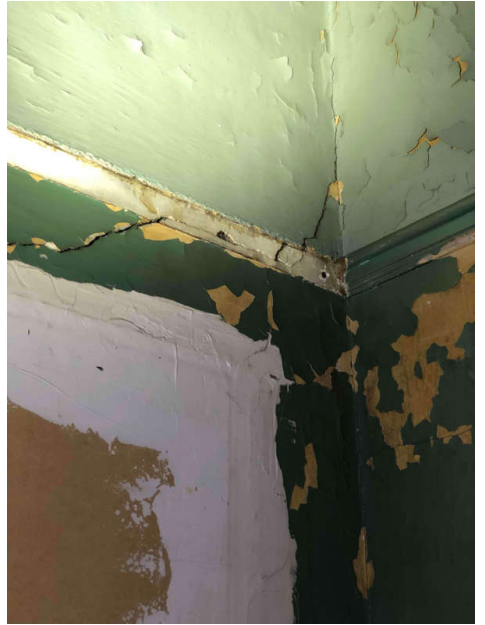
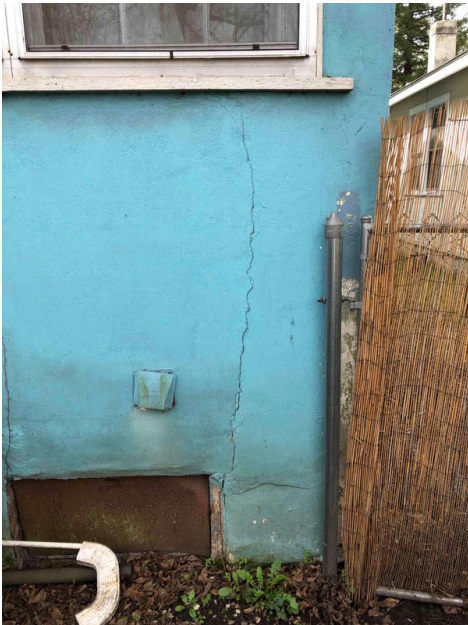
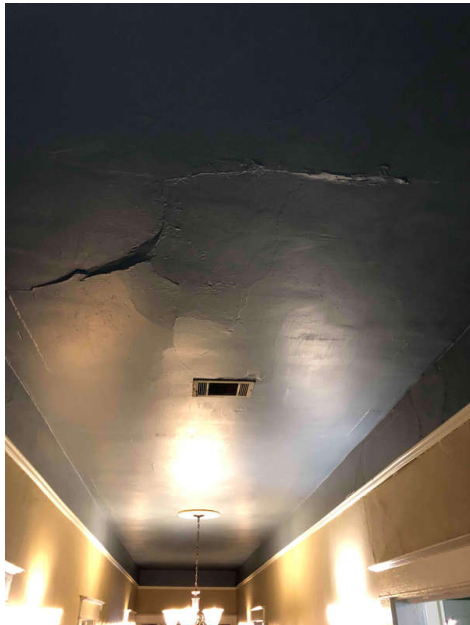
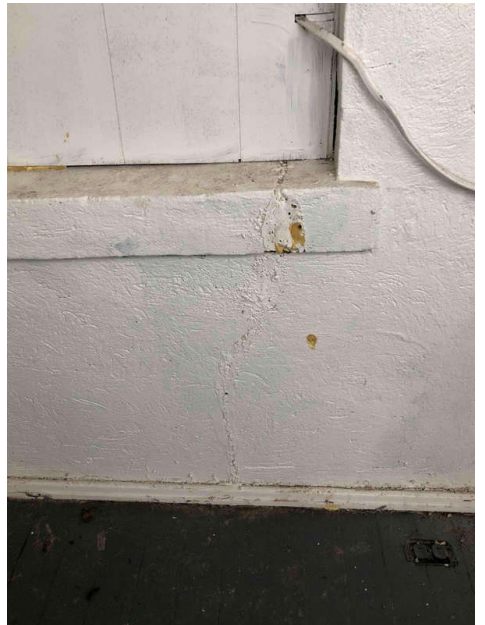
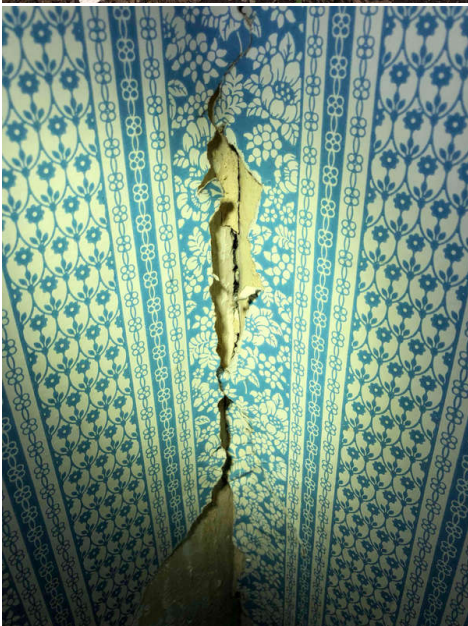
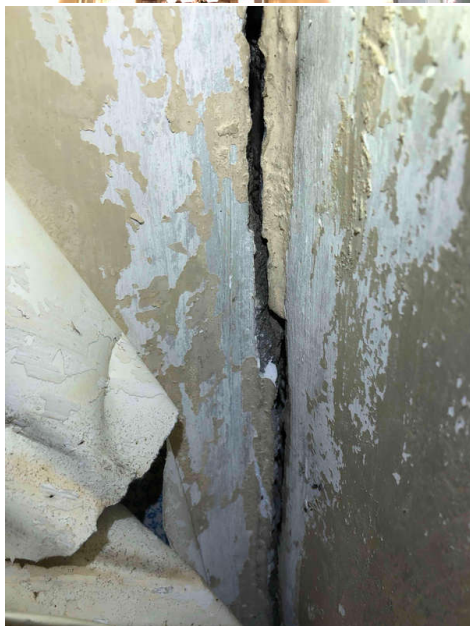
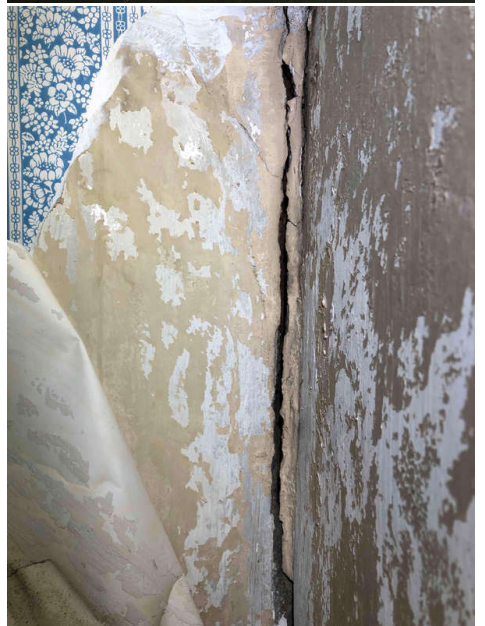
VARIOUS LOCATIONS

DIFFERENTIAL SETTLEMENT CRACKING (SIGNIFICANT)

Settlement cracking was observed to have multiple planes of movement in multiple locations both interior and exterior. Generally speaking, the more planes of movement, the more problematic the settlement can be. Further evaluation by a licensed structural engineer is recommended.

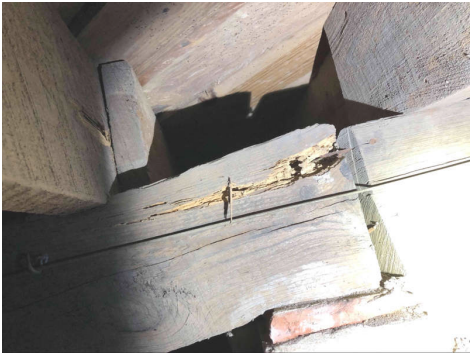
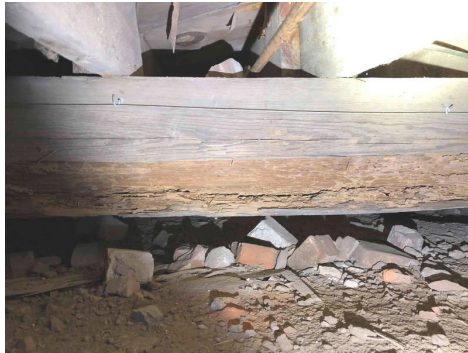
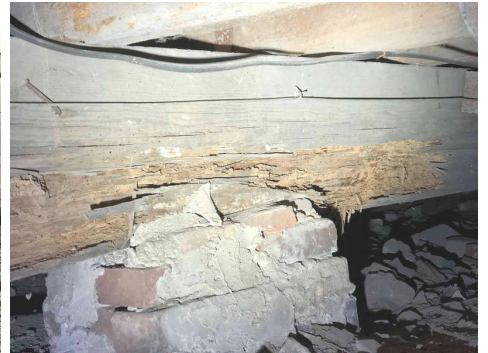
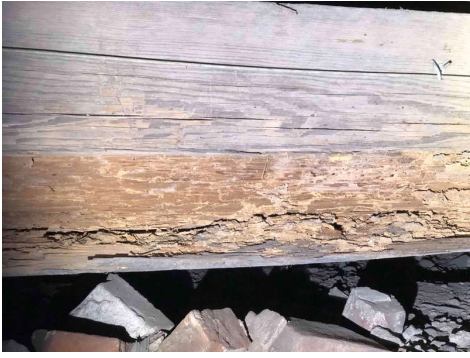
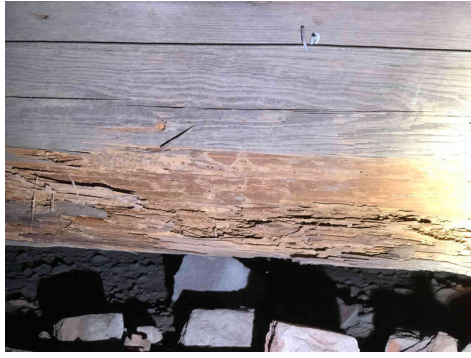
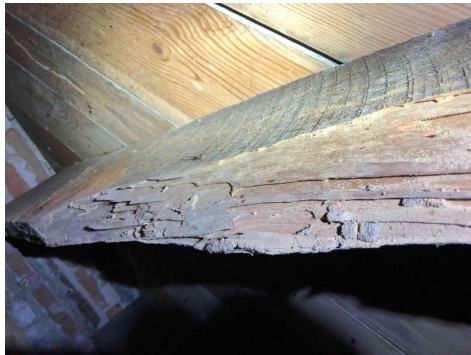
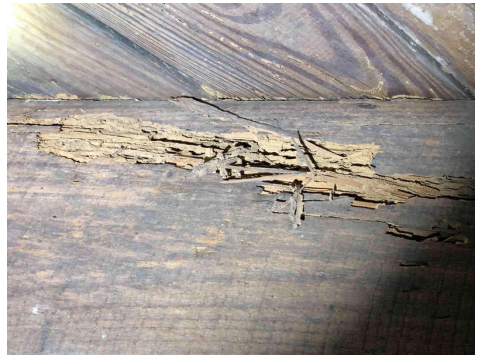
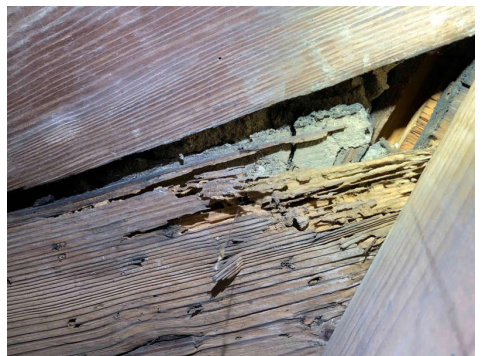
MULTIPLE LOCATIONS

PAST TERMITE DAMAGE

Past termite damage observed in the crawlspace. At the time of the inspection there was no active termite activity observed. A termite letter/inspection is recommended prior to the end of your due diligence period.

* Termite damage was observed at various locations in the crawlspace. The floor joists and subfloor exhibited damages.

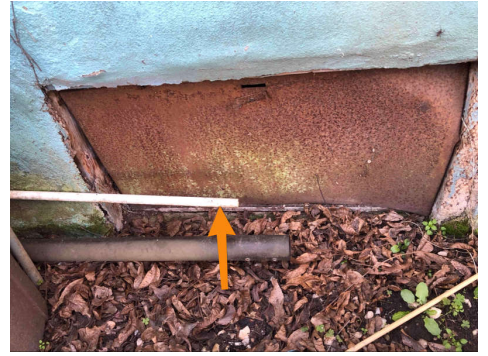
REAR OF HOME

DRAIN LINE TERMINATION

The condensate drain line terminates in front of the rear crawlspace access. The drain line should be relocated away from the crawlspace entrance and the foundation wall.

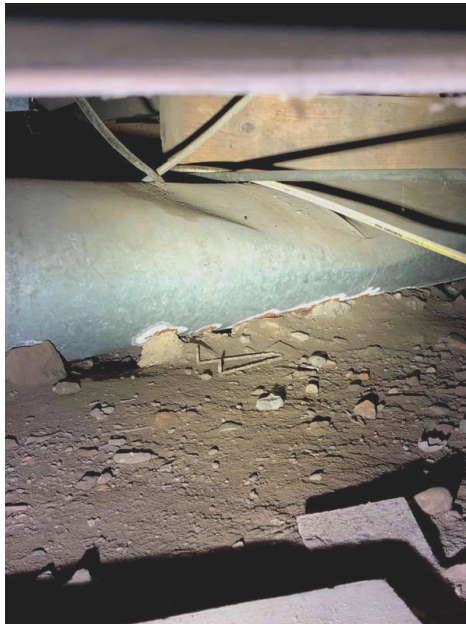
DUCT DAMAGED

The ductwork in one or more areas was exhibited mechanical damages.

*The return duct showed signs of corrosion and rust in multiple areas.

*The return duct was punctured. The puncture was observed near the rear of the crawlspace.

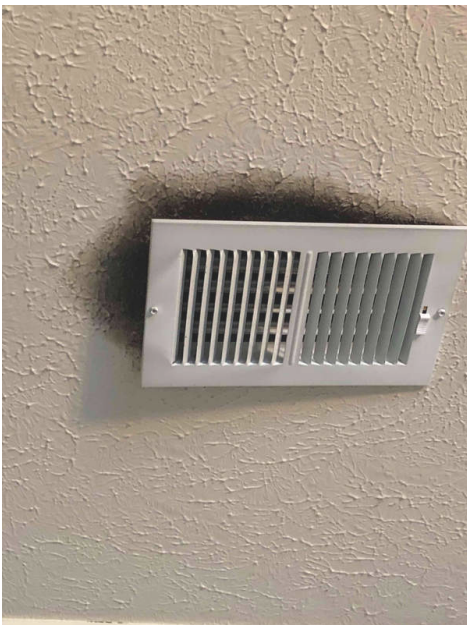
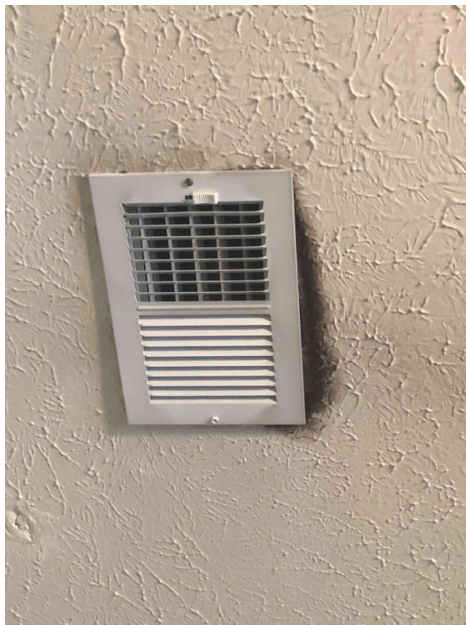
STAINING AROUND VENTS

Staining at the vents may be the result of:

Soot

Dirty/Dusty ducts and insulation

Mold Spores

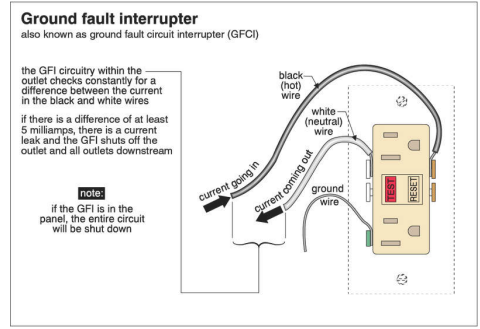
ALL OF HOME

GFCI RECEPTACLES NOT INSTALLED

GFCI protection should be provided anywhere there is a receptacle installed in an area subject to moisture, as the presence of moisture greatly increases the danger of accidental shock. Recommended locations include:

Recommendation
Contact a qualified electrical contractor.

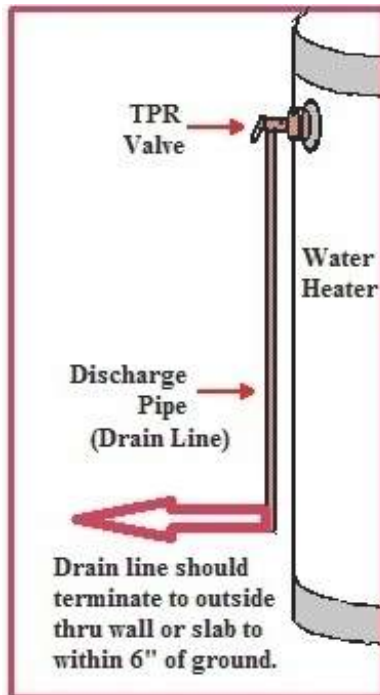
TPR VALVE DISCHARGE PIPE INCORRECT SIZE

The TPR valve should have a discharge pipe installed that has a diameter equal to or not less than the diameter of the TPR valve outlet. This discharge pipe should extend to within 6 inches over the floor.

Recommendation
Contact a qualified plumbing contractor.

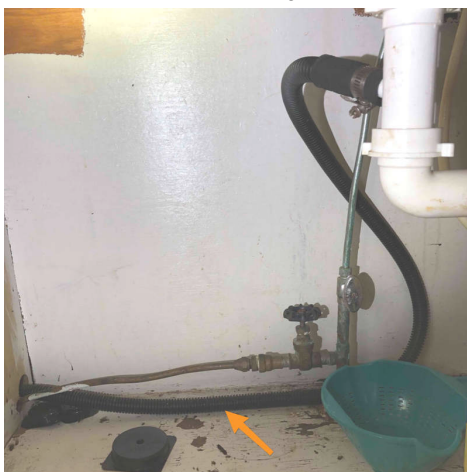
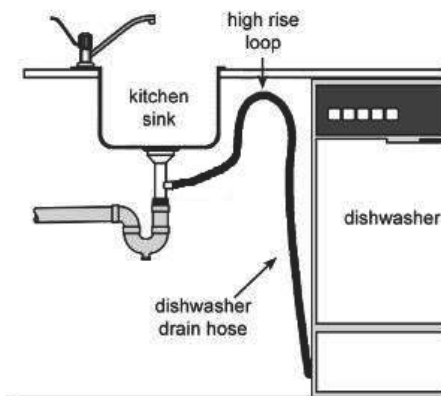
HIGH LOOP NEEDED

Recommended DIY Project

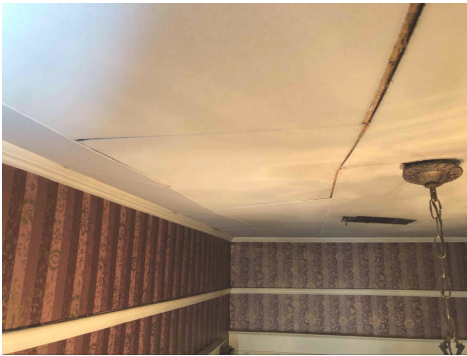
The ceiling tiles were sagging in various locations throughout the home. The most notable area of sagging was above the front door entrance.

The sagging did not appear to be the result of subsequent damage from leaks in the roof. Tiles appeared to have detached from the plaster ceiling. This may be the result of settlement, moisture, or quite possibly detachment overtime.
