## SUMMARY

1234 Main St. Columbia MD 21044

Steven Madewell  
MD License #33112  
Madewell Inspection Services, LLC  
(301) 404-8437  
[steve@madewellhomeinspections.com](mailto:steve@madewellhomeinspections.com)

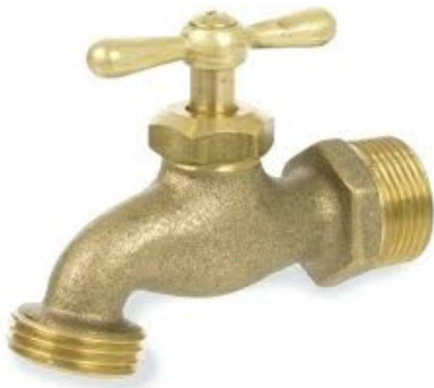
Hose Bib Example

**FRONT HOSE BIB LOOSE**

The front hose bib was loose at the time of the inspection. Recommend securing the front exterior hose bib.

Contact a qualified professional.
