SUMMARY
1234 Main St. Columbia MD 21044
Buyer Name
07/06/2019 9:00AM

Steven Madewell
MD License #33112
Madewell Inspection Services, LLC
(301) 404-8437

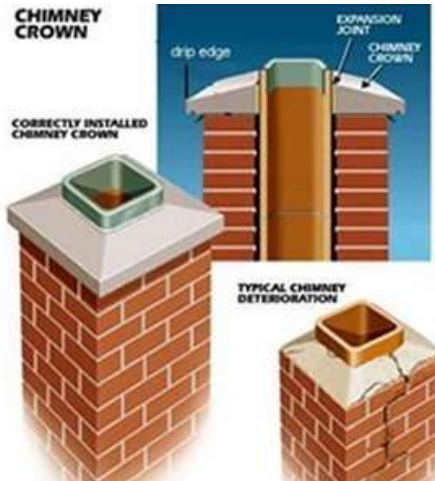
Chimney Crown Diagram

The chimney crown was cracked or damaged at the time of inspection. Cracks or missing mortar can allow moisture intrusion into the chimney and masonry, resulting in further damage to the masonry chimney and liner. Recommend a qualified chimney contractor evaluate and repair the chimney crown.
