2.1.1 A. Foundations

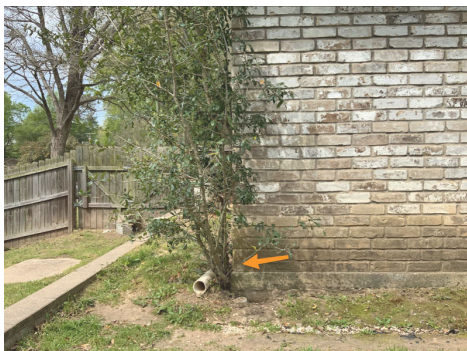
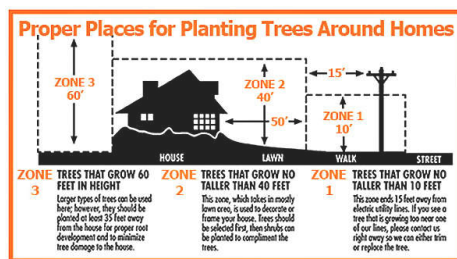
**SLAB- TREES TOO CLOSE TO THE HOME**

Tree(s) in close proximity of the foundation was observed. Client should consider the installation of a root barrier to reduce the possibility of damage to the foundation from tree roots and moisture removal, or have the trees taken down so that they do not damage the property over time.

Recommendation  
 Contact a qualified professional.

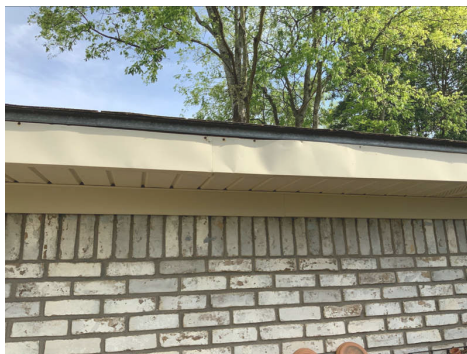
Front of home right side of garage

### SIDING OVER FASCIA COULD USE REPAIR

The siding over the fascia is in need of repair in areas it is wrinkled and there are nail heads exposed and rusted.

Contact a qualified siding specialist.

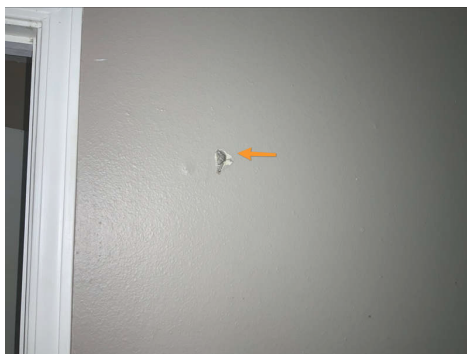
Master Bedroom

There are one or more areas throughout the structure where there is/are (a) hole(s) in the wall. This should be repaired by a drywall contractor.

Contact a qualified drywall contractor.

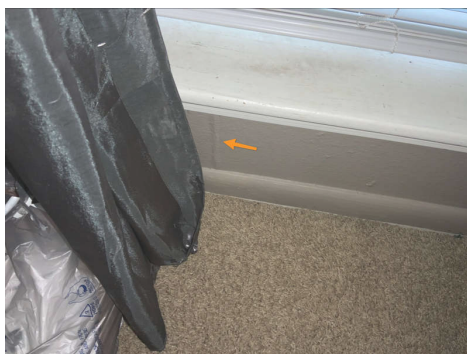
Master Bedroom window left side bottom

The same tape on the wall and one or more areas is bulging this is likely due to seam tape not being installed properly. This is cosmetic in nature and can be repaired easily during maintenance.

Contact a qualified drywall contractor.

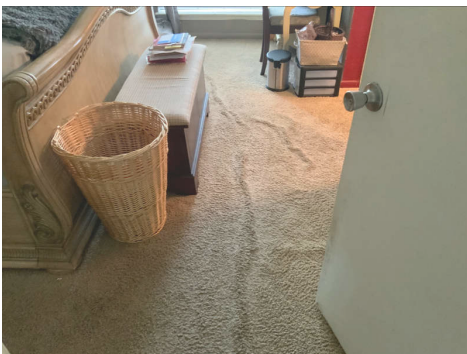
Master Bedroom

There are one or more areas throughout the home where the carpet could use stretching so that it does not become a trip hazard.

Recommendation  
Contact a qualified professional.

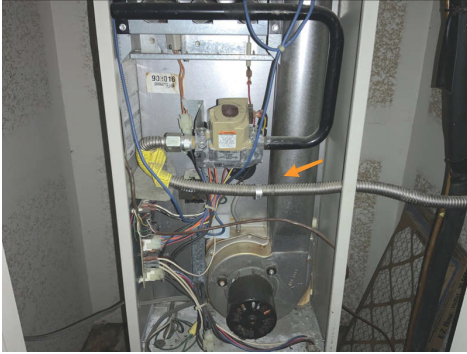
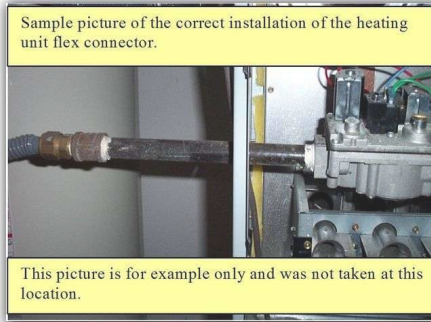
The gas supply flex connector was observed to be passing through the heating unit cabinet. Undercurrent mechanical installation standards, this is no longer an excepted practice. Only rigid black gas pipe is allowed to pass through the heating unit cabinet.

Example of how furnace gas line should be installed

Contact a qualified professional.

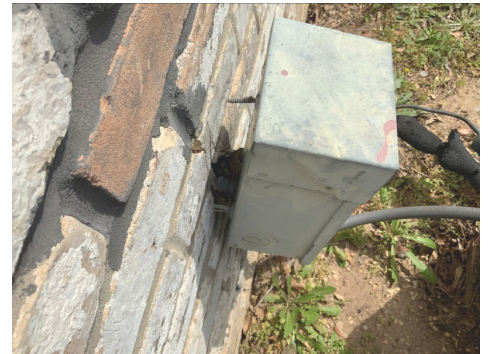
**DISCONNECT BOX NEEDS REPAIR**

The disconnect box at this home is not fastened to the wall and should be repaired. The disconnect box as it is now could allow water into the box and it is just not safe at this time.

Contact a qualified HVAC professional.

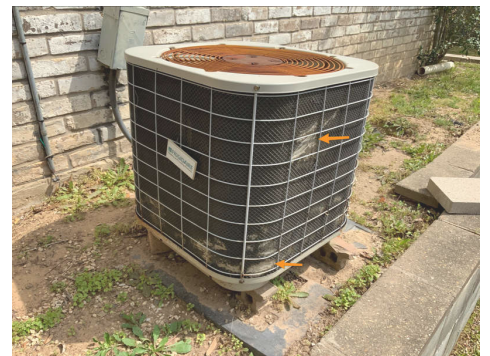
**FINS DAMAGED**

There are one or more areas on the condensing unit where the fins are damaged and the coils are exposed. We recommend that this unit be serviced and further evaluated by a licensed HVAC Technician prior to closing.

Contact a qualified HVAC professional.

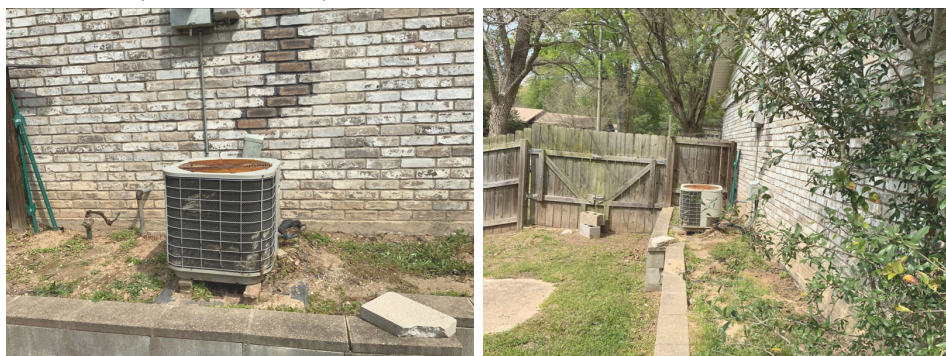
The condensing unit(s) were not level. This can put strain on the fan motor, prevent proper lubrication of the compressor, and affect system performance. I recommend that the units are leveled as needed by an HVAC contractor or other qualified person.

Contact a qualified HVAC professional.

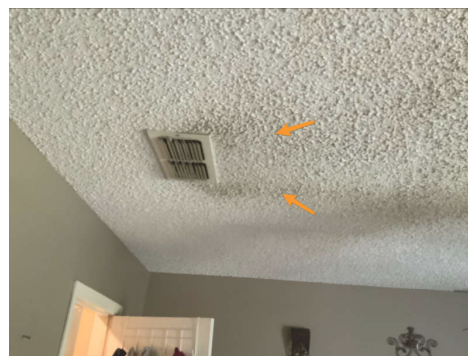
We recommend that you consider having the ductwork cleaned prior to living in the home to help cut down on allergens that may have accumulated in the ducts from animals or other things that the previous owners may have had in the home. This is fairly inexpensive and will let you start out with cleaner air

Contact a qualified professional.

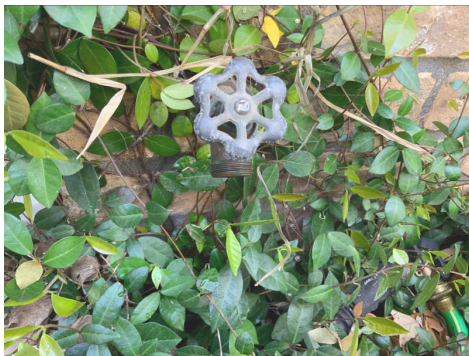
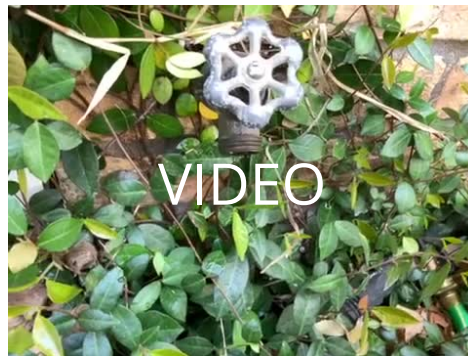
Front of home

There are one or more hose bibs dripping on the exterior of the home. We recommend that this/these hose bibs be repaired.

Contact a qualified professional.

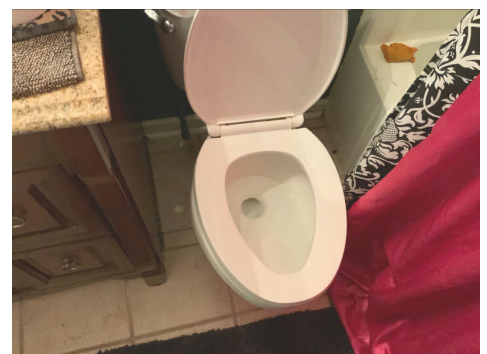
Hall Bathroom

**TOILET LOOSE AT THE FLOOR**

There are one or more toilets in the home that are loose at the floor. When a toilet is loose at the floor it can damage the wax ring and cause leaks. We recommend that all toilets be tightened and that you take into consideration that the wax ring may need to be replaced before you tighten the toilet.

Contact a handyman or DIY project

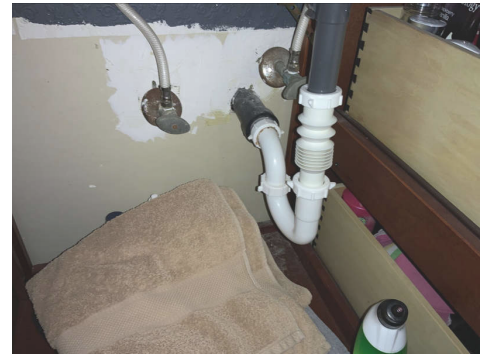
Hall Bathroom

Although, Accordion Drain line material is easy to use, it is not recommended for use in sinks because it is thin, easily torn, and the ridges on these piping materials are known to catch trash and clog easily.

Contact a qualified professional.

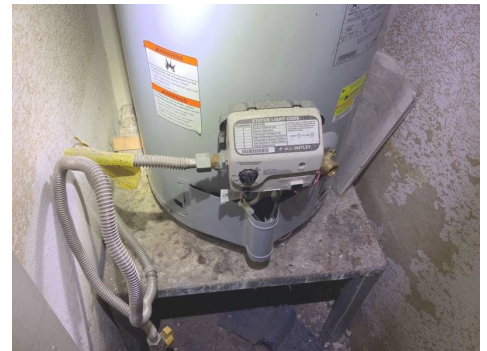
There is not a drain pan installed under this water heater. We recommend that a pan be installed for safety to keep the floor and finish materials from being damaged if there was a leak in the water heater.

Contact a handyman or DIY project

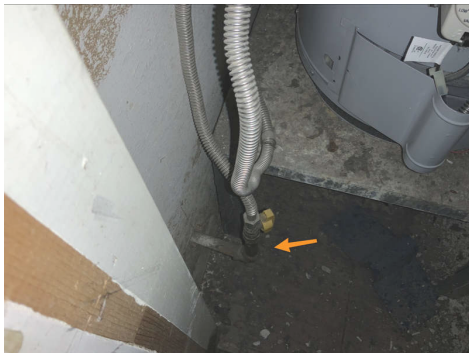
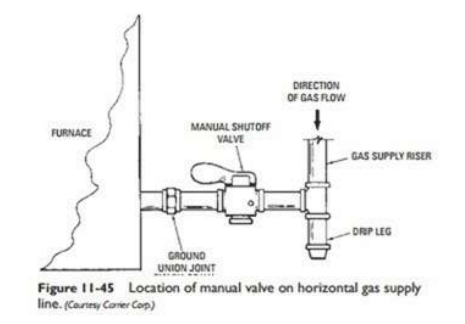
### NO DRIP LEG ON GAS LINE

The water heater and/or furnace gas supply line is not equipped with a sediment trap just before the gas appliance connector. This condition does not meet current installation requirements and should be corrected.

furnace drip leg/sediment trap example

Recommendation  
Contact a qualified plumbing contractor.

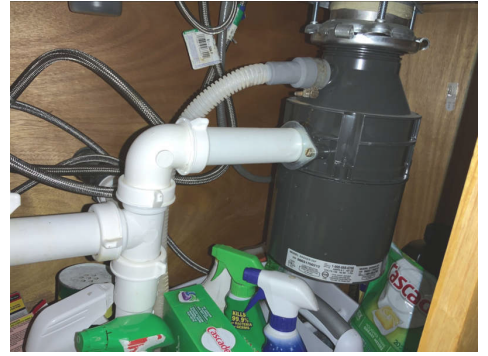
### DISHWASHER HIGH LOOP MISSING

A "high loop" or "air gap" was not present for the dishwasher drain line at visible portions. A high loop or air gap prevents wastewater from siphoning back into the dishwasher during operation. The proper installation of the dishwasher drain line is recommended by a licensed plumber or other qualified person.

Contact a handyman or DIY project

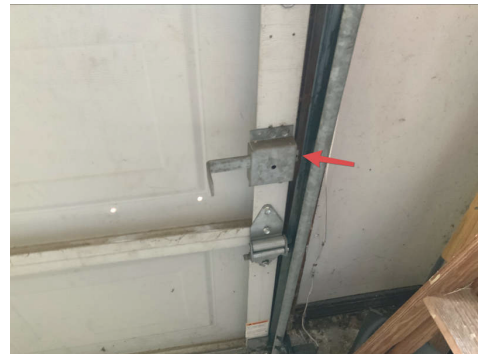
The garage door lock(s) is/are still in service, we strongly recommend that the locks on the garage door be disabled.

Since local building codes are so finicky, I wouldn't doubt that some areas might even require a "permanent" disabling of the locking mechanism.

Contact a qualified professional.
