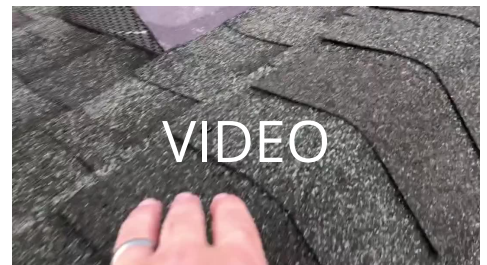
NAILS EXPOSED / RAISED SHINGLES

There were some locations where the nails have either pushed up or were face nailed and they needed to be sealed. There are a couple of different options out there. [Here is an example](#). If neglected, they could develop into a leak or blown off shingle. Any observed leaks will be noted elsewhere.

Recommendation
Contact a qualified handyman.

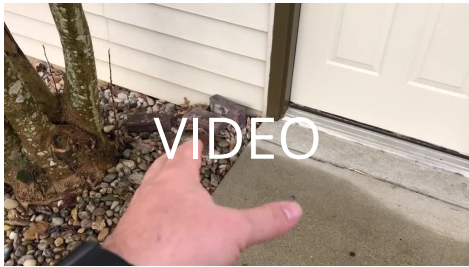
There should be a gap between the siding and the soil/ground. There is a risk of moisture wicking as well as a pathway for wood destroying insects.

Contact a qualified professional.

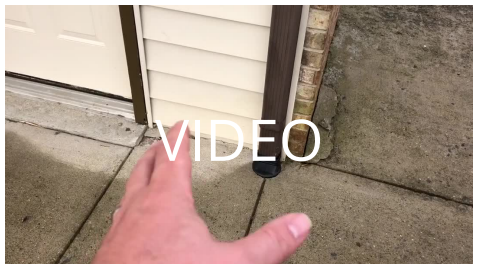
3.1.2 Siding, Flashing & Trim **CONCRETE CLEARANCE**

There should be a gap between the siding and the concrete and flashing. No major concerns observed but moisture could get trapped between or behind.

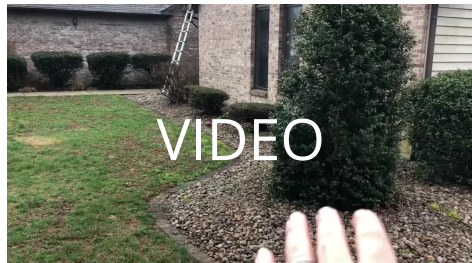
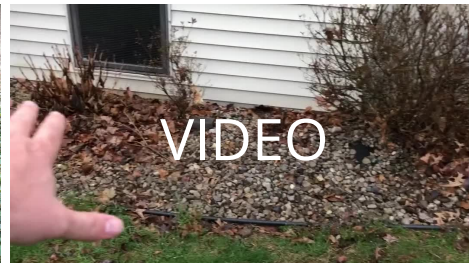
Grading is sloping towards the home in some areas. This could lead to water intrusion and foundation issues. Recommend qualified landscaper or foundation contractor regrade so water flows away from home.

Contact a qualified landscaping contractor

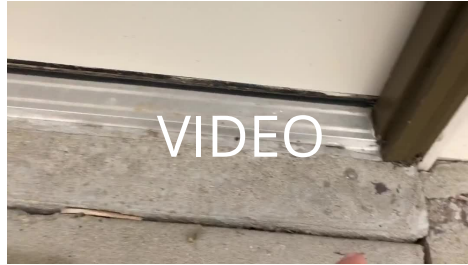
JAMB - MOISTURE DAMAGE

Some moisture induced degradation was noted at one or more exterior jambs and door. Though this is typical, attempts to prevent furthering and repair damage should be considered. [Here is some more information that may be useful.](#)

Contact a qualified handyman.

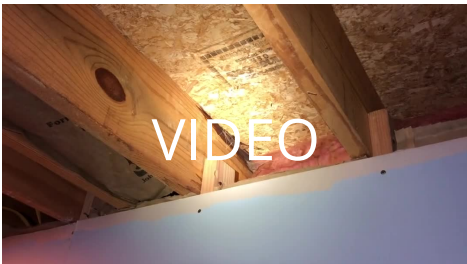
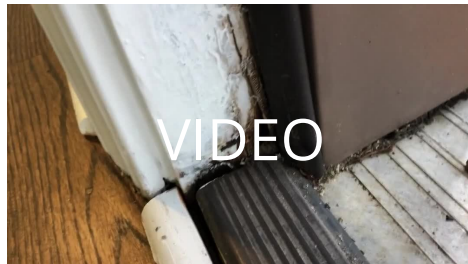
MOISTURE INTRUSION

There was evidence of moisture intrusion under the or thru the exterior door.

Contact a handyman or DIY project

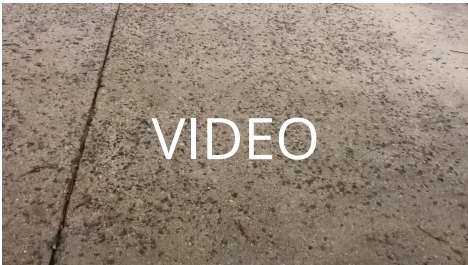
SURFACE DAMAGE

Deterioration noted at the driveway caused either by poor finishing practices or salt/brine. Some continuation is possible.

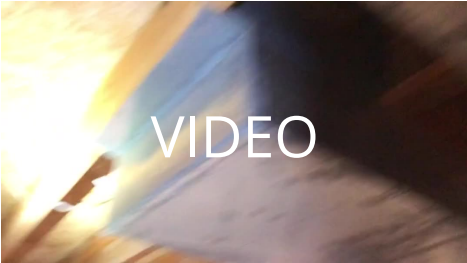
The floor joists showed evidence of microbial growth. No elevated moisture levels were detected. Laboratory testing would be needed to confirm.

Recommendation
Contact a qualified professional.

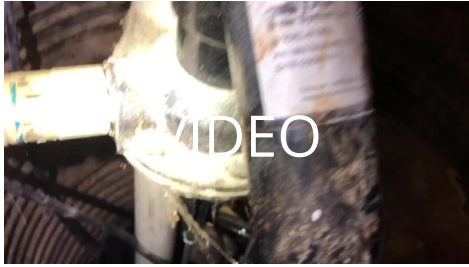
The back up pump was leaking and causing the system to operate more frequently.

Recommendation
Contact a qualified plumbing contractor.
