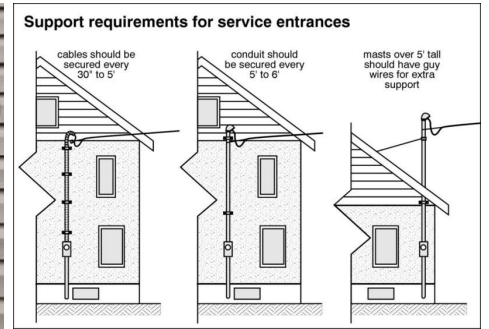
MAST OR METER NOT SECURED OR LOOSE

The service mast or meter appeared loose or inadequately secured. Further review and correction is needed to prevent failure.

Contact a qualified electrical contractor.

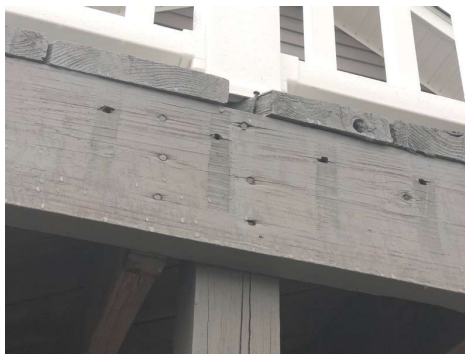
RIM JOIST MISSING LAG BOLTS

SAFETY The rim joist on the deck should be bolted to the post. Or the post should be notched. Failure is possible and the deck could collapse. Repair is needed.

Contact a qualified deck contractor.

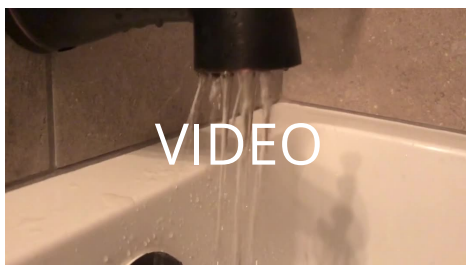
VOLUME/PRESSURE LOW

Contact a qualified plumbing contractor.
