SUMMARY

1234 Main St. Moore OK 73160

George Carpenter
OK License # 70001319
Kingdom Inspections LLC
405-596-7038
george@kingdominspectionsllc.com

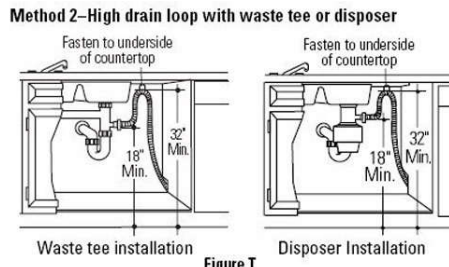
High Loop Examples

The dishwasher drain line (discharge hose) did not have an air gap or a high loop. The dishwasher drain line usually attaches to the garbage disposal. The drain line should either arch above the level of the sink drain, have an anti-siphon valve, or have a vacuum break. This keeps debris in the disposal from siphoning back to the clean dishes. We recommend the drain line be elevated or a back flow device installed.

Recommendation
Contact a qualified appliance repair professional.
