2.1.1 Siding, Flashing & Trim

DAMAGED SIDING

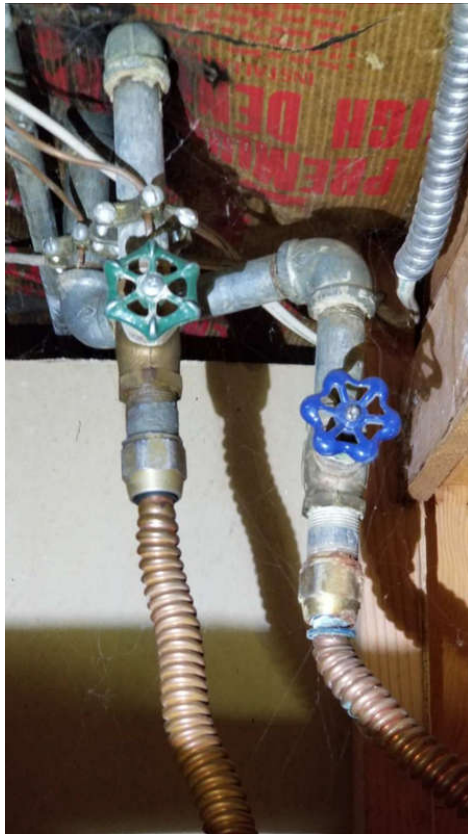
Basement water heater

DISTRIBUTION PIPE LEAKING

Distribution pipe appeared to be leaking. Recommend a qualified plumber evaluate and repair. Aged galvanized plumbing with signs of corrosion and leakage throughout the home. Recommend budgeting for complete replacement.
