## SUMMARY

1234 Main St. Fort Worth Texas 76126

Kent Keith  
TREC Professional Inspector #7413  
Green Tag Inspection Services  
8177053200  
[kent@fortworthinspector.com](mailto:kent@fortworthinspector.com)

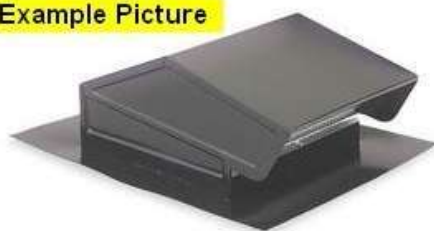
Example Picture

**The dryer vent hood on the roof is an improper type and can cause lint to collect. It should be replaced with a vent hood with a self-closing backdraft damper.**
