## SUMMARY

1234 Main St. Anamosa IA 52205

Royal Home Inspections, LLC  
ASHI, InterNACHI Certified...

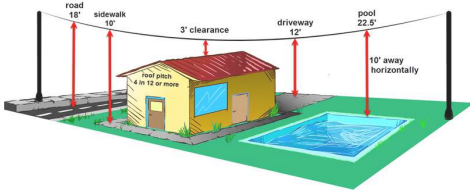
The overhead service-drop conductors have inadequate height clearance above a walking surface. Safe building practices require 10 feet (3m) clearance above walking surfaces (including decks , stairs, and balconies). The Inspector recommends that before the expiration of your Inspection Objection Deadline, you consult with your electrical service provider to discuss options and costs for correction. Any work on the service conductors should be performed by a qualified personnel only.

Recommendation  
Contact a qualified electrical contractor.

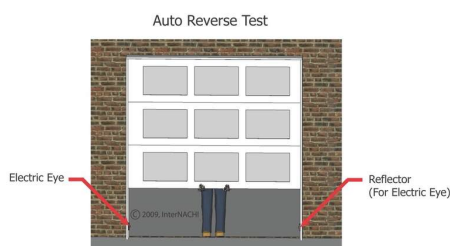
With testing it damaged the door. It appeared to have some alignment issues prior. As the bottom track is tight. Also Bolts were not installed correctly.

Contact a qualified garage door contractor.

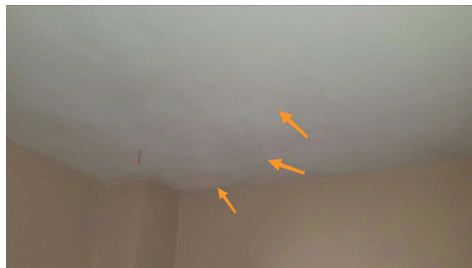
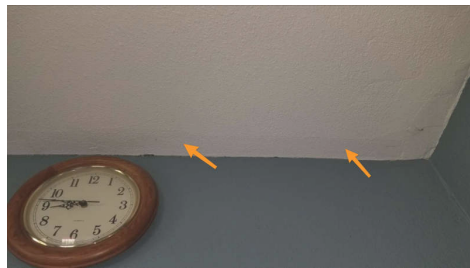
Plaster cracking on ceiling observed at the time of inspection. This can be caused by many different issues. Recommend contacting a general contractor to verify sagging will not continue or if plaster should be replaced.

Recommendation  
Contact a qualified professional.

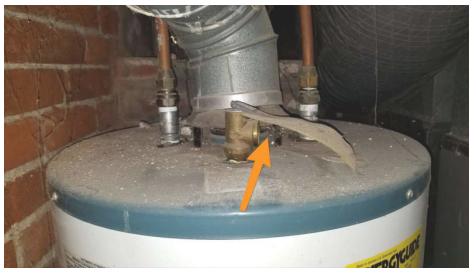
Incorrect discharge pipe was installed at the temperature/pressure relief (TPR) valve. The TPR valve is designed to open and release extremely hot water when water temperature or pressure inside the tank exceeds safe levels. With no discharge pipe installed, persons near the tank might be badly burned by hot water released by the TPR valve. The Inspector recommends that a properly-configured discharge pipe be installed by a qualified plumbing contractor.

DISCHARGE PIPE ON TPR VALVE

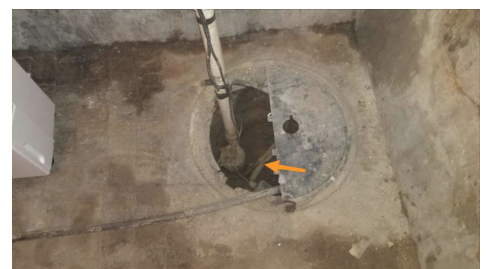
Basement

The sump pump did not respond to the controls and should be serviced by a qualified plumbing contractor.
