SUMMARY  
1234 Main St. Johnson City Tennessee  
37604  
Buyer Name  
03/05/2019 9:00AM

Michael Ray  
Tennessee Licensed Home...  
Home Check Inspection Services, LLC.  
(423) 791-1264  
homecheckinspect@comcast.net

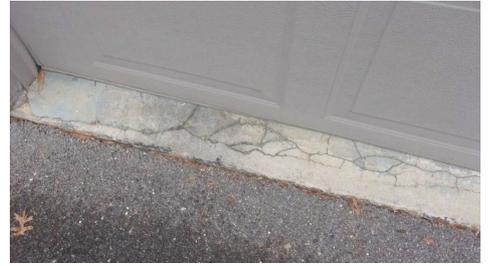
There is some cracking / damage to the concrete garage floor apron where it abuts the exterior asphalt driveway.

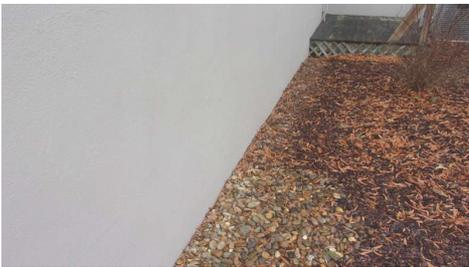
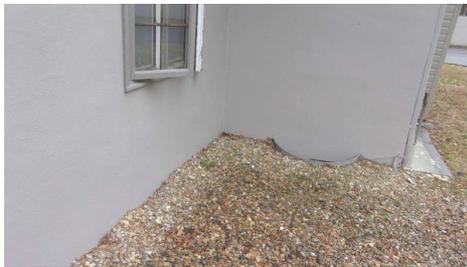
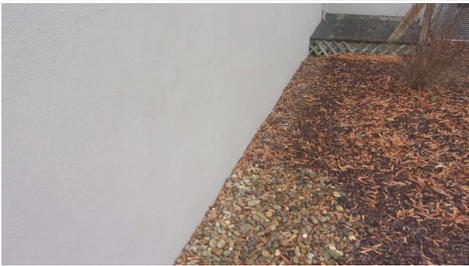
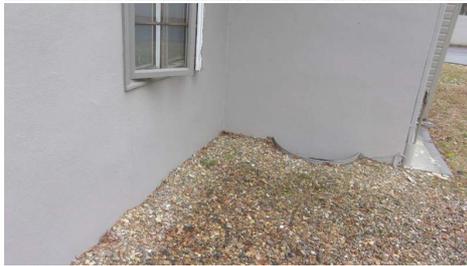
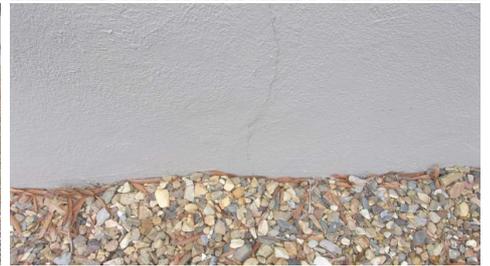
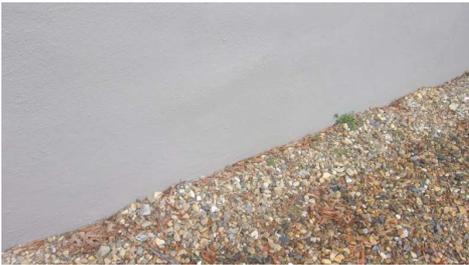
### 2.6.1 Grading and Drainage

## FLAT / NEGATIVE GRADING

There are areas around the home where the soil grade is flat or negatively sloped toward the home or there are holes in the soil at the base of the home's exterior. Water is not forgiving, some say it is the leading cause of damage to a home. Water infiltration of a foundation wall or structural issues due to hydrostatic pressure or soil heaving or freezing is always possible. To help remove water from the base of the home's foundation the soil around the home should be positively sloped away from the home.

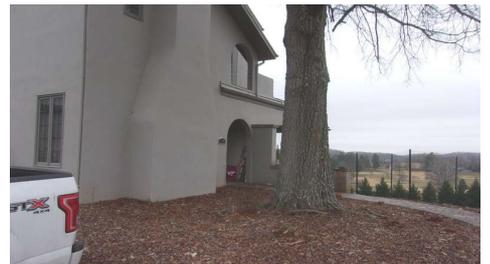
### 2.7.1 Vegetation

## TREES CLOSE TO FOUNDATION

There is a tree at the left front of the home in close proximity to the home. Overtime tree root systems can cause structural damage. The root systems for trees differ, with some roots extending out 2 to 3 times the drip line or about 1.5 times the height of the tree. Recommend consulting a Tree Service for their recommendation.

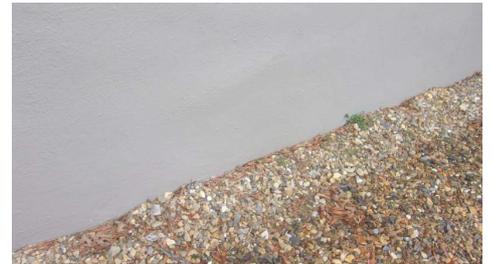
#### MISSING SWEEP CREED

There is no visible weep screed at the base of the exterior stucco cladding. A weep screed is a type of building material used along the base of an exterior stucco wall. The screed serves as a vent so that the moisture can escape the stucco wall finish just above the foundation. It additionally acts as a barrier for moisture wicking up the foundation toward the stucco.

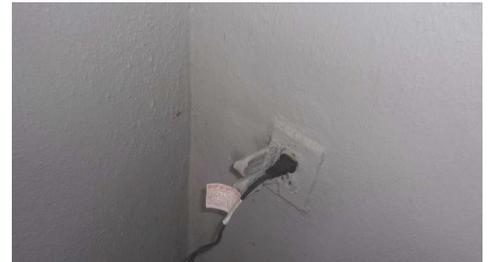
All exterior outlets should be Ground Fault Circuit Interrupters (GFCIs). GFCI protection was required in 1971 by the NEC but it is unknown when the city adopted the code. Although homeowners are not required to upgrade their home's each time new codes are approved (every three years). There are certain codes that are for personally safety and these changes will be recommended when needed. Recommend installing GFCIs on exterior outlets.

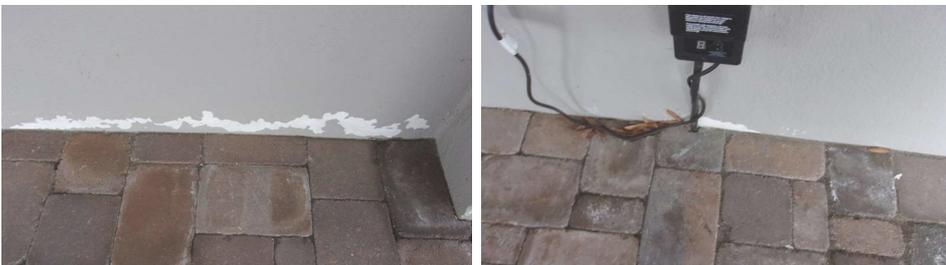
**PAINT CHIPPING**

There is some paint chipping of the stucco on the exterior wall to the right of the front door as well as on the second level balcony.

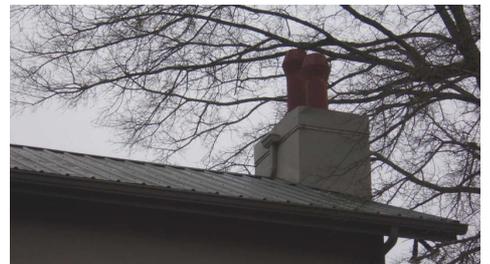
### CHIMNEY SPARK SCREEN ARRESTOR MISSING

No chimney spark screens appear present on the chimney flues as viewed from the ground. Also a good indicator that the flues do not have a spark screens is fact that leaves and debris fell into the fireplaces when the fireplace dampers where inspected. With out a spark screen or cap debris, leaves, and water can / may enter the chimney.

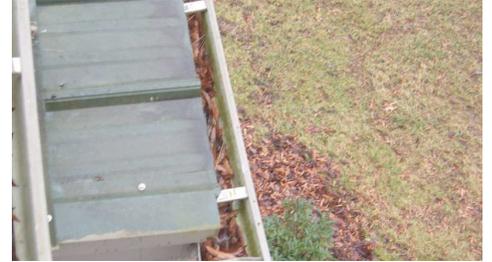
There are no screens of the gutters.

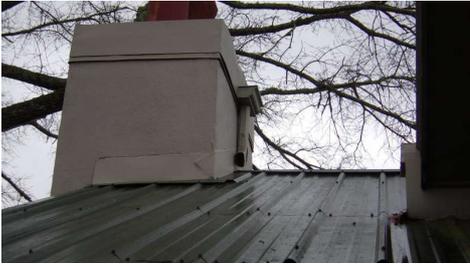
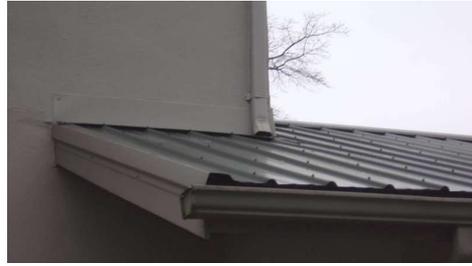
There are downspouts that are releasing water directly onto the upper metal roofing with water then draining down the roof to the lower gutter. This is not recommended simply because of the impact of a concentrated flow of water on the roof. It may also cause water to splash onto the stucco chimney cladding or the flashing at the base of the chimney.

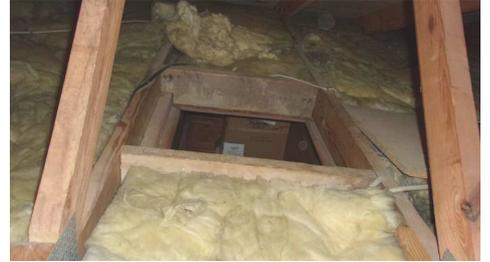
#### 5.1.1 Access

### ACCESS SIZE

The attic access ceiling panel is smaller than the standard panel size of 22.5 x 30. It is located in the upper floor back right bedroom closet.

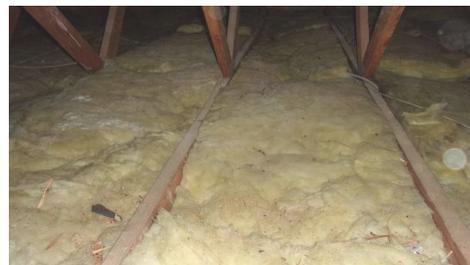
The ceiling trusses in the attic are visible above the insulation. It is recommend that these trusses be covered with insulation to help reduce thermal bridging, which is heat transfer through uninsulated wood members. Recommend a qualified attic insulation contractor install additional insulation.

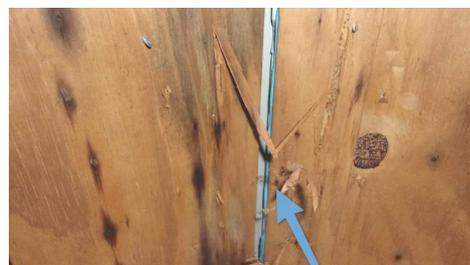
The attic has ridge venting through the metal cap on the ridge of the roof line. The roof sheathing is normally cut back about 2 inches to allow air flow from the soffits / eaves up through the roof venting. The visible sheathing at the ridge is cut back less than this 2 inches.

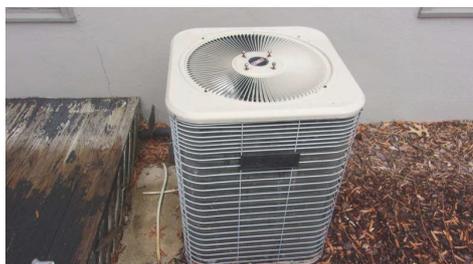
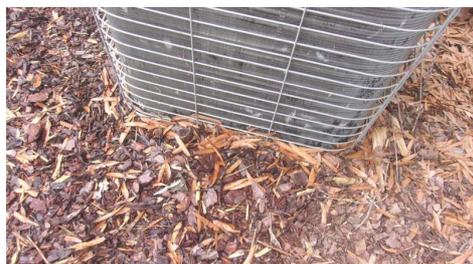
### 6.4.2 Air Conditioner

The outside condensing unit should be raised at least 6 inches off the ground in moderate snowfall areas. Recommend evaluation.

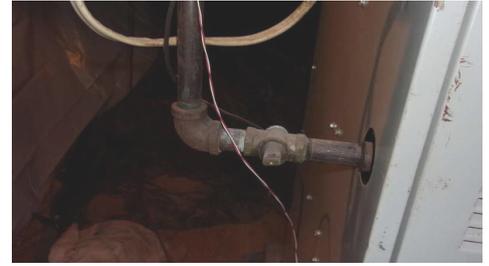
6.5.1 Gas Furnace

**NO DIRT LEG**

There is no dirt leg on the gas line to the appliance. Recommend installation.

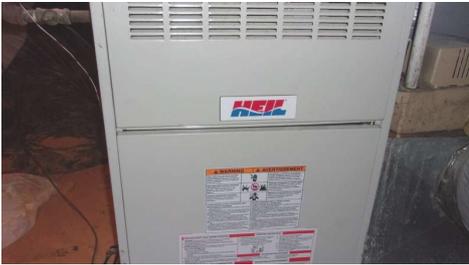
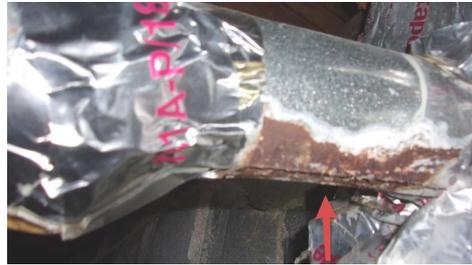
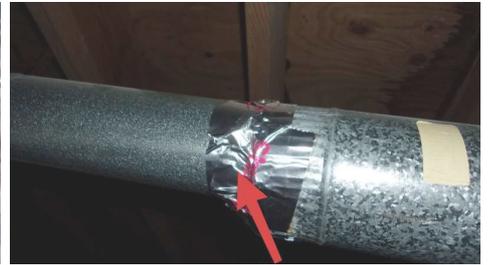
6.5.2 Gas Furnace

**GAS EXHAUST PIPING LEAKING**

The exhaust line off the crawlspace located gas furnace is rusted, the line is differing sizes (instead of one sized piping), the seams are taped and the end point of the exhaust line is not connected and appears to be exhausting carbon monoxide into the home (crawlspace). This needs to be corrected immediately.

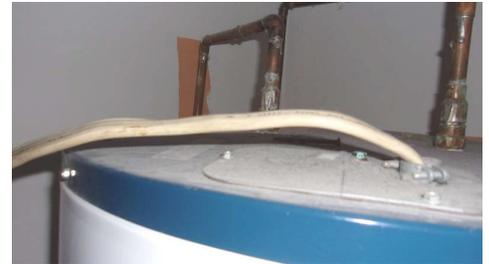
7.7.1 Hot Water Systems

**ELECTRIC WIRING NOT PROTECTED**

The electrical wiring to the water heater is not protected and needs to be in protective conduit.

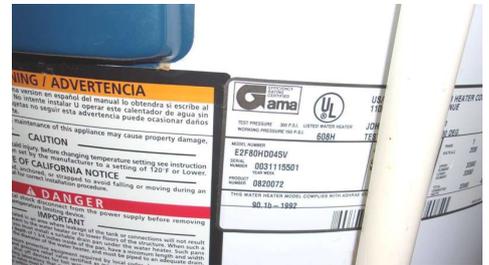
7.7.2 Hot Water Systems

**NEAR END OF LIFE**

Water heater, per the data plate, was manufactured in the year 2000. The normal life expectancy of a water heater is roughly 8-12 yrs. So replacement at some point in time should not be a surprise.

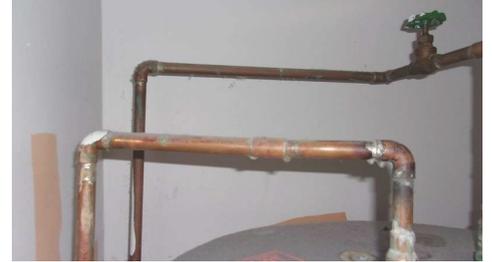
No expansion tank was present. Expansion tanks allow for the thermal expansion of water in the tank without putting pressure on water distribution lines. They are installed on the cold water lines. These are required in certain areas for new installs. Recommend installation when replaced.

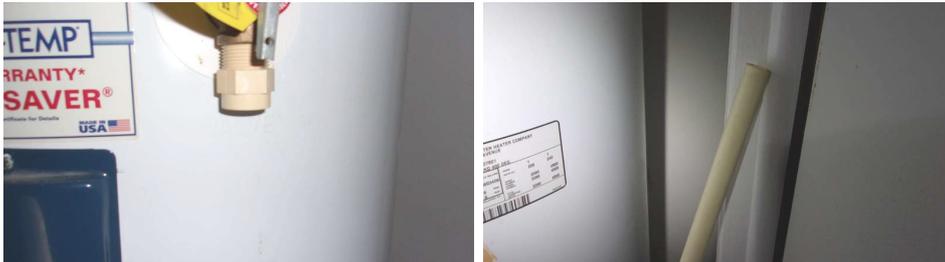
#### 7.7.5 Hot Water Systems

### NO TPR PIPE

1. Not fully secured, easily becomes disconnected and
2. The TPR pipe is PVC.

Recommend replacing with non PVC piping and securing / attaching to TPR valve.

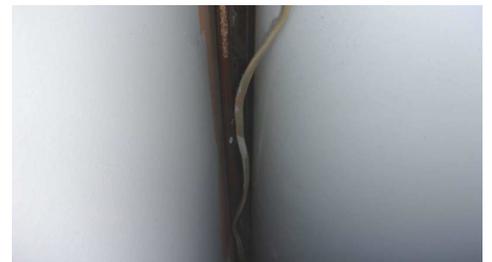
#### 7.7.6 Hot Water Systems

### NO ELECTRIC DISCONNECT

There is no water heater electrical disconnect located at the water heater. One is required for the protection of a service person when repairing or replacing the unit. However, since the water heater is in the same room as the electric panel the shut in the panel will suffice.

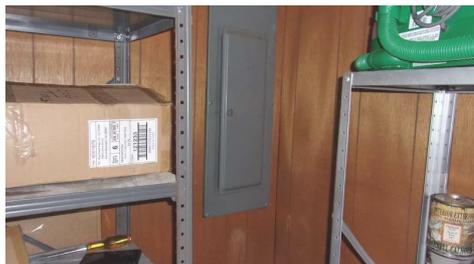
#### 8.4.1 Main Service Panel

### WORKING SPACING

The Main Service Panel is not in unobstructed clear space. The panel should be in clear space (30 inches x 36 inches) that is at least 30 inches wide with 36 inches in front of the panel. The panel does not need to be centered in the 30 inches but the door needs to open a full 90 degrees. Not complying with this is considered a safety issue. I recommend this be corrected. A licensed electrician should address this issue.

There is no lighting for the Main Service Panel. Should be lighting for each panel. The Main Service Panel requires unobstructed space around the panel.

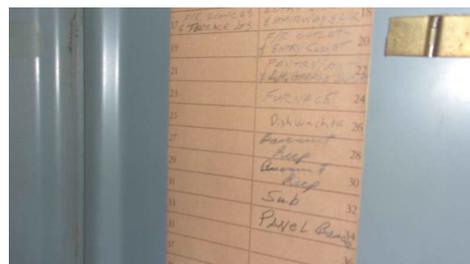
#### 8.4.2 Main Service Panel

### INCOMPLETE OR MISSING DIRECTORY

The service panel directory is missing or incomplete. All service panels should have a complete Breaker / Fuse Directory. A directory will allow a specific circuit to be disconnected without shutting off the homes main disconnect. The inspector has no way of confirming the accuracy of the directory, only whether it is missing or appears incomplete. For personal safety a complete circuit directory is required. A licensed electrician should be contacted about developing a panel directory.

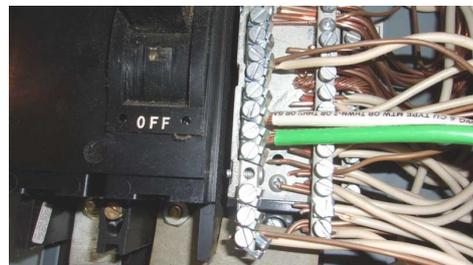
#### 8.4.3 Main Service Panel

### BUS BAR BONDING SCREW

There is no visible grounding screw (green) to verify the grounding of the neutral / ground bus bars to the panel. I recommend a licensed electrician be consulted and their recommendation for correction be followed.

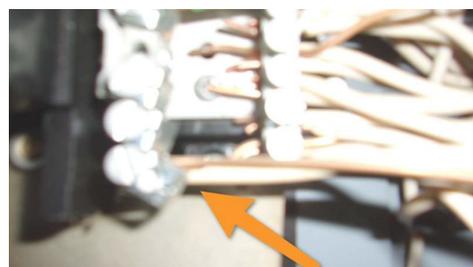
Neutral (white) wires are not to be doubled up where they are secured to the neutral / ground bus bar. One neutral wire only under a screw on the bus bar. This is not the case in this panel.

Recommend evaluation and correction by a licensed electrician.

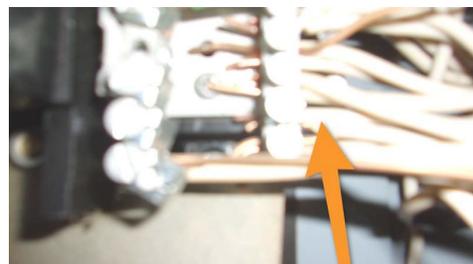
#### 8.4.6 Main Service Panel

### NEUTRALS AND GROUNDS TOGETHER

In a service panel neutral (white) wires and ground (bare) wires are to be separated where secured to the neutral / ground bus bar. In this panel there are neutral and ground wires together, under the same screw, on the bus bar. This needs to be corrected by a licensed electrician.

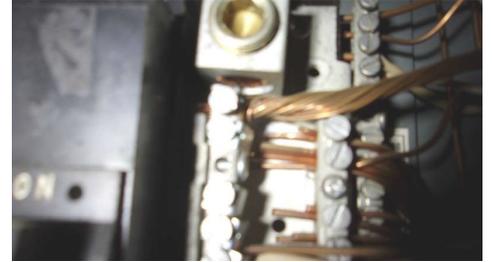
There is a stranded ground wire where not all of the wire strands are under the ground screw. Recommend correction.

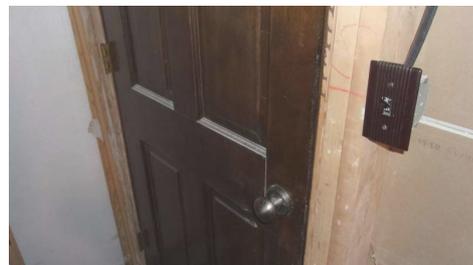
The crawlspace door does not latch properly. It additionally has no weather stripping, threshold, etc. Since this door separates conditioned from unconditioned space sealing this door properly is recommended.

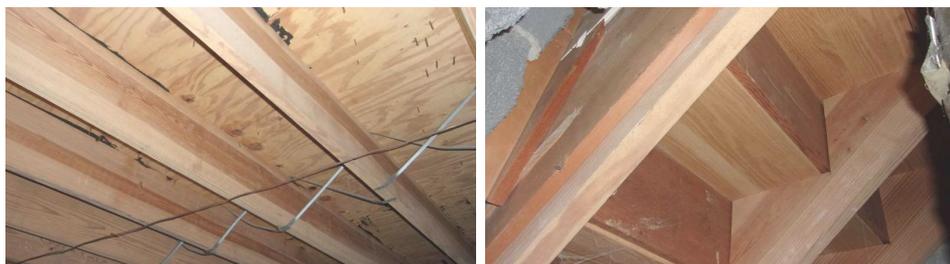
#### **MISSING INSULATION**

There is no insulation installed between the floor joists in the home's crawlspace. Installation of insulation with a value of at least R-19 is recommended. If insulation with kraft paper (a vapor barrier) is used, it should be installed so the vapor barrier is up tightly against the subfloor so there is no air space between the insulation and the subfloor. Additionally, the insulation should not be compressed, this will significantly reduce its effectiveness.

Additionally, the underside of the steps from the main to lower level, in the crawlspace, are not insulated. Recommend this be done as well.

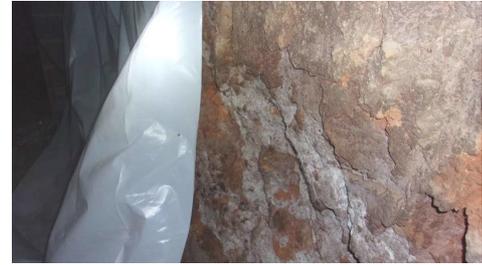
There are signs of a mildew like substance on the crawlspace soil. This is normally the result of moisture escaping from the soil. The proper installation of vapor retarder over the soil is recommended. In addition to having the mildew like substance treated or removed.

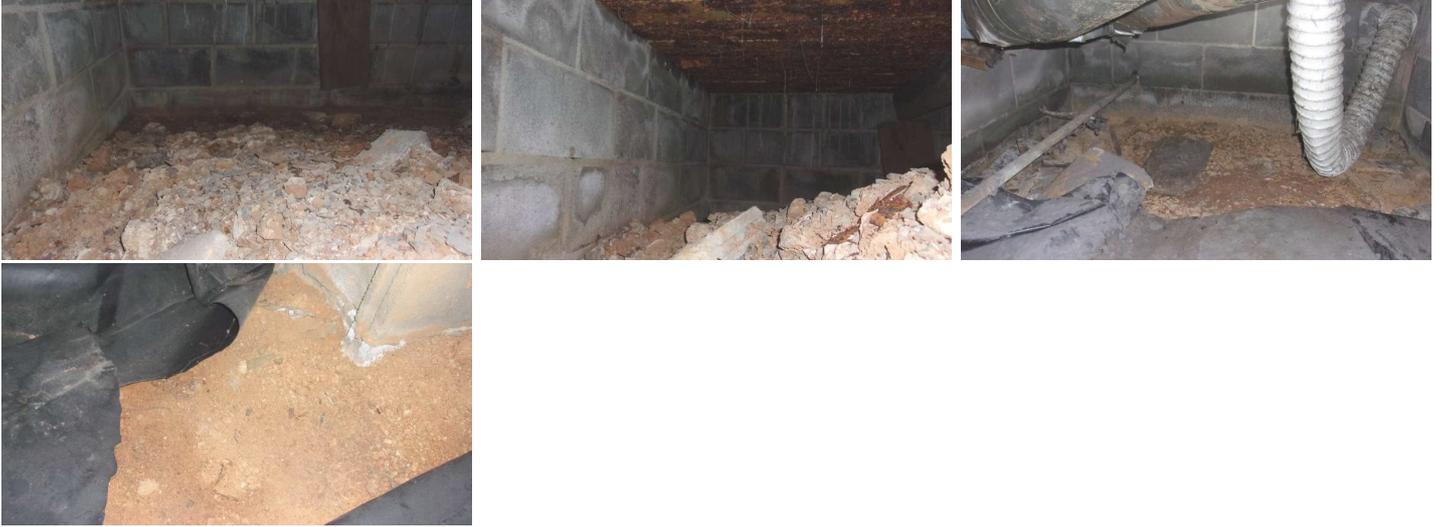
**IMPROPER INSTALLATION / INCOMPLETE**

Vapor barrier is improperly installed. This can result in unwanted moisture. Typically a vapor barrier or retarder should be at least 6 mil plastic that completely covers the soil; free of holes and tears; and all seams overlapped at least 6 inches and taped / sealed. The vapor retarder should be cleanly cut around foundation walls and columns or be extended up and be secured / sealed to the walls and columns.

Recommend repair.

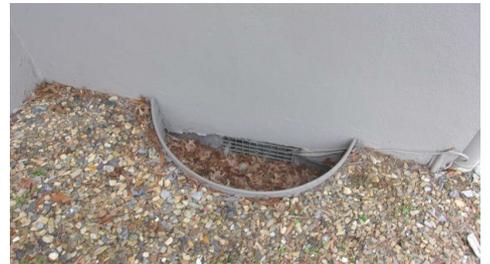
The home's crawlspace lacks the standard recommended amount of venting. At this time there is one crawlspace vent on the back side of the house. If the crawlspace has a full / complete / correctly installed vapor barrier / retarder one square foot of venting is required per 1500 sq. ft. of crawlspace. If the crawlspace does not have a full / complete / correctly installed vapor retarder, as is the case here, then one square foot of ventilation is required per 150 sq.ft. Recommend this be corrected by adding mechanical venting and adding / correcting the vapor retarder.

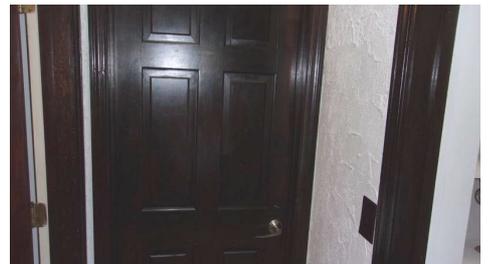
10.1.1 Door To Living Space

**NOT FIRE RATED**

The door separating the garage and home is not a fire rated door. This firewall door must be at least 1 3/8-inch thick, metal / steel, or a 20-minute fire-rated solid wood door. Since this door has decorative panels it does not meet the 1 3/8 inch parameter.

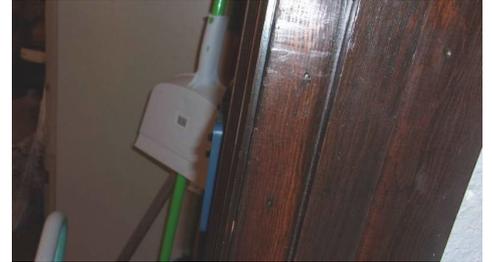
10.1.2 Door To Living Space

**NOT SELF-CLOSING**

The door between an attached garage and the home should have self-closing hinges or a self closing device to help prevent spread of a fire to living space. This door must close and latch on its own. Recommend installation.

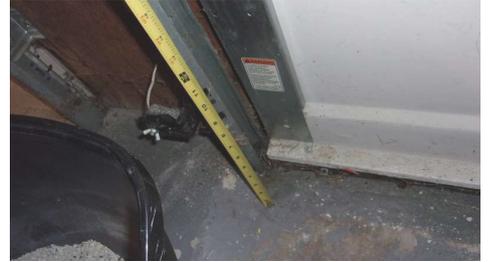
The electronic eye auto reverse on either side of the right side garage door (from the outside) needs to be no greater than 6 inches above the floor. Recommend correcting.

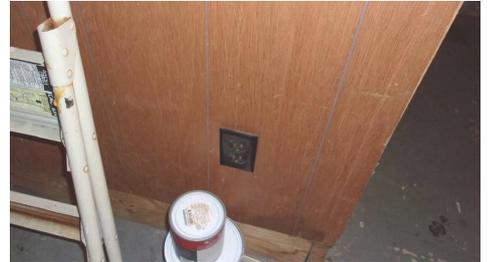
The single electrical outlet in garage (that was visible) should be at least three feet above the floor because a spark from this outlet the can be a source of ignition for gas fumes.

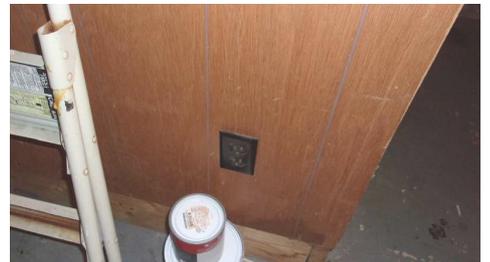
There is no GFCI protection on the single outlet visible in the garage, by the living space door. Ground Fault Circuit Interrupter (GFCI) protection is required on all 120 volt receptacles in garages and grade level areas of unfinished accessory buildings as of 1971. GFCI protection is not required for receptacles in the garage ceiling nor for dedicated receptacles that serve an appliance that is not easily moved.

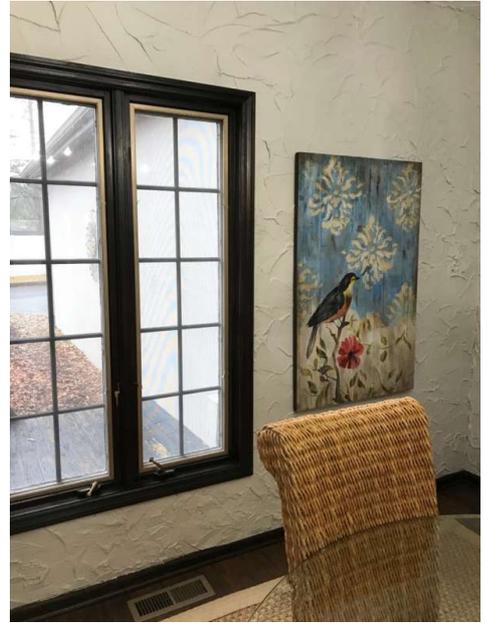
The right side window in the dining room does not close fully with the crank and the hinges are not operating correctly.

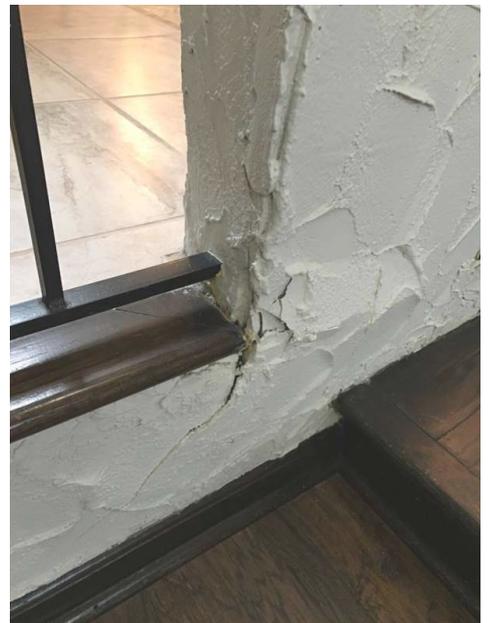
#### 14.4.1 Ceilings / Walls

### MAJOR CRACKS

There is major cracking visible in this rooms walls / ceiling. They may indicate soil movement or insufficient wall support resulting in wall sagging. Cracks of around a 1/4 of an inch with visible displacement (up or down / in or out) around the cracks are considered to be of structural concern and should be evaluated.

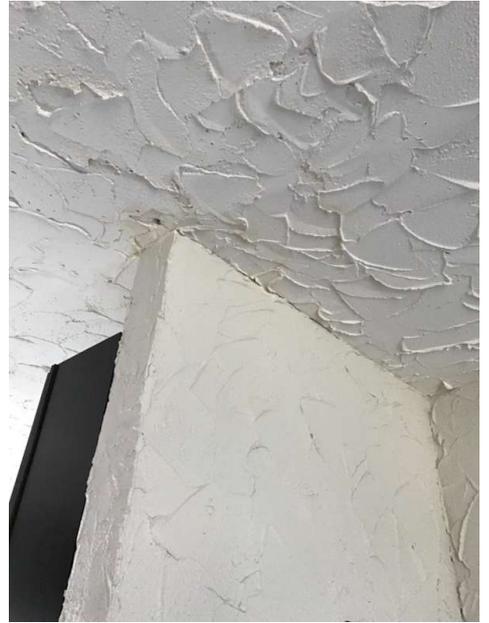
#### 14.4.2 Ceilings / Walls

### MOISTURE STAINS / DAMAGE

There are stains on the walls/ceilings that appear to be the result of moisture. The source of moisture may / may not have been corrected. There was / was not a sign of moisture in this area, at the time of the inspection, as tested for with a thermal imaging camera.

If there was no corresponding moisture intrusion point identified then it is recommended that this area be monitored in order to detect continued or further damage. This area is below the upper level bathroom.

This is located where the back main level living room meets the kitchen (close to the stove).

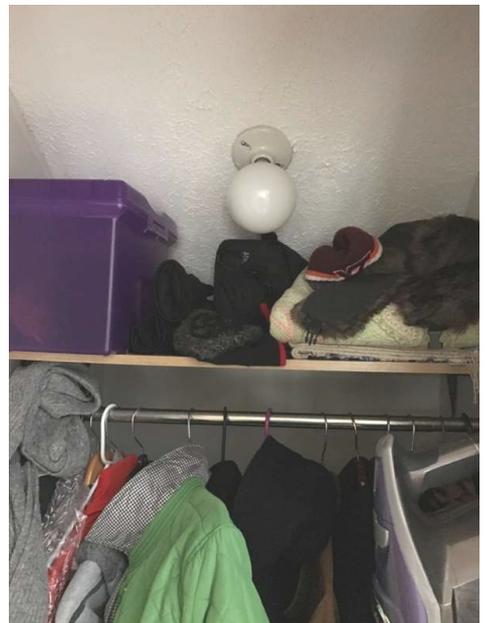
The closet lighting does not meet today's safety clearance standards. Although not an issue when the home was constructed, the lack of standard clearances is considered a safety issue. Recommend adherence to today's standards.

Recessed (totally enclosed) incandescent, fluorescents or LED lighting fixtures in closets shall be no closer than 6 inches from a closets defined storage area. Storage area height is roughly defined as the highest of 6 feet from the floor, the height of clothes hanging rod or the height of a shelf above the clothes hanging rod.

Surface mounted lights shall be at least 6 inches from a closets defined storage area. Storage area height is roughly defined as the highest of 6 feet from the floor, the height of clothes hanging rod or the height of a shelf above the clothes hanging rod.

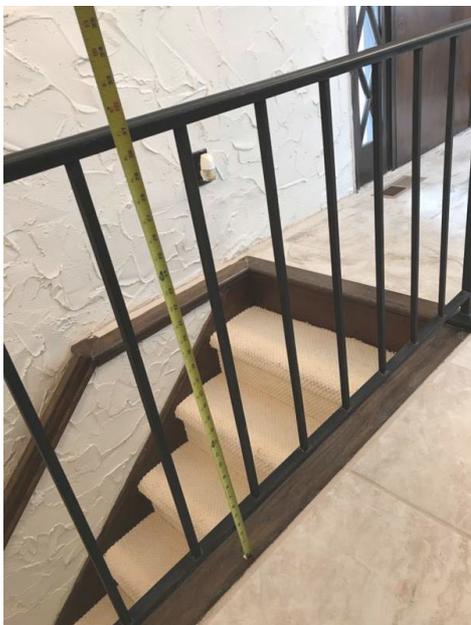
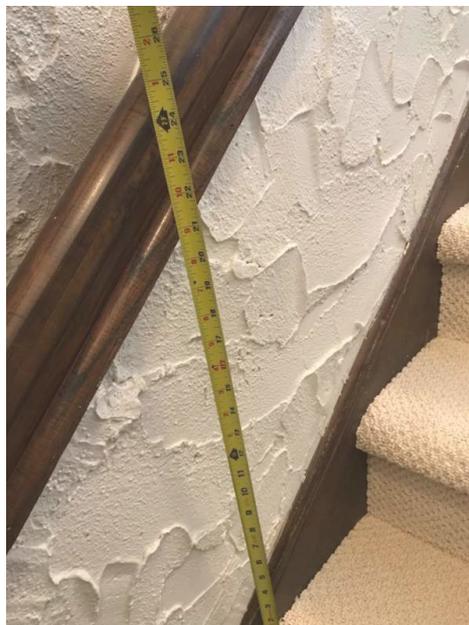
The stair railings are 31.5/25 inches high. They do not meet the recommended building standard railing height of 34 to 38 inches. This is considered a safety issue, recommend addressing.

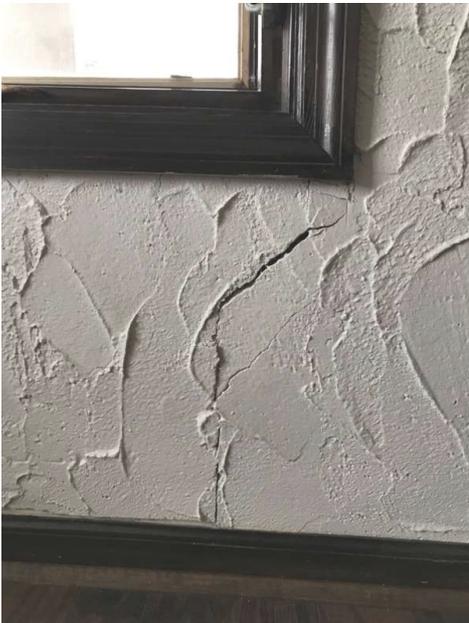
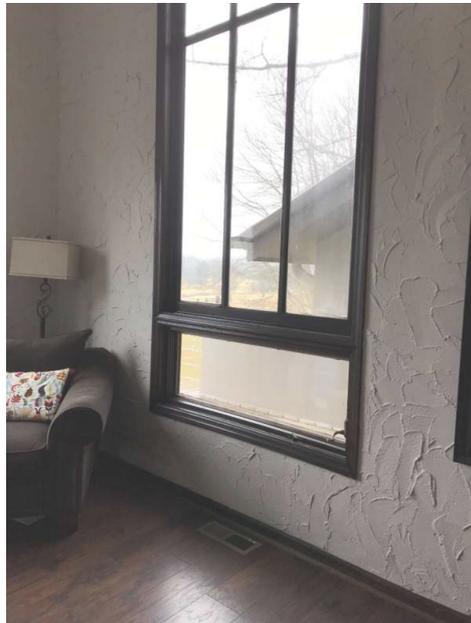
There is major cracking visible in the bedrooms walls. They may indicate soil movement or insufficient wall support resulting in wall sagging. Cracks of this size with visible displacement around the cracks are considered to be of structural concern and should be evaluated by a structural engineer.

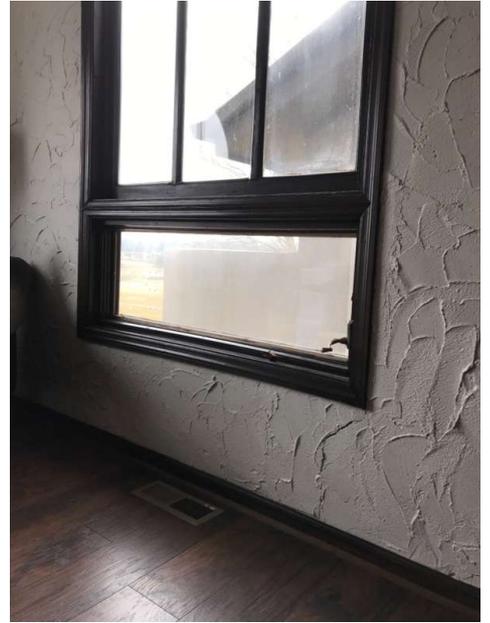
### 21.8.1 Windows

#### **DO NOT EASILY OPEN**

The bottom casement window under the cathedral window in the seating is difficult to open. This is not an egress concern as there is an operable exterior door in the master bedroom .

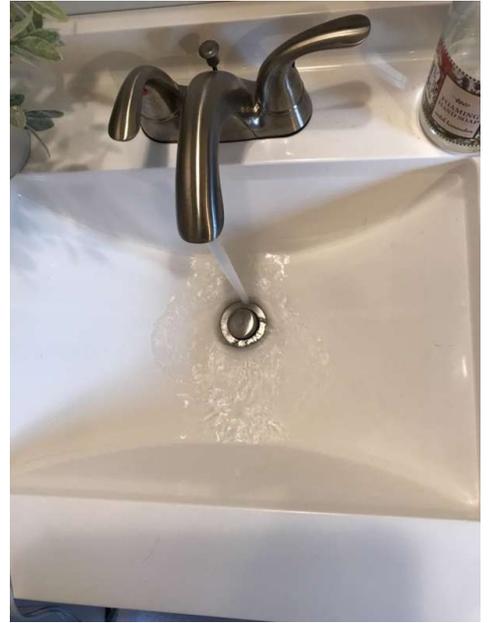
Just a heads up that the sink does not have a water overflow hole. So caution should be taken when filling the sink with the stopper closed.

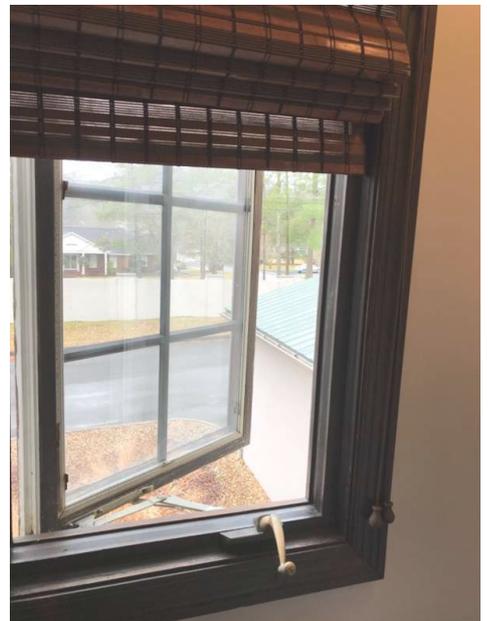
There are window screens or storm windows missing. They may be in storage. Recommend addressing with the homes current owner to see if the are locateable.

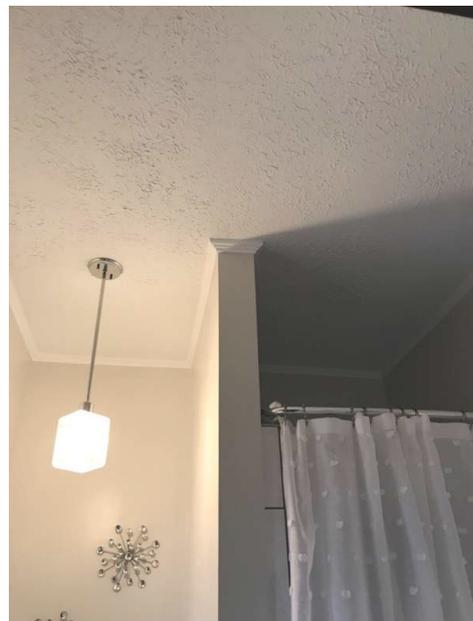
There is no bathroom moisture exhaust venting. Bathroom venting is installed to remove moisture from the bathroom not to keep the air fresh. Even with a window in the bathroom exhaust venting is recommended simply because opening a window in freezing weather is usually not done. Many times we don't always remember to open the window before showering. If installed an exhaust fan should vent to the homes exterior not to the attic.

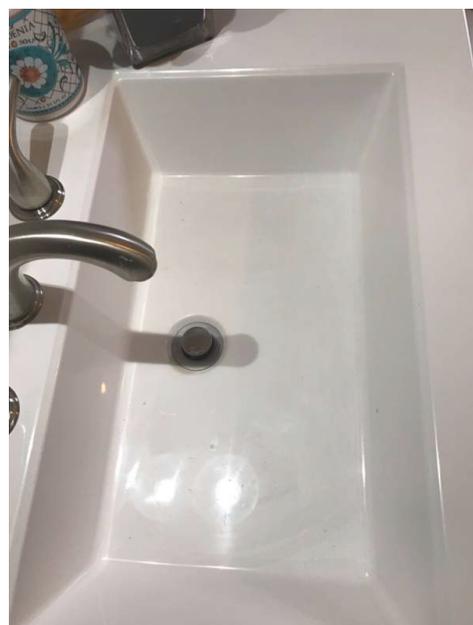
23.4.1 Sink(s)

### NO OVERFLOW HOLES

Just a heads up that the sink does not have a water overflow hole. So caution should be taken when filling the sink with the stopper closed.

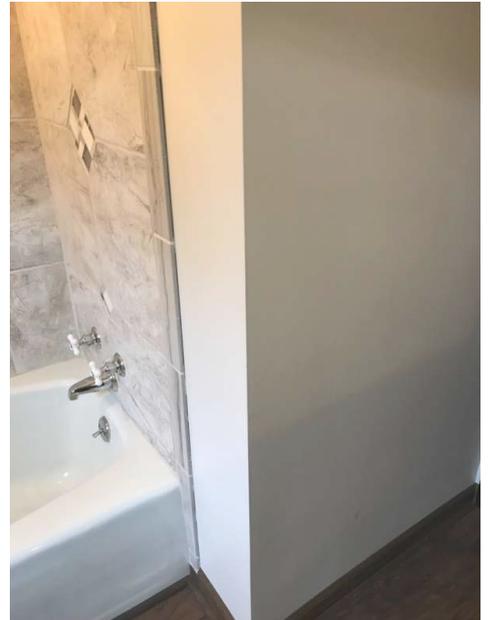
Common building standards are to install a wall panel in the wall behind the shower faucet to allow access for faucet repair or replacement. One has been installed in this case.

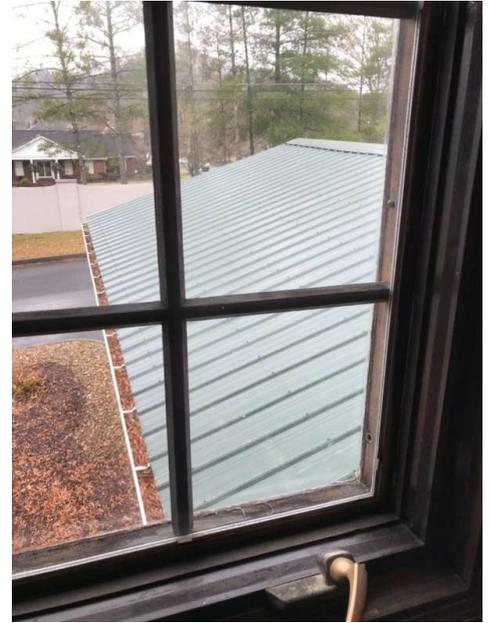
23.11.1 Windows  
**MISSING SCREEN(S) / STORM WINDOWS**

There are window screens or storm windows missing. They may be in storage. Recommend addressing with the homes current owner to see if the are locateable.

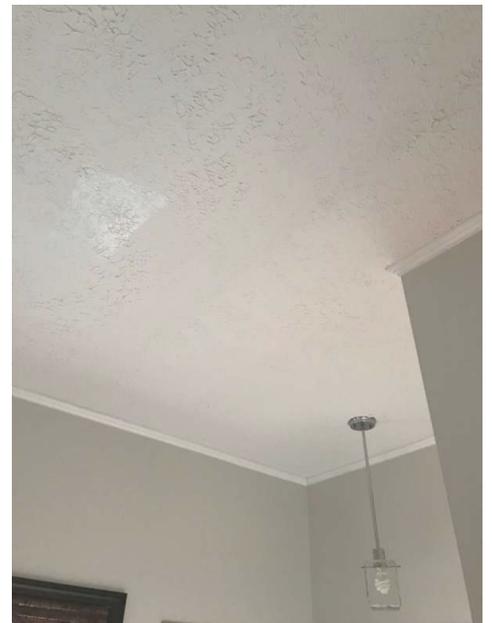
### 23.12.1 Moisture Exhaust Fan

#### **NO VISIBLE VENTING**

There is no bathroom moisture exhaust venting. Bathroom venting is installed to remove moisture from the bathroom not to keep the air fresh. Even with a window in the bathroom exhaust venting is recommended simply because opening a window in freezing weather is usually not done. Many times we don't always remember to open the window before showering. If installed an exhaust fan should vent to the homes exterior not to the attic.

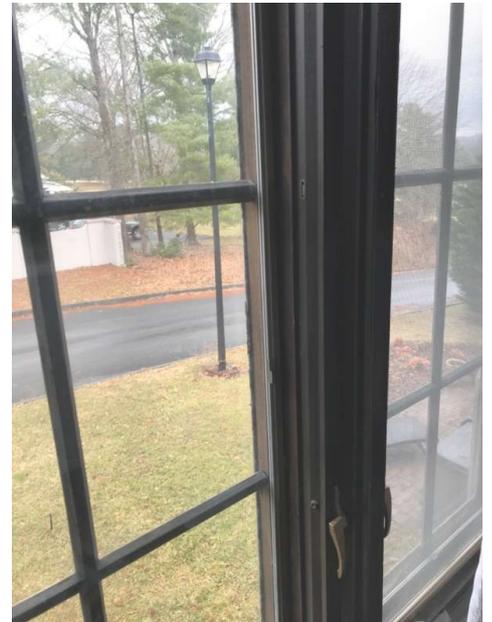
**MISSING SCREEN(S) / STORM WINDOWS**

LEFT CASEMENT CLOSEST TO CLOSET

There are window screens or storm windows missing. They may be in storage. Recommend addressing with the homes current owner to see if the are locateable.

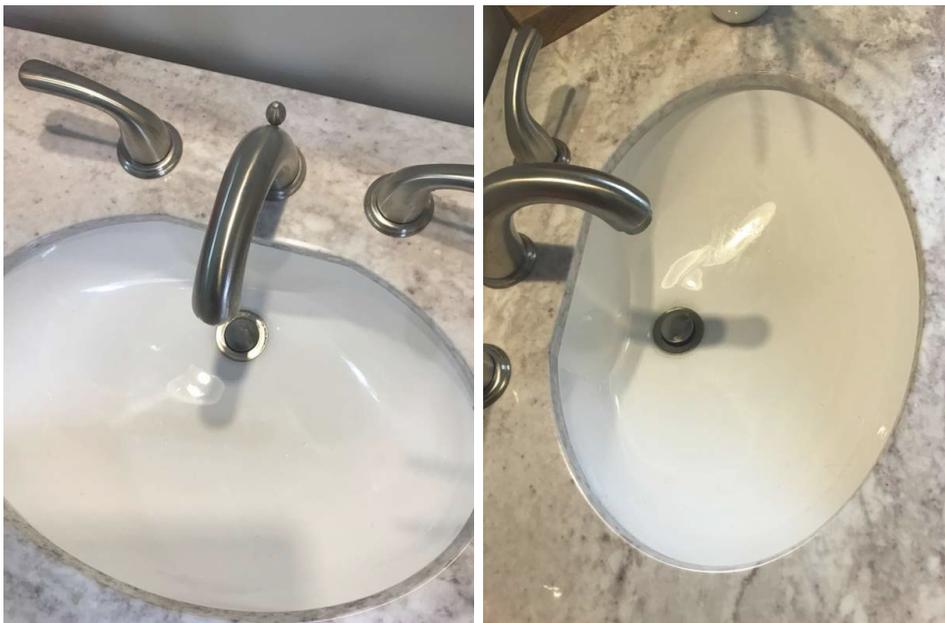
25.4.1 Sink(s)

**NO OVERFLOW HOLES**

Just a heads up that the sink does not have a water overflow hole. So caution should be taken when filling the sink with the stopper closed.

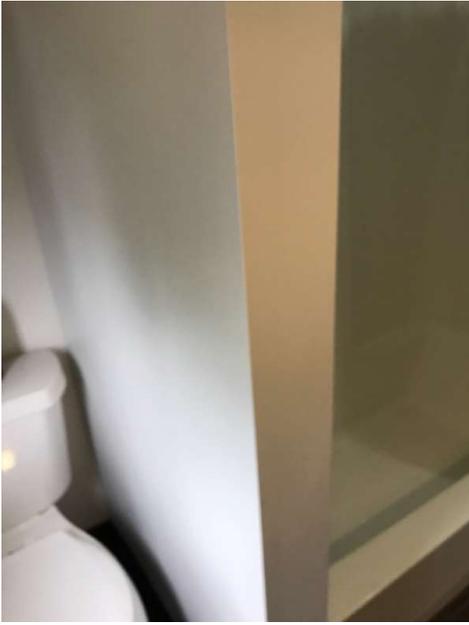
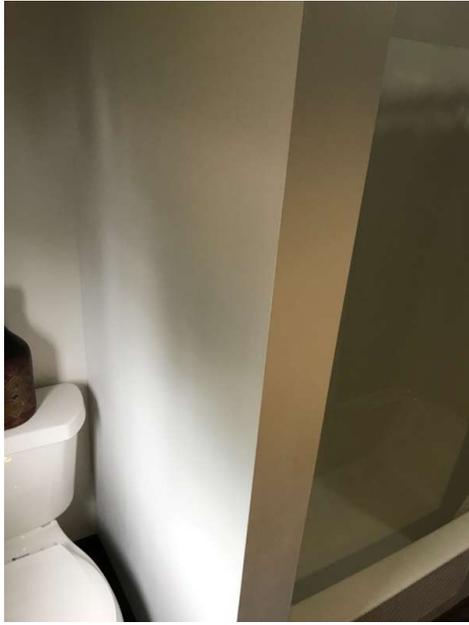
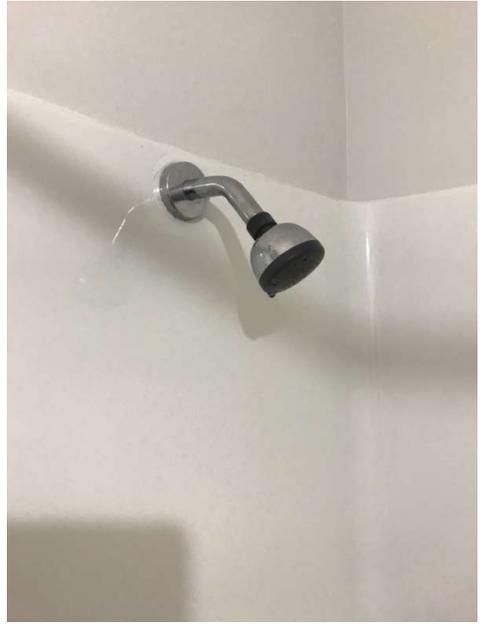
Common building standards are to install a wall panel in the wall behind the shower faucet to allow access for faucet repair or replacement. One has been installed in this case.

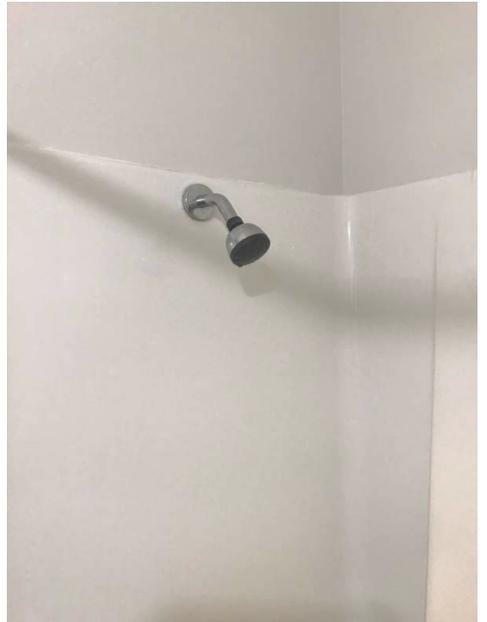
25.8.3 Tub or Tub / Shower Combined  
**LOOSE SHOWER HEAD**

Shower Head is not secure in the wall.

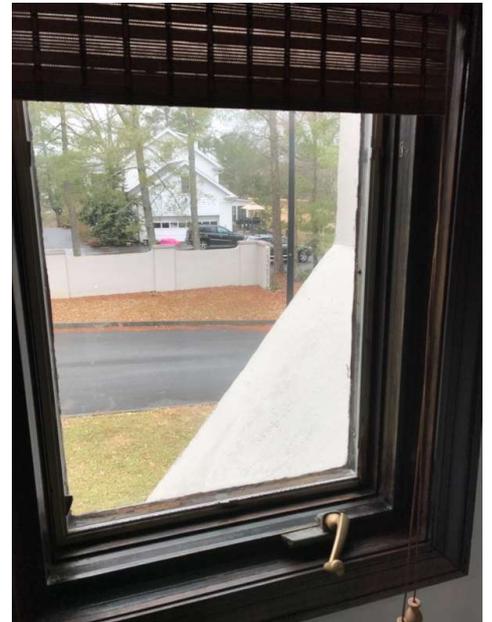
25.11.1 Windows

**MISSING SCREEN(S) / STORM  
WINDOWS**

There are window screens or storm windows missing. They may be in storage. Recommend addressing with the homes current owner to see if the are locateable.

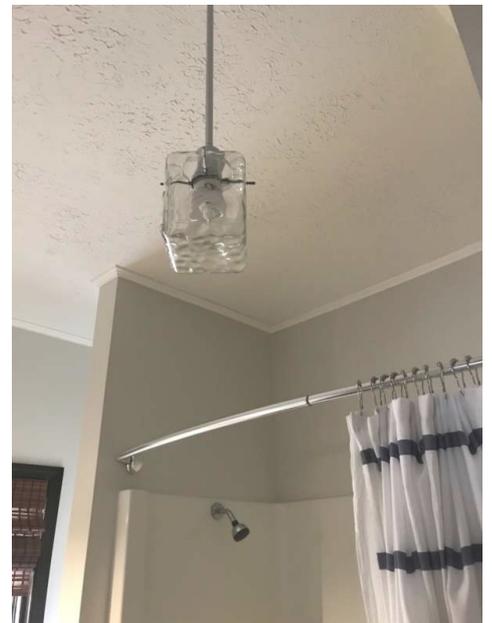
#### 25.12.1 Moisture Exhaust Fan

### NO VISIBLE VENTING

There is no bathroom moisture exhaust venting. Bathroom venting is installed to remove moisture from the bathroom not to keep the air fresh. Even with a window in the bathroom exhaust venting is recommended simply because opening a window in freezing weather is usually not done. Many times we don't always remember to open the window before showering. If installed an exhaust fan should vent to the homes exterior not to the attic.

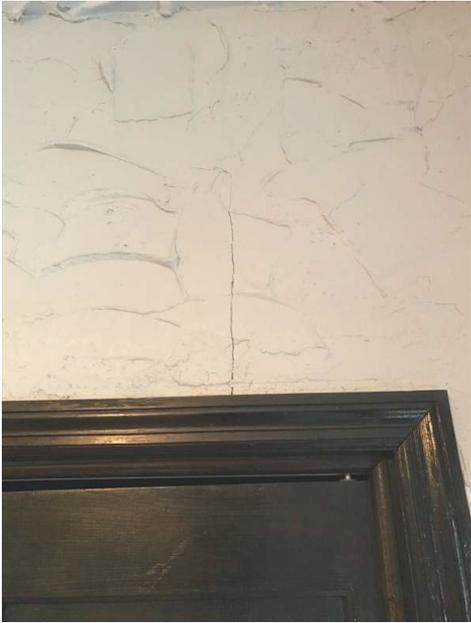
There are minor cracks in the walls /ceiling. Cracks at the corners of doors and windows are not uncommon. They may be due to long-term settlement or from the shifting / shrinking of a door or window header. Joint cracks can be the result of expansion and contraction of framing or structural stress.

Located on the right side above the closet door.

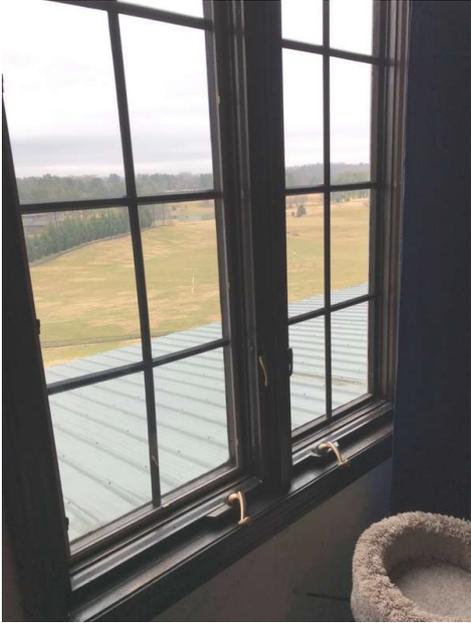
26.8.1 Windows

**MISSING SCREEN(S) / STORM WINDOWS**

There are window screens or storm windows missing. They may be in storage. Recommend addressing with the homes current owner to see if the are locateable.

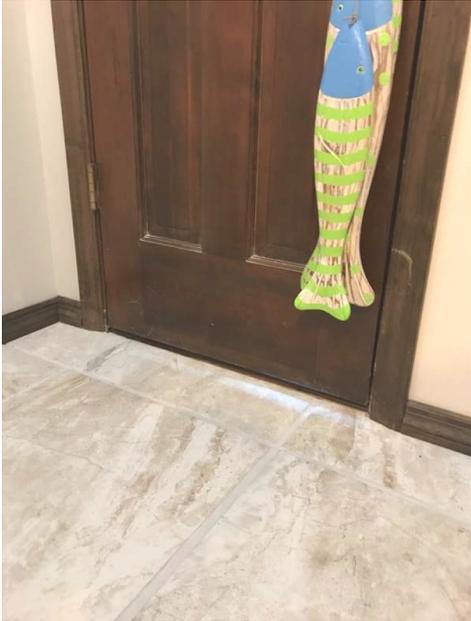
Since there is no HVAC return air vent in the bathroom the clearance at the base of the doors should be at least 3/4 of an inch to allow for airflow back to the HVAC return vent. If door is closed a great deal of the time it is recommended the door base be trimmed to allow for adequate air return.

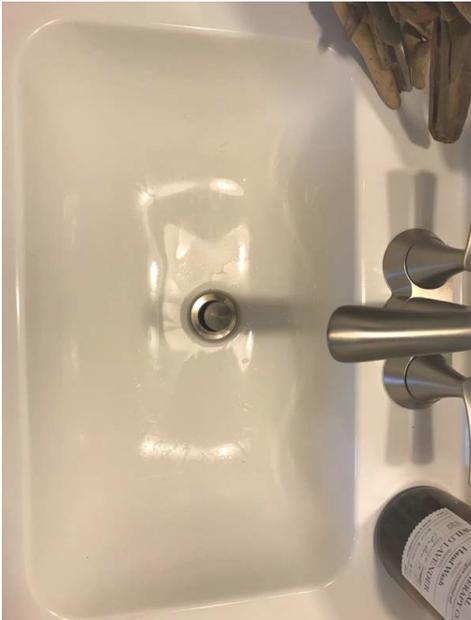
28.4.1 Sink(s)

Just a heads up that the sink does not have a water overflow hole. So caution should be taken when filling the sink with the stopper closed.

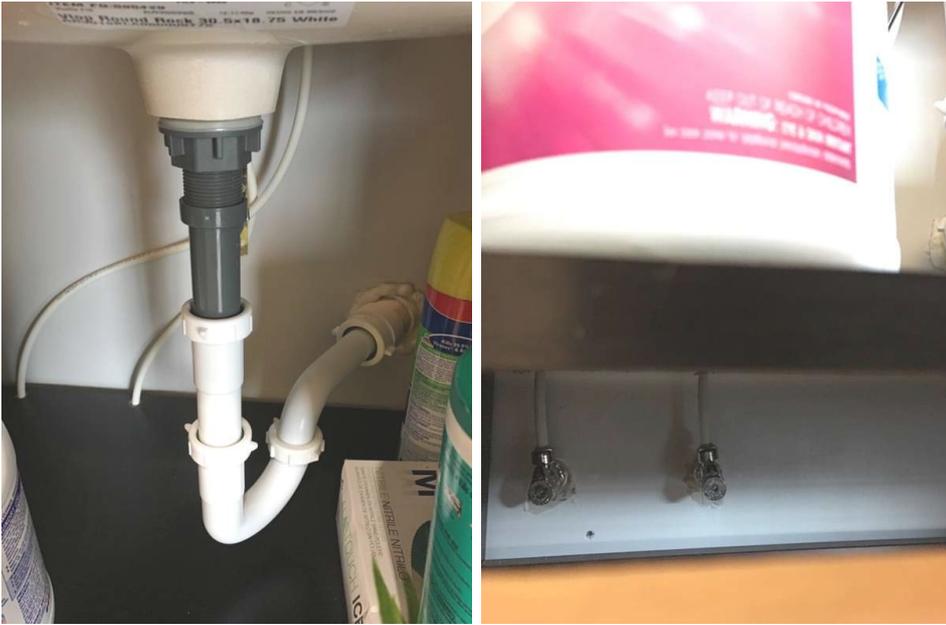
28.4.2 Sink(s)

There are no shut off valve to the supply lines .

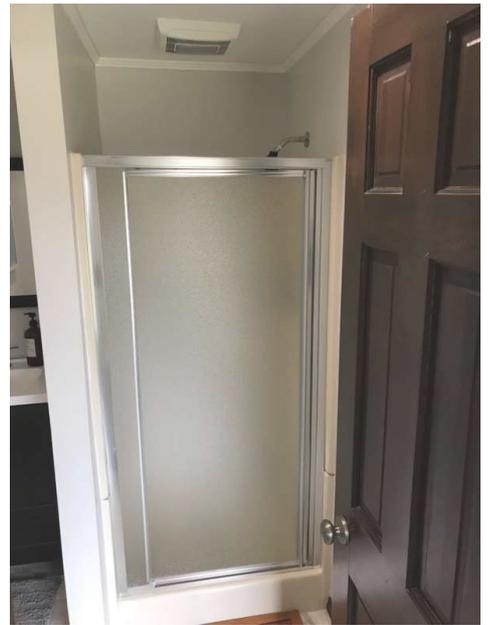
There is no panel to access the shower plumbing fixtures for repair or replacement.
