SUMMARY

1234 Main St.Saco Maine 04072

11/18/2017 9:00AM

Matthew Blain
InterNACHI ID# NACHI17050108
Blue Lobster Home Inspection INC
207-391-4244
bluelobsterhomeinspection@gmail.com

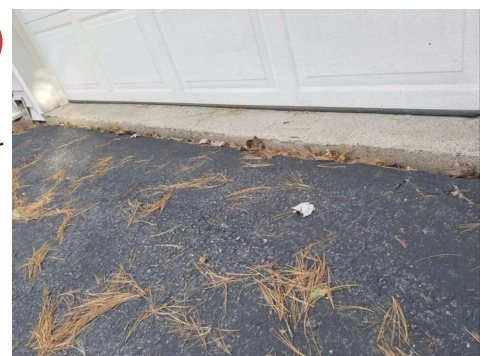
2.3.2 Driveway

TRIP HAZARD

One or more trip hazards were found in the driveway due to cracks, settlement and/or heaving. Recommend having a qualified contractor evaluate and repair or replace driveway sections as necessary to eliminate trip hazards.

Contact a qualified driveway contractor.

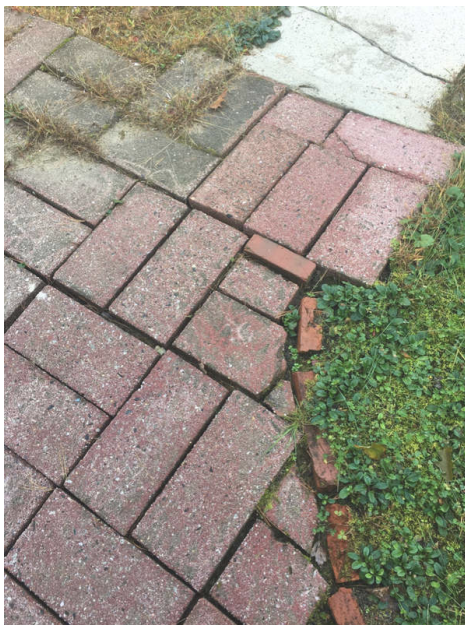
TRIP HAZARD

One or more trip hazards were found in sidewalk and/or patio sections due to cracks, settlement and/or heaving. A qualified contractor should evaluate and repair or replace sidewalk and/or patio sections as necessary to eliminate trip hazards.

Recommendation
Contact a qualified concrete contractor.

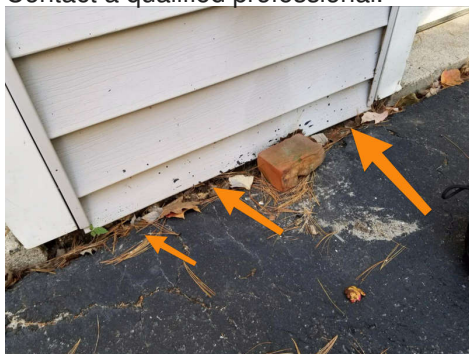
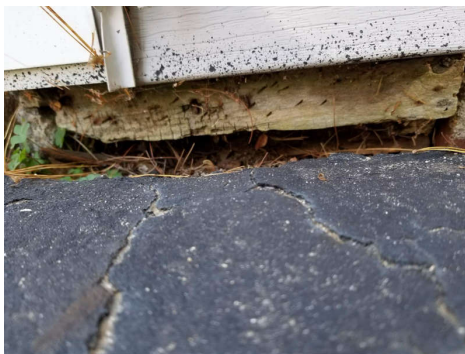
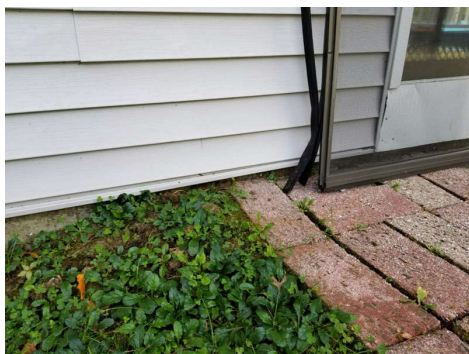
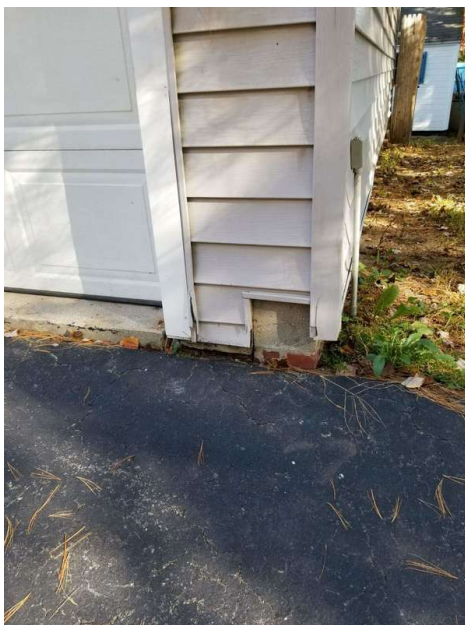
2.5.1 Soil Contact

SOIL WITHIN 6" OF SIDING/TRIM, ROT

Soil is in contact with or less than six inches from siding and/or trim. This is a conducive condition for wood destroying insects and organisms. Wood siding and/or trim is rotten in some areas as a result. A qualified contractor should evaluate and repair as necessary, replacing all rotten wood. Also, the soil should be graded and/or removed as necessary so there

are at least six inches of space between the siding and trim and the soil below.

Recommendation
Contact a qualified professional.

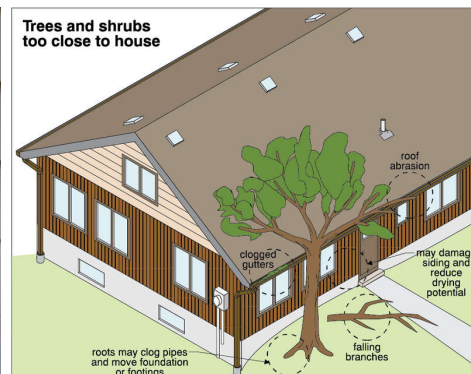
2.6.1 Vegetation <1' FROM EXTERIOR

Vegetation such as trees, shrubs and/or vines are in contact with or less than one foot from the structure's exterior. Vegetation can serve as a conduit for wood destroying insects and may retain moisture against the exterior after it rains. Vegetation should be pruned and/or removed as necessary to maintain a one foot clearance between it and the structure's exterior.

Contact a qualified landscaper or gardener.

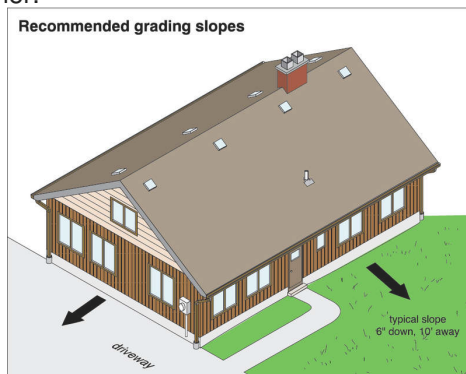
2.7.1 Drainage

NEGATIVE PERIMETER SLOPE - SOIL

The perimeter grading slopes towards the structure in one or more areas. This can result in water accumulating around the structure's foundation, or in basements and crawl spaces if they exist. Accumulated water is a conducive condition to wood destroying insects and organisms. Wet soil may also cause the foundation to settle and possibly fail over time. Recommend grading soil so it slopes down and away from the structure with a slope of at least 5% (10% or better is optimal) for at least 6 feet.

Contact a qualified landscaper or gardener.

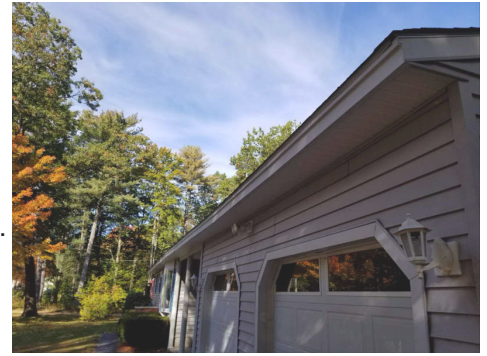
2.9.1 Gutters

MISSING

One or more gutters are missing. This can result in water accumulating around the structure's foundation, or in basements and crawl spaces if they exist. Accumulated water is a conducive condition to wood destroying insects and organisms, and may also cause the foundation to settle and possibly fail over time. A qualified contractor should install gutters and downspouts where missing. Also, extensions such as splash blocks or tie-ins to underground drain lines should be installed as necessary to carry rain water away from the house.

Contact a qualified professional.

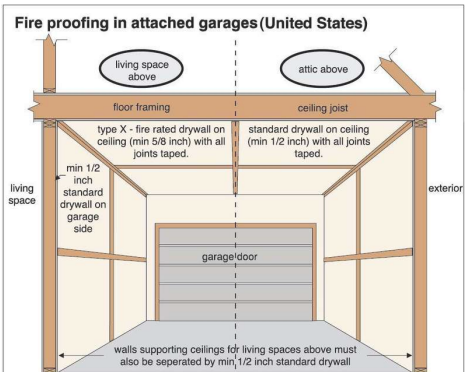
GARAGE FLOOR CRACKS - MINOR

Minor cracks were found in the garage floor. However they don't appear to be a structural concern and no trip hazards were found. No immediate action is recommended, but the client(s) may wish to have repairs made or have cracked sections replaced for aesthetic reasons.

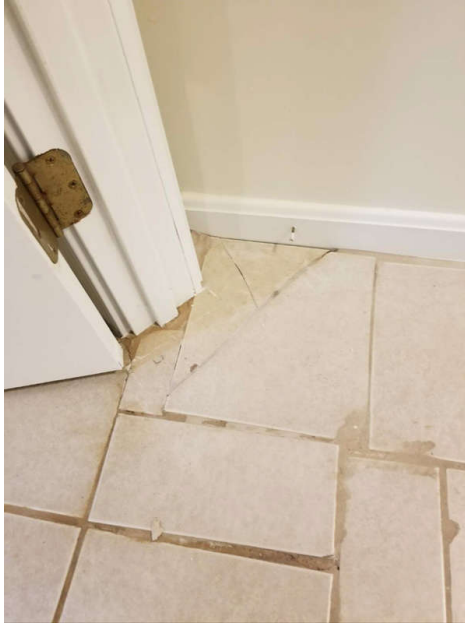
10.18.1 Floors

TILE, STONE AND GROUT - DETERIORATED

Tile, stone and/or grout flooring is damaged and/or deteriorated in one or more areas. A qualified contractor should evaluate and make repairs as necessary. For example, replacing broken tiles and deteriorated grout, and resealing grout.

Recommendation
Contact a qualified professional.

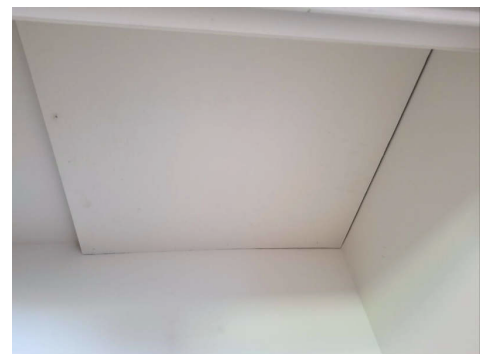
INSUFFICIENT INSULATION

The ceiling insulation's R rating is significantly less than what's recommended for this area. The Department of Energy recommends that attics in Maine be insulated to R49 or approximately 16 inches deep in a typical attic. Recommend having a qualified contractor install additional insulation as per standard building practices for better energy efficiency.

Contact a qualified insulation contractor.

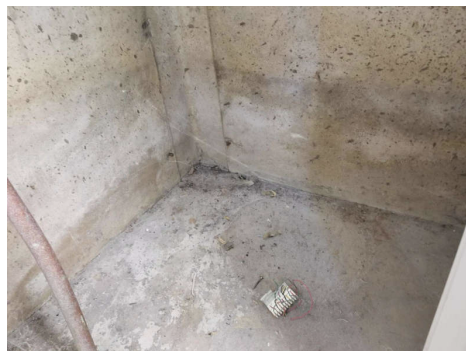
Evidence of prior water intrusion was found in one or more sections of the basement/crawl space. For example, sediment stains on the vapor barrier or foundation, and/or efflorescence on the foundation. Accumulated water is a conducive condition for wood destroying insects and organisms and should not be present in the basement/crawl space. The client(s) should review any disclosure statements available and ask the property owner(s) about past accumulation of water in the basement/crawl space. The basement/crawl space should be monitored in the future for accumulated water, especially after heavy and/or prolonged periods of rain. If water is found to accumulate, a qualified contractor who specializes in drainage issues should evaluate and repair as necessary. Typical repairs for preventing water from accumulating in basement/crawl spaces include:

Repairing, installing or improving rain run-off systems (gutters, downspouts and

extensions or drain lines)
Improving perimeter grading
Repairing, installing or improving underground footing and/or curtain drains

Ideally, water should not enter basements/crawl spaces, but if water must be controlled after it enters the basement/crawl space, then typical repairs include installing trenches, gravity drains and/or sump pump(s) in the crawl space.
