RECOMMENDATIONS SUMMARY

1234 Main St. Vancouver WA 98685

Buyer Name
07/10/2017 9:00AM

Tim & Andrew Tewson
Licensed in Washington & Oregon
Slopeside Home Inspections
360-841-7103
tim@slopesideinspections.com

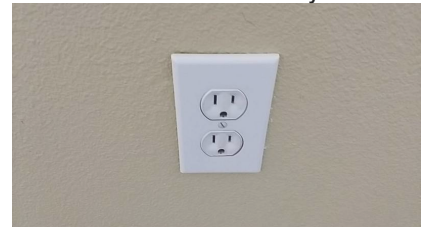
North West Bedroom

One or more cover plates were loose at the time of the inspection on the first floor.

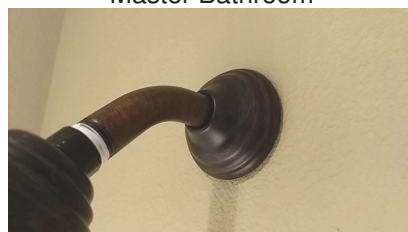
2nd Floor Bathroom

Shower head pipes were loose in both upstairs bathrooms. Recommend correction by a qualified professional.
