SUMMARY
1234 Main St. Charleston SC 29414
Buyer Name
05/09/2019 9:00AM

Adam Richardson
RBI49221, AHIT Cert, BPI BA, ...
PGR Home Inspections
8437890653
adam@pgrhomeinspections.com

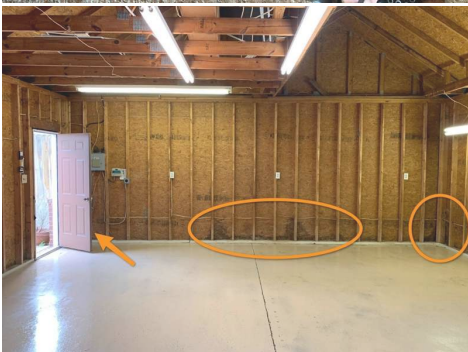
MOISTURE INTRUSION/ WOOD ROT

Several areas of moisture intrusion with high moisture present were found along the walls and framing of the detached garage. One or more of these areas had wood rot present. Recommend a qualified contractor evaluate the detached garage framing and locate the moisture intrusion point, evaluate the extent of the rot damage and repair.

Recommendation
Contact a qualified professional.
